TARGETED BROWNFIELD ASSESSMENT

PERRY ARMORY

ASTM E 1527-05
Phase I Environmental Site Assessment
All Appropriate Inquiry

March 16, 2010

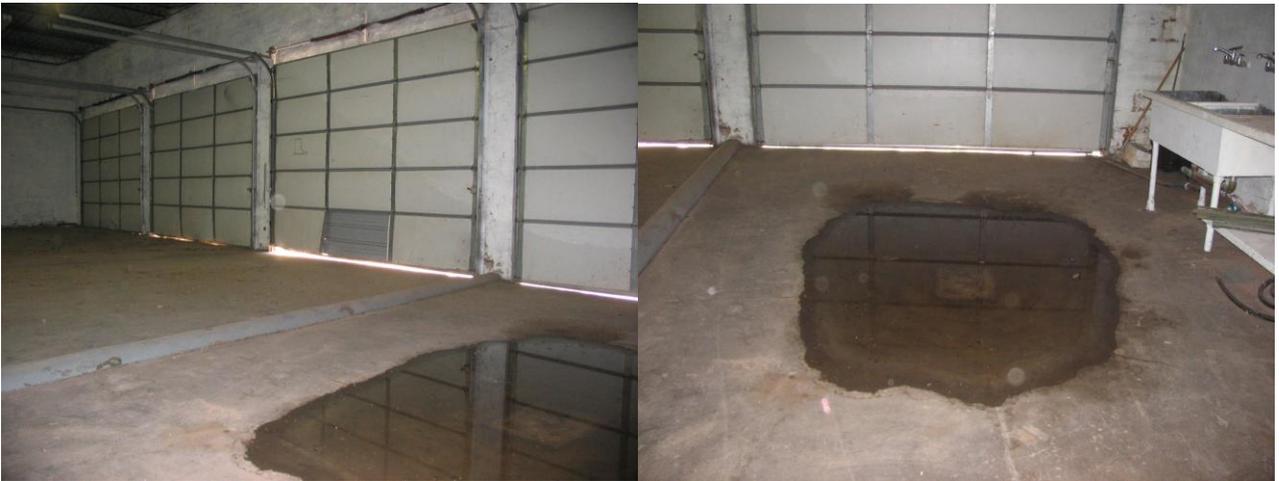
Standing liquid above drain in automotive garage (Photo: KP)

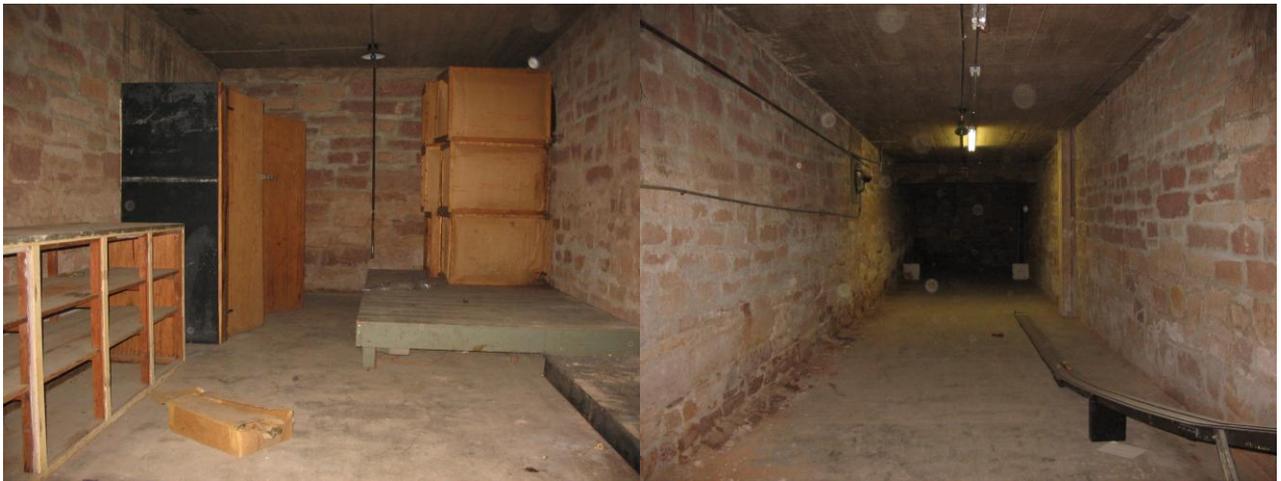
- 1,171.00 ug/ft² of lead was found at the south end of the IFR pit.
- 15,740.00 ug/ft² of lead was located in the center of the IFR.
- 161.35 ug/ft² of lead was found at the entry to the IFR.
- 58.00 ug/ft² of lead was on the drill floor.
- 12,415.00 ug/ft² of lead found at the 10-foot by 10-foot target room adjacent to the bullet trap.

Indoor firing range; IFR (Photos: KP)

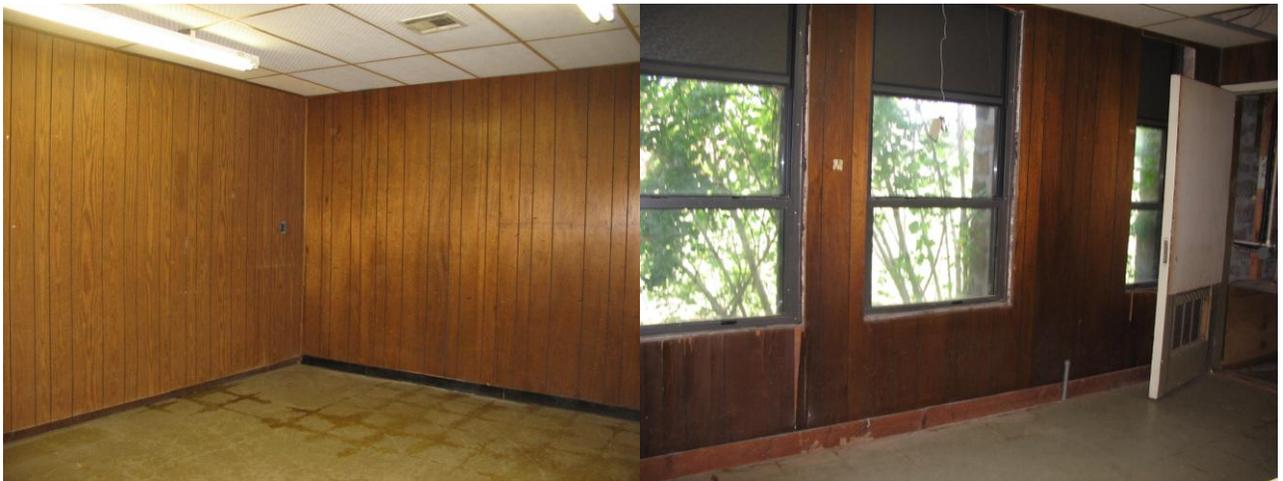
Classrooms with 9x9 tile on the floor (Photos: KP)

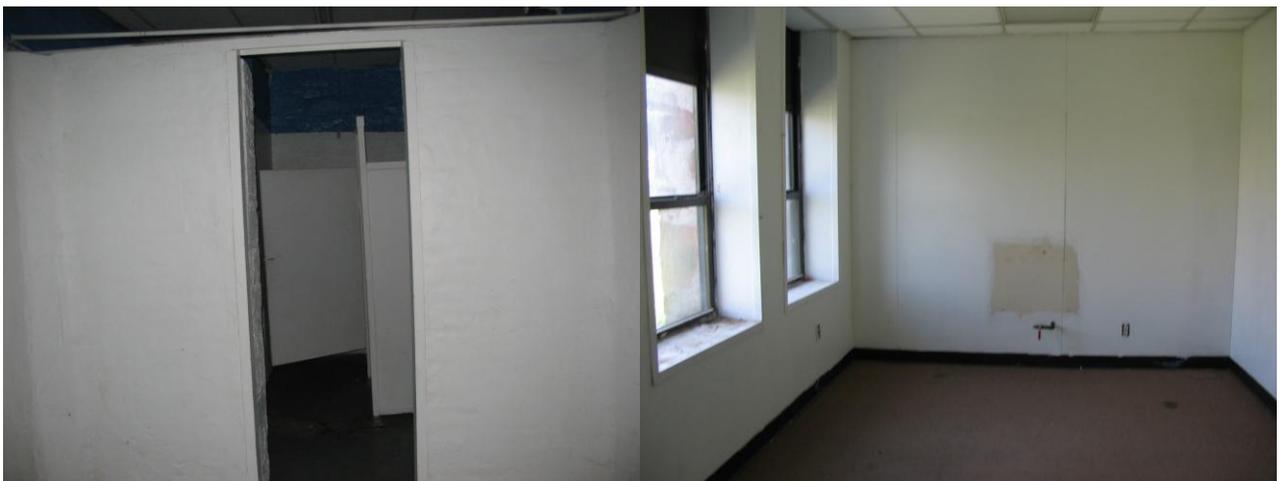
Bathroom and office with gas pipe coming out of the wall (Photos: KP)

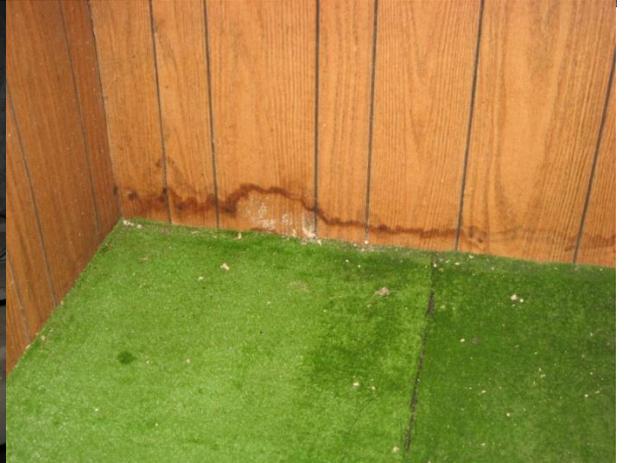
Water damage along west wall in classroom.

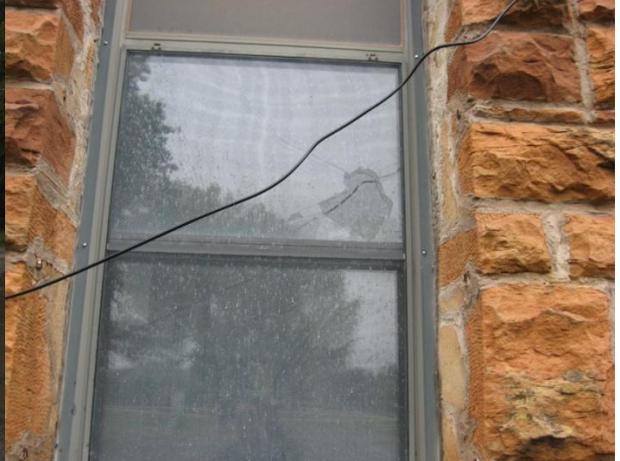
Broken window on south side.

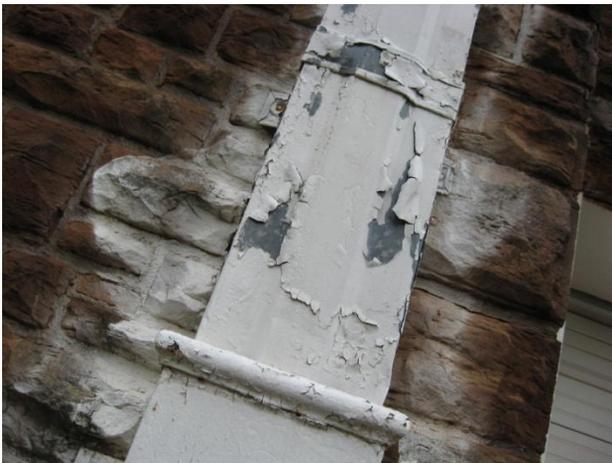
Peeling paint on downspout.
