## **FIVE-YEAR REVIEW**

**Compass Industries  
OKD980620983  
Tulsa County, Oklahoma**

This memorandum documents the U.S. Environmental Protection Agency's (EPA) approval of the Compass Industries Five-Year Review Report prepared by the U.S. Army Corps of Engineers on behalf of EPA.

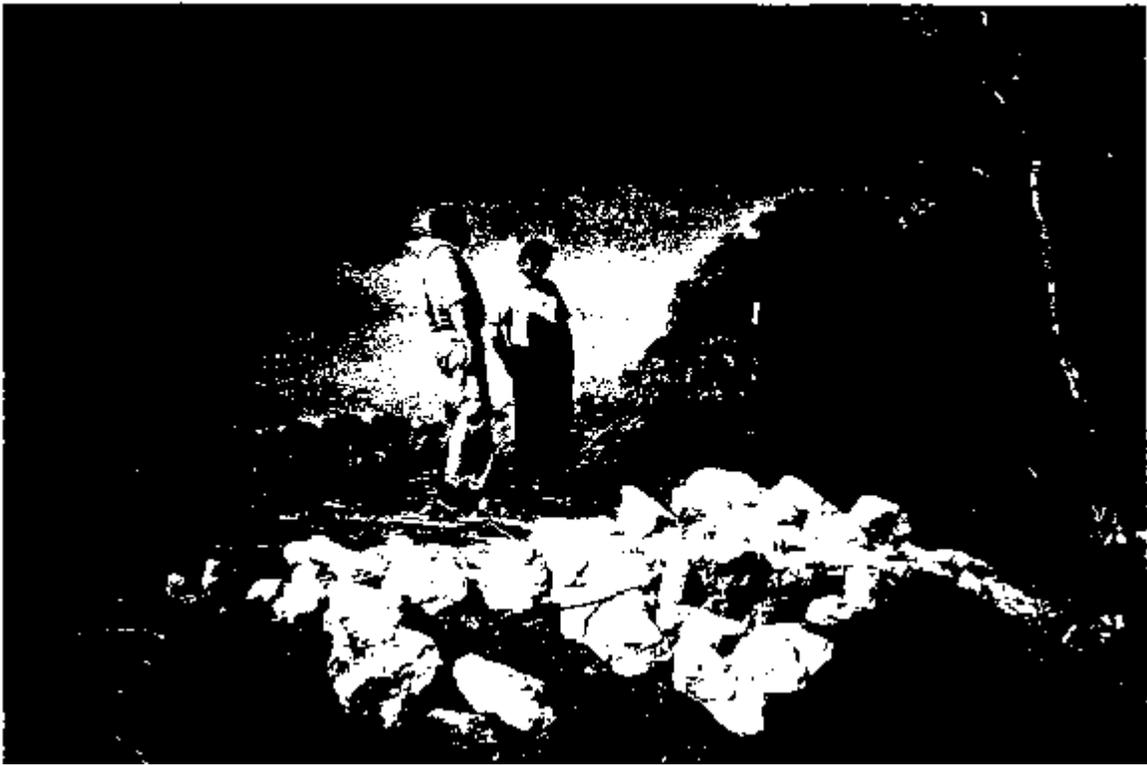
EPA Project Manager, Shawn Ghose, and O&M Contractor, Scott Stelle discuss a recent slope repair during the 1994 Walkover Inspection.

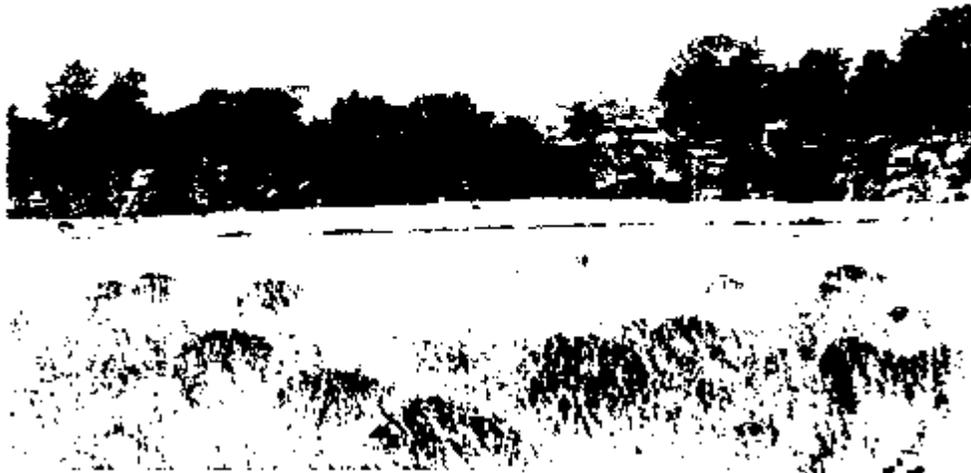
Looking northwesterly across cap. North slope seep is located just below the cap between these rock outcrops.

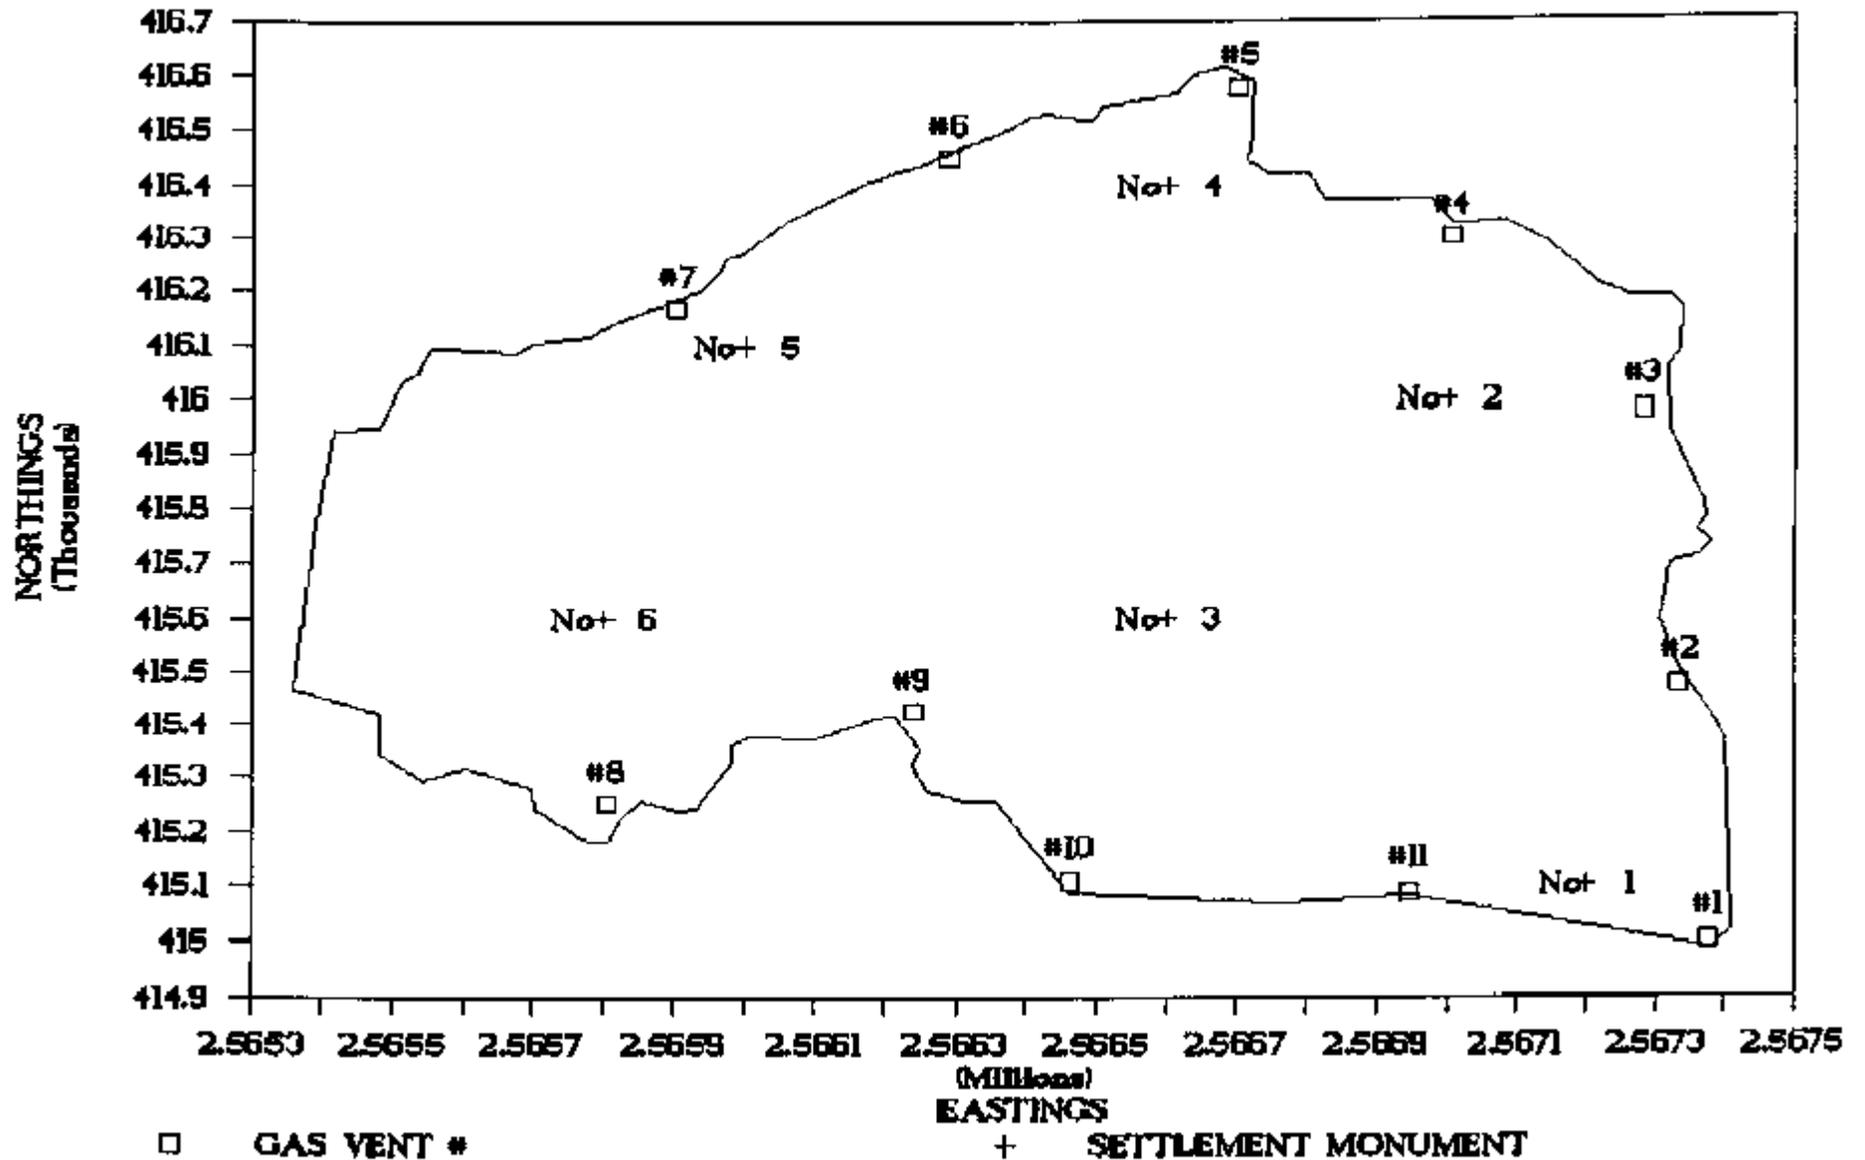
## GAS VENT & SETTLEMENT MONUMENT LOCATION

The PRPs have sampled the vents monthly since receiving direction from the EPA in October 1993. Consistently, several vents have indicated the presence of organic vapors. This indicates that the waste is continuing to off gas and that the venting system is working. The organic vapor concentrations have ranged up to 1,000 ppm measured inside the vent pipes. The organic vapors are probably methane gas from the biodegradation of the waste materials and will not constitute a hazard in the open atmosphere at these levels. The results of the vent sampling with a figure showing the vent location are provided in Attachment 6.
