Endure Sta. 364+36.00 Customer Sta: 29823+08.0
Wall Thickness: 0.745 in
Min CSD: 34.104 in Max CSD: 41.624 in
Deformation - Dent with associated ovality
Orientation: 11:58

Upstream Weld # (West Weld): IFT-205
Downstream Weld # (East Weld): IFT-209

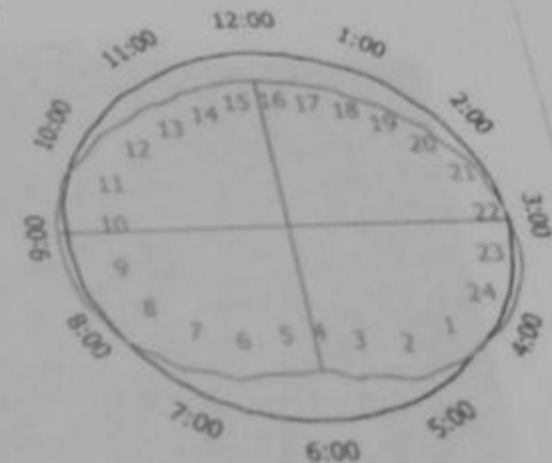
Dent	Ovality	Total
Size: 1.194 in	3.579 in	3.773 in
4OD: 2.843 %	6.141 %	8.985 %
Length: 18.00 in	324.000 in	324.000 in
Width: 58.38 in

Estimated dent size after excavation: 1.194 in
Affects girth weld
Field Reported

Possible Debris

AJ called in 809-349AJ survey.

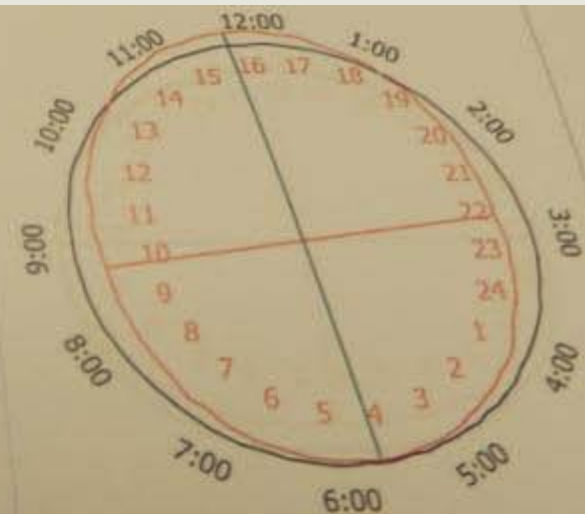
809-509B2 Survey Station: 29741+63.6

Wall Thickness: 0.888 in
Min CSD: 37.815 in Max CSD: 41.747 in
Deformation - Ovality
Orientation: 02:50
Depth: 1.982 in
4OD: 4.720 %
Length: 144.00 in
Affects girth weld
Field Reported

Upstream Weld # (West Weld): INTT-60
Downstream Weld # (East Weld): INTT-58R

This "trimmed to fit" bend appears to be under stress. Further analysis will be needed in this area to verify.

Possible stress located at this bend. A measurement for stress on this bend will not be very accurate due to the debris induced vibration seen on the upstream side of this factory bend.
