DCVG Dig on First Phase

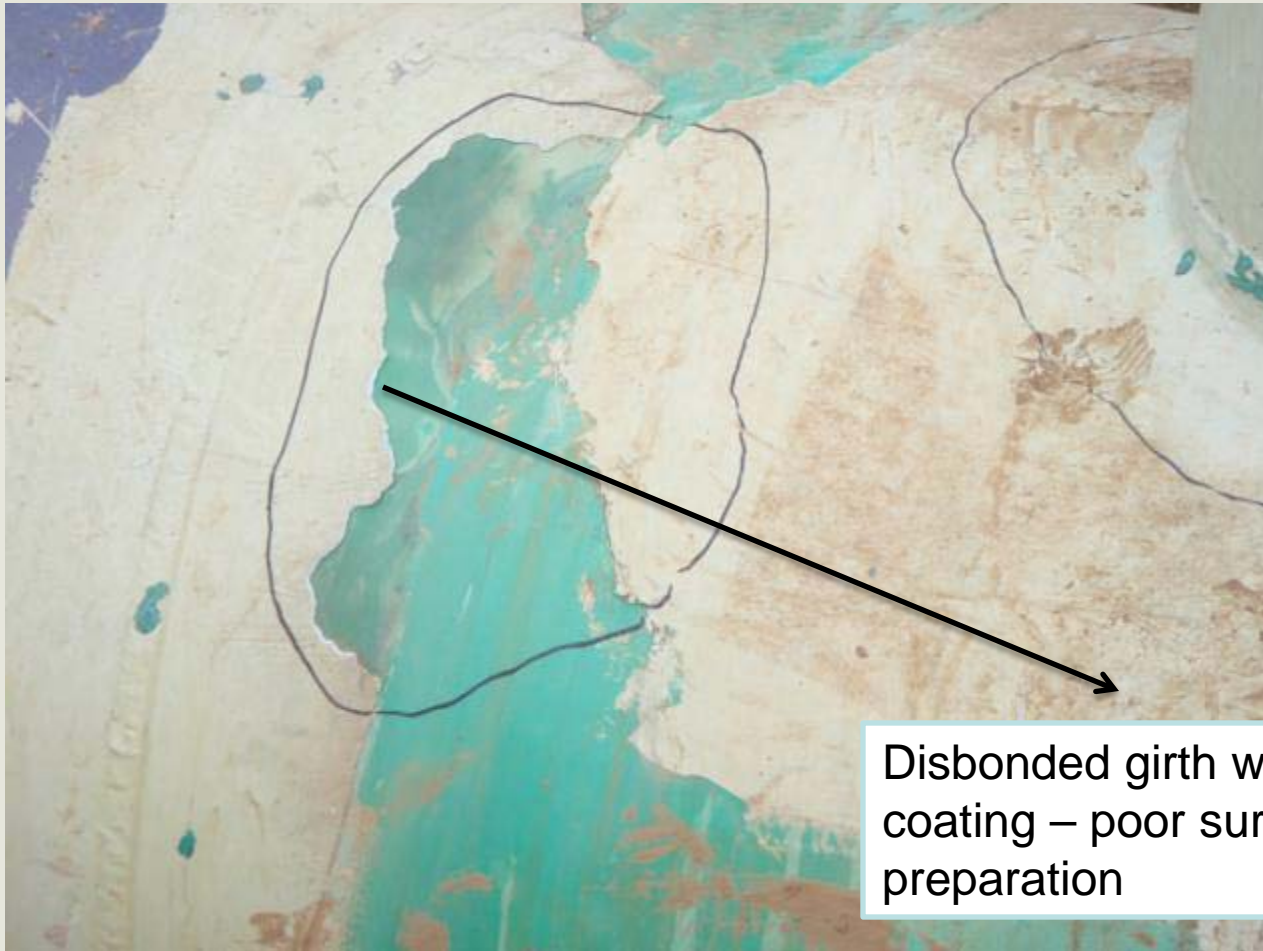
Disbonded girth weld
coating – poor surface
preparation
