OCC  
Pipeline Safety Seminar  
September 2011

Construction Issues

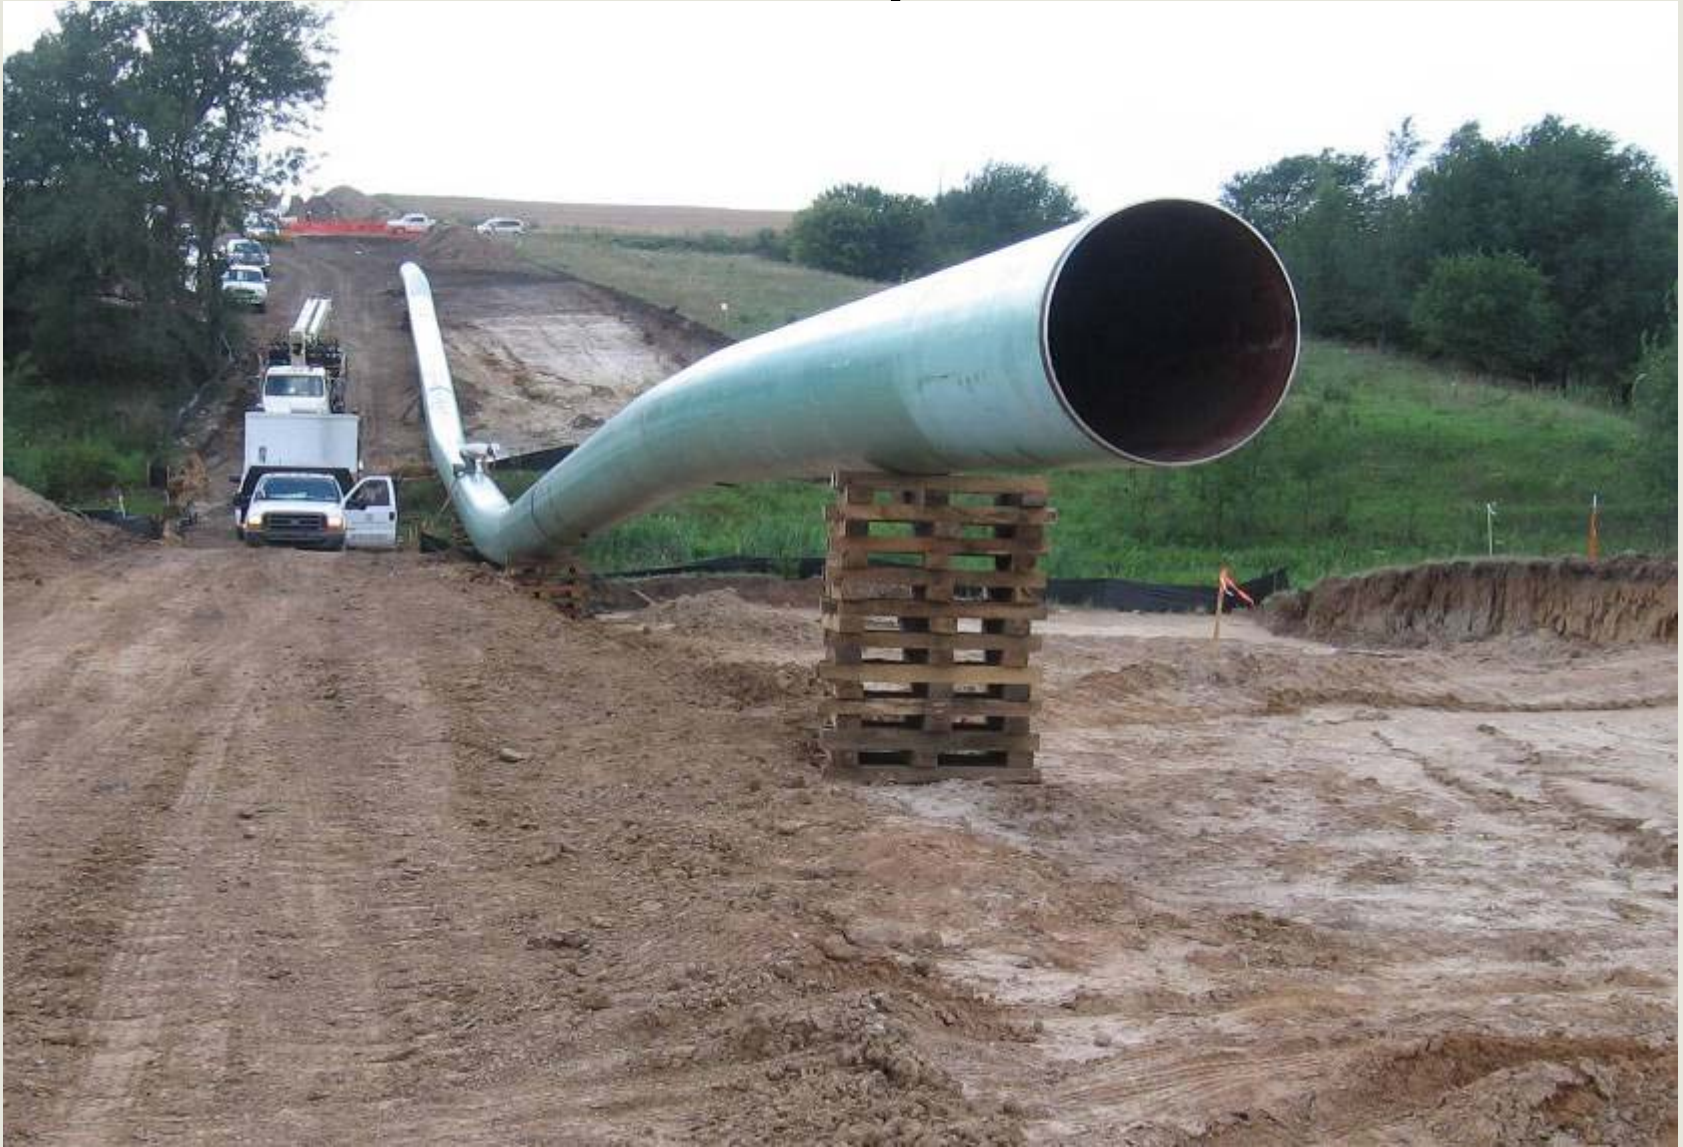
Pipe on skids can move and fall.  
You want to park where!

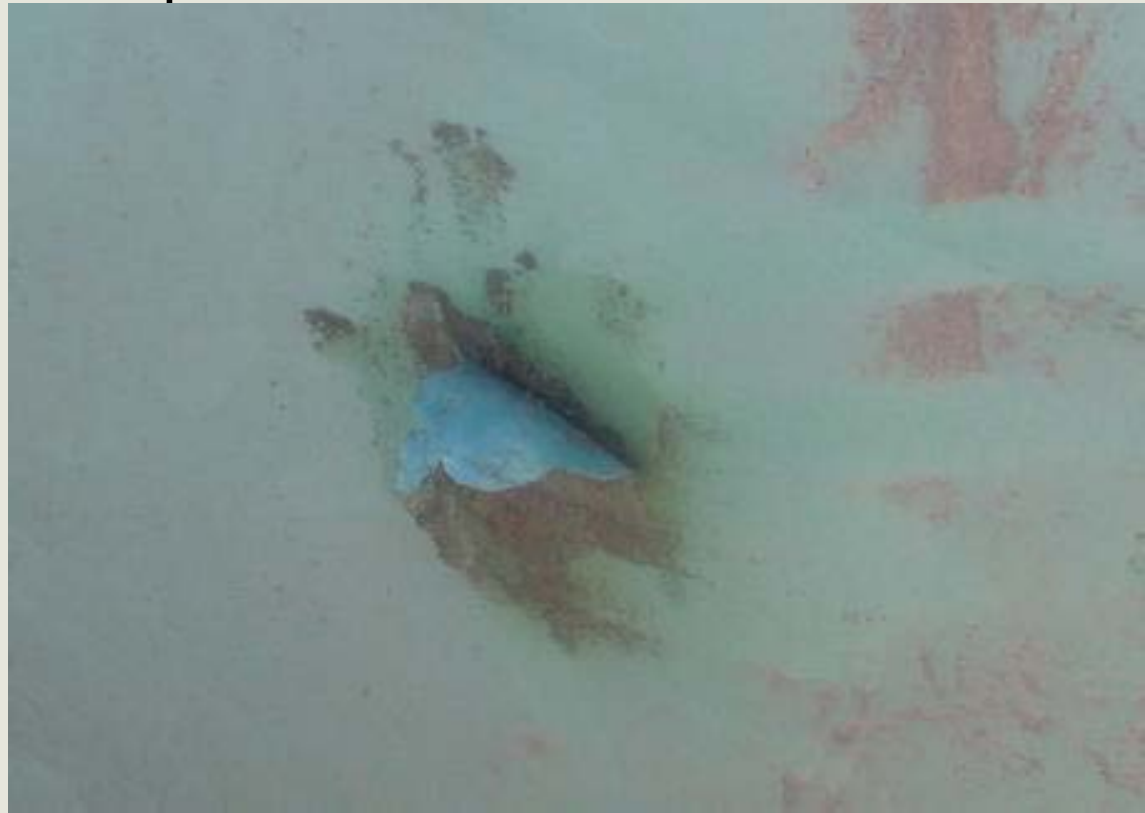
- Poor application practices.
- Soil stress can remove poorly installed patch stick repairs.
- Heating the patch stick and dripping the product on the coating holiday is not acceptable.

The photo shows a poorly adhered patch stick repair. This was found while uncovering a newly built pipeline.

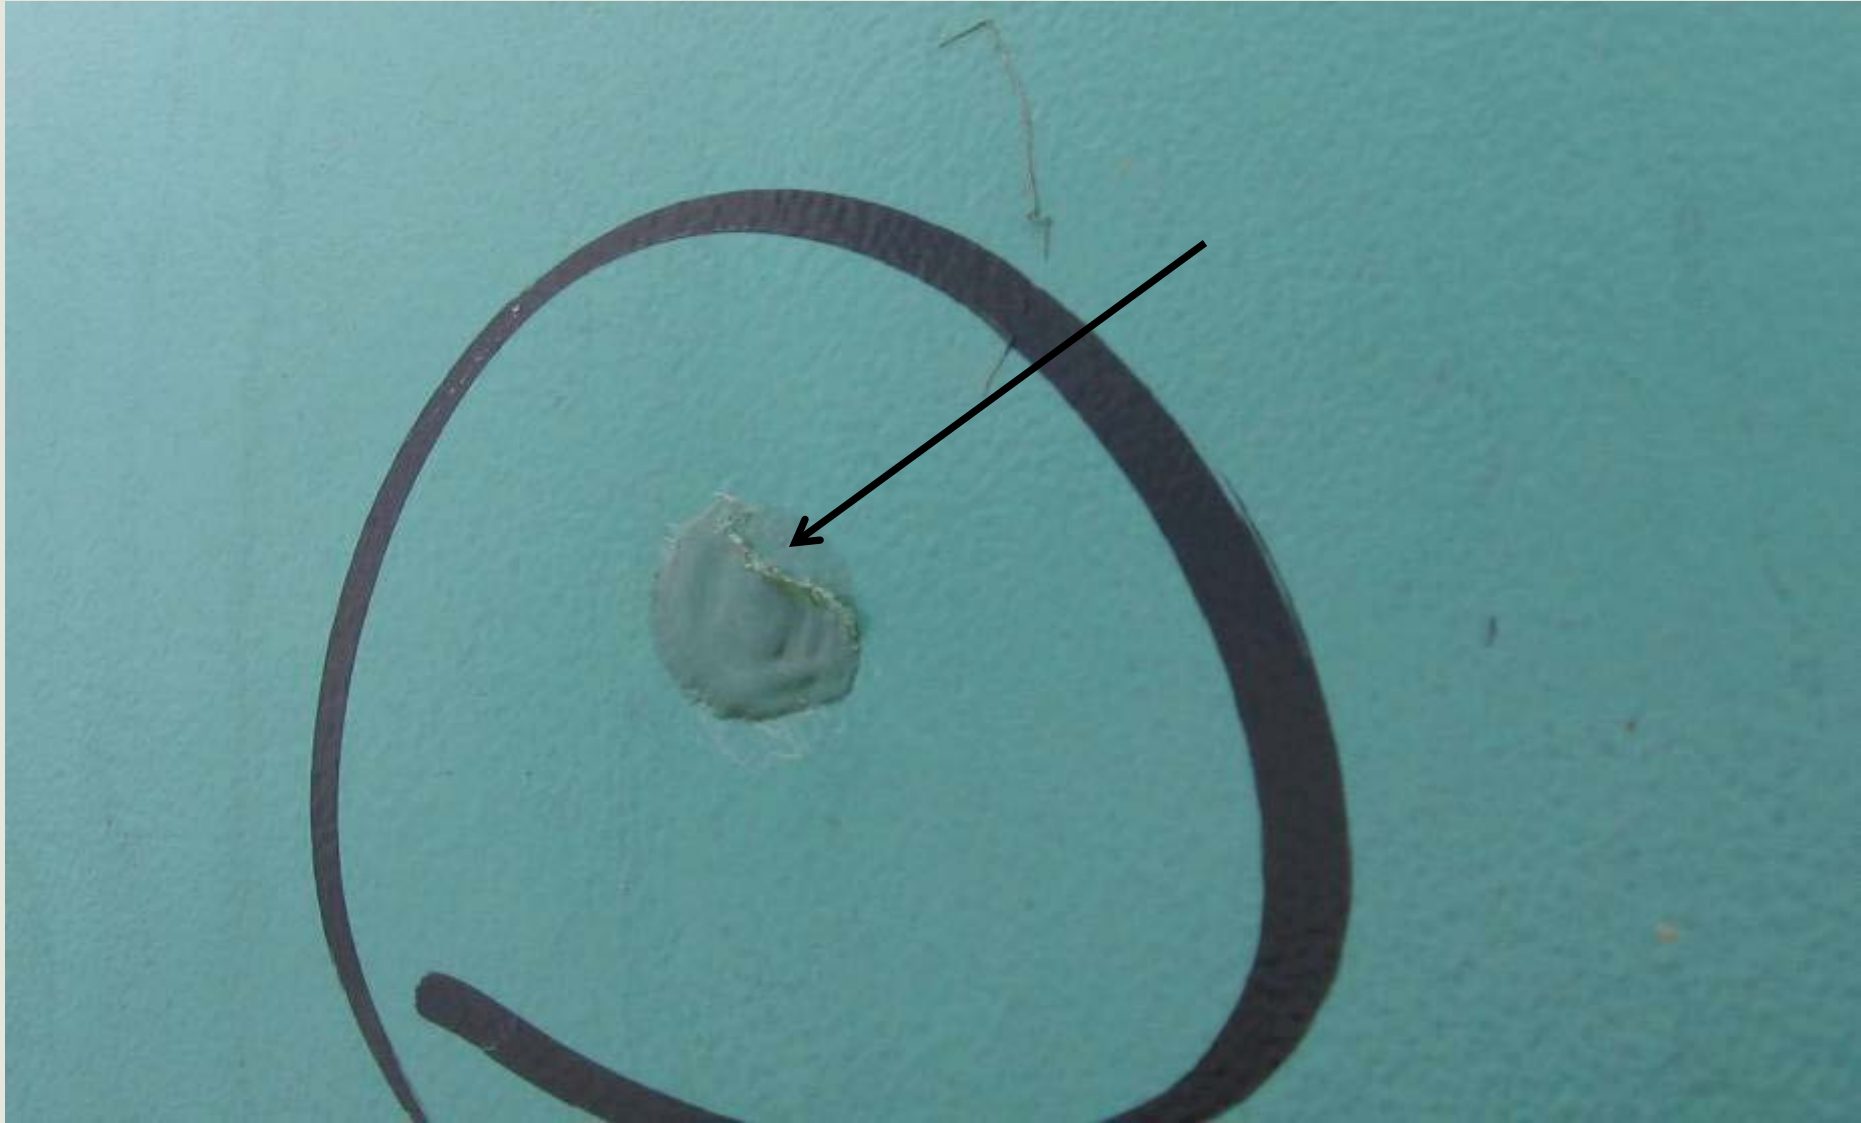
Manufacturer's procedures for patch stick application must be followed. The photo shows that a fingernail was able to scratch off an applied patch stick repair

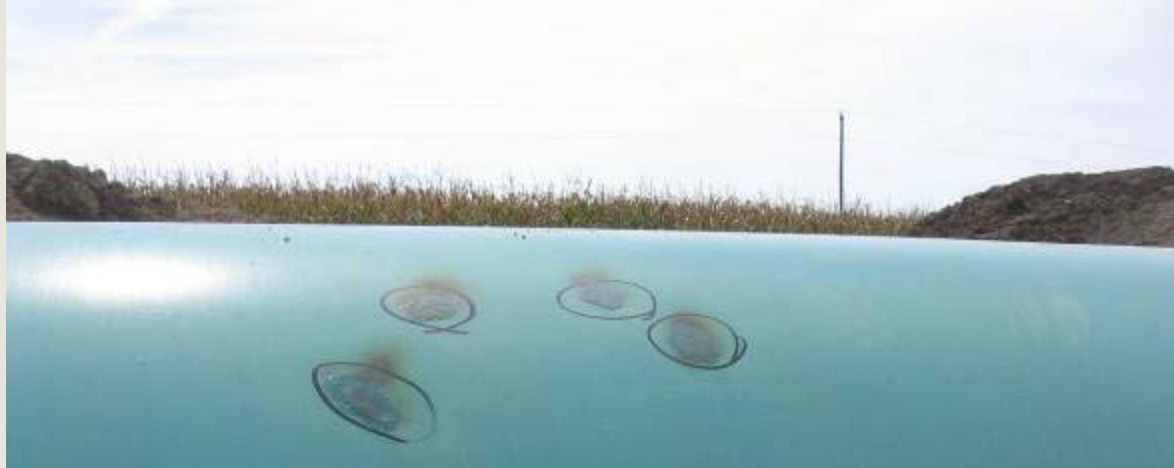
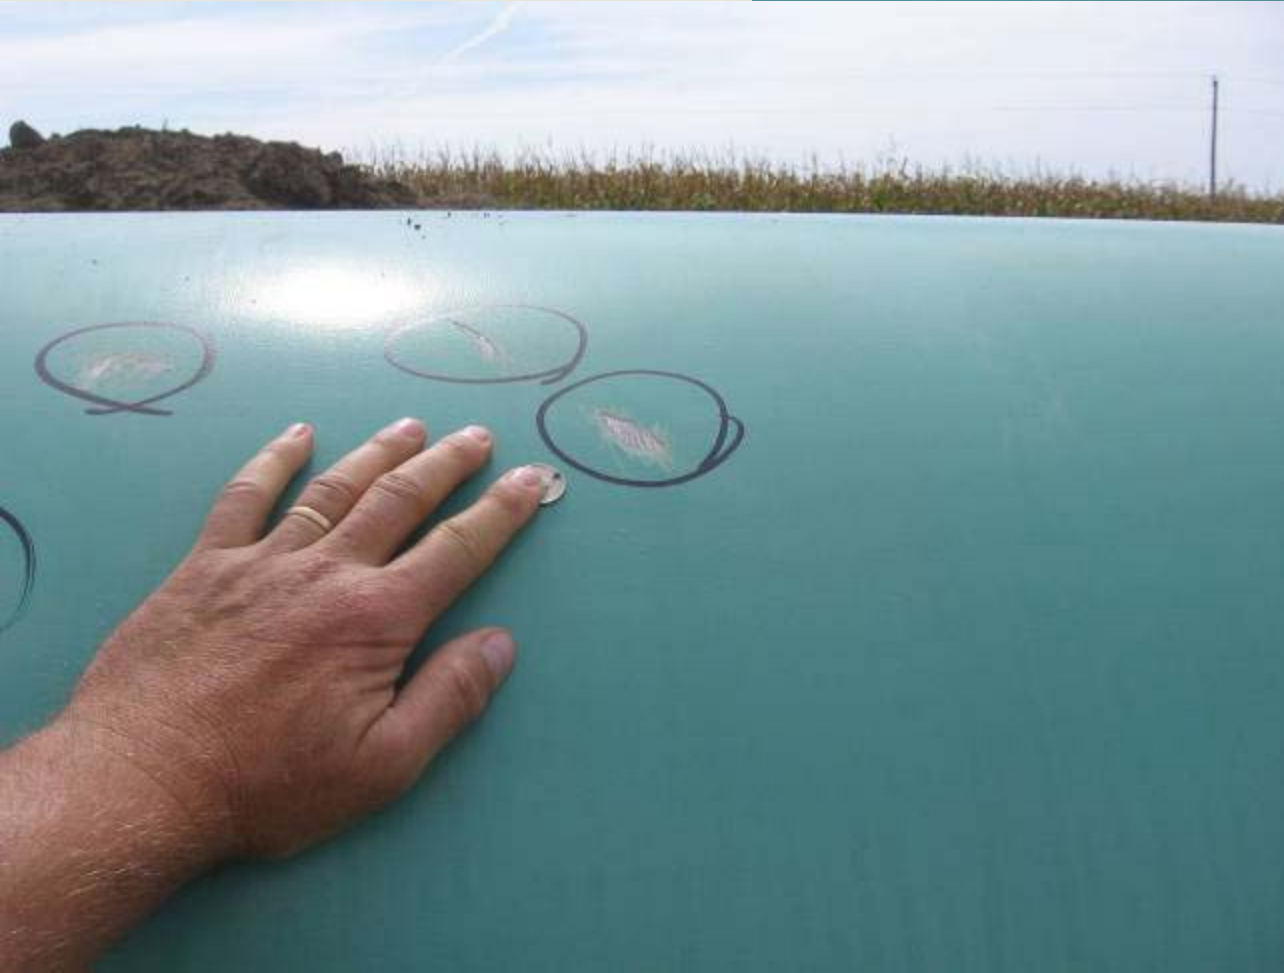
Patch Sticks are only for  
pinhole or abrasion repair.  
2 part epoxy should have  
been used.

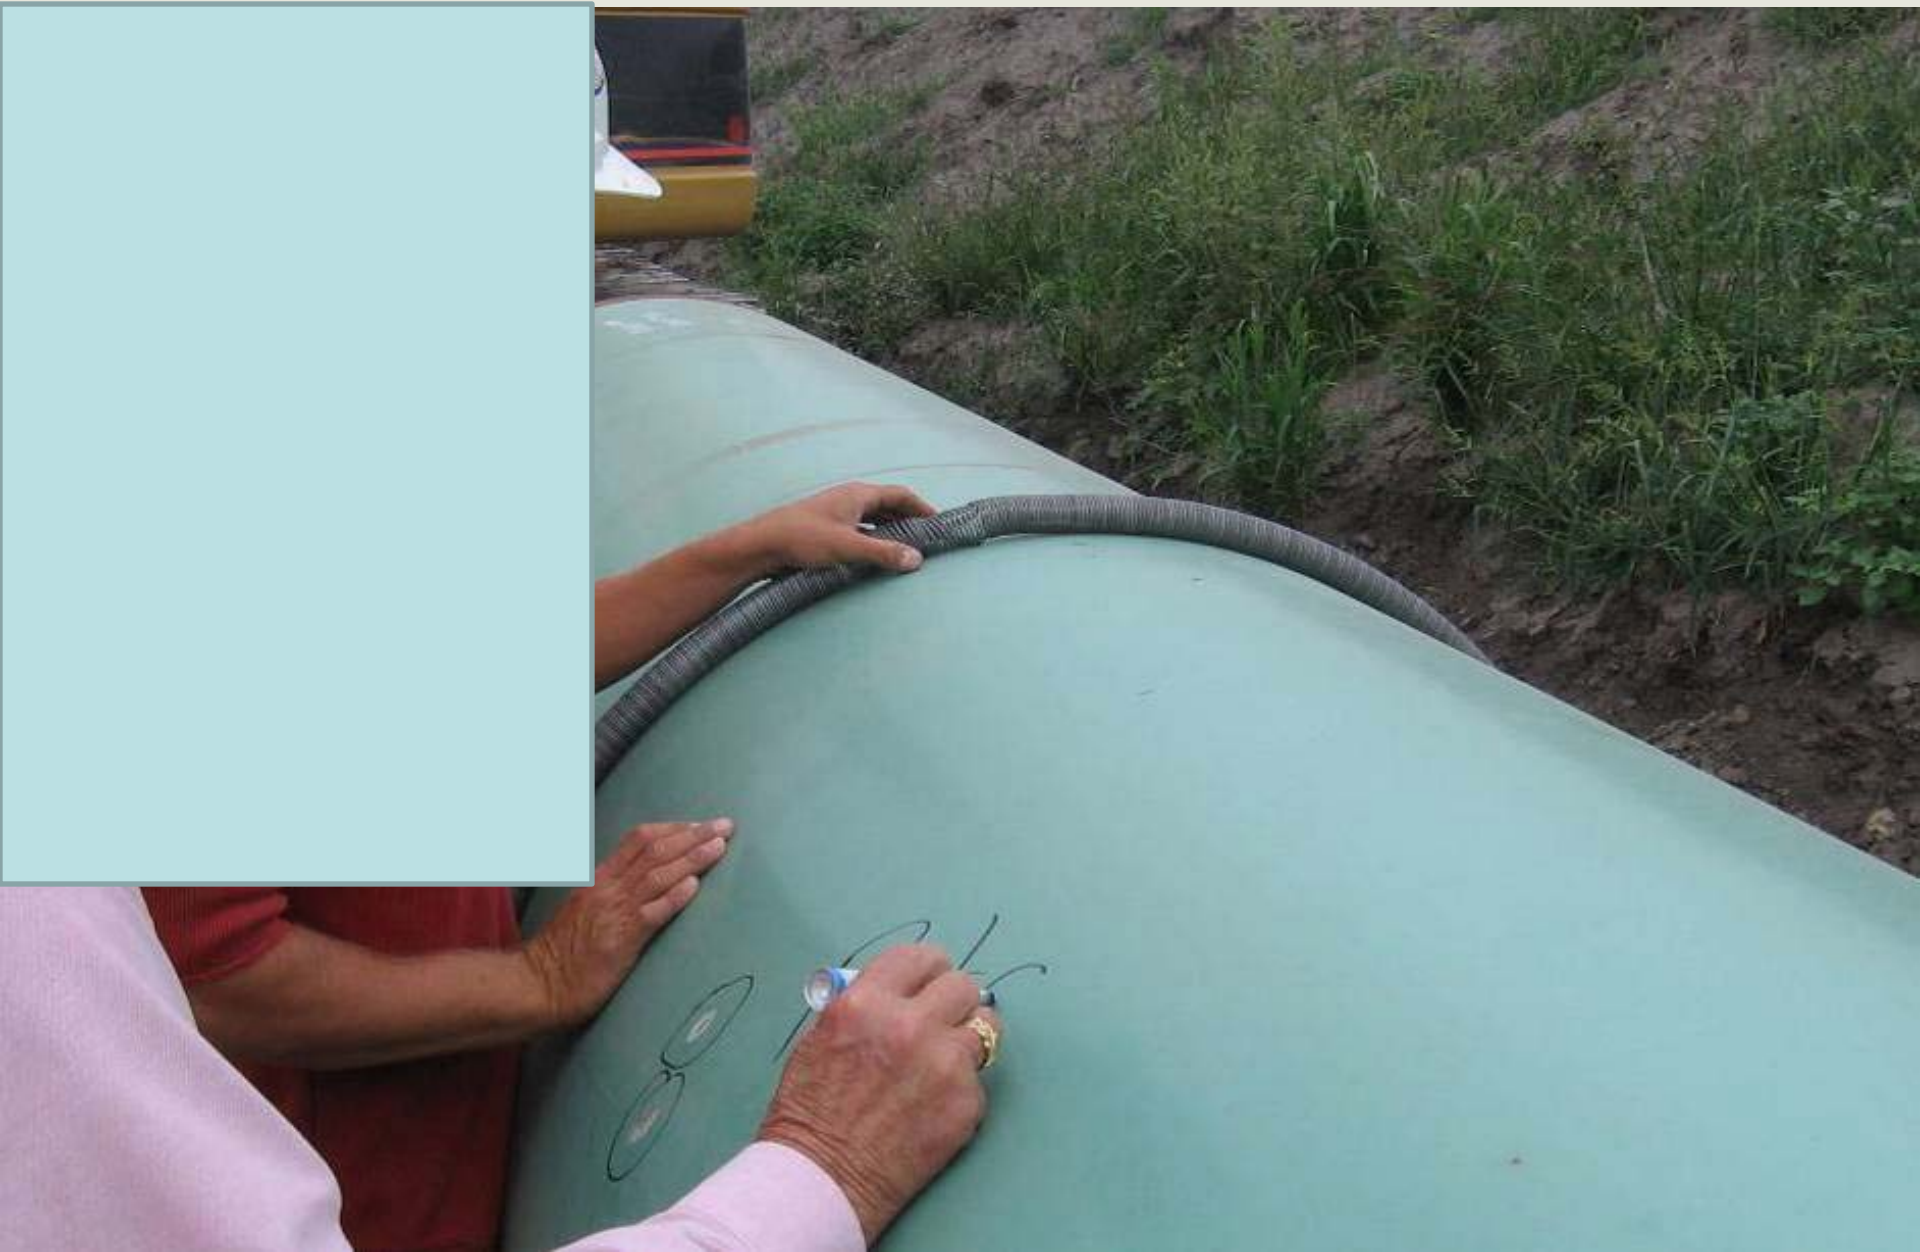
A bent jeep spring can miss coating holidays

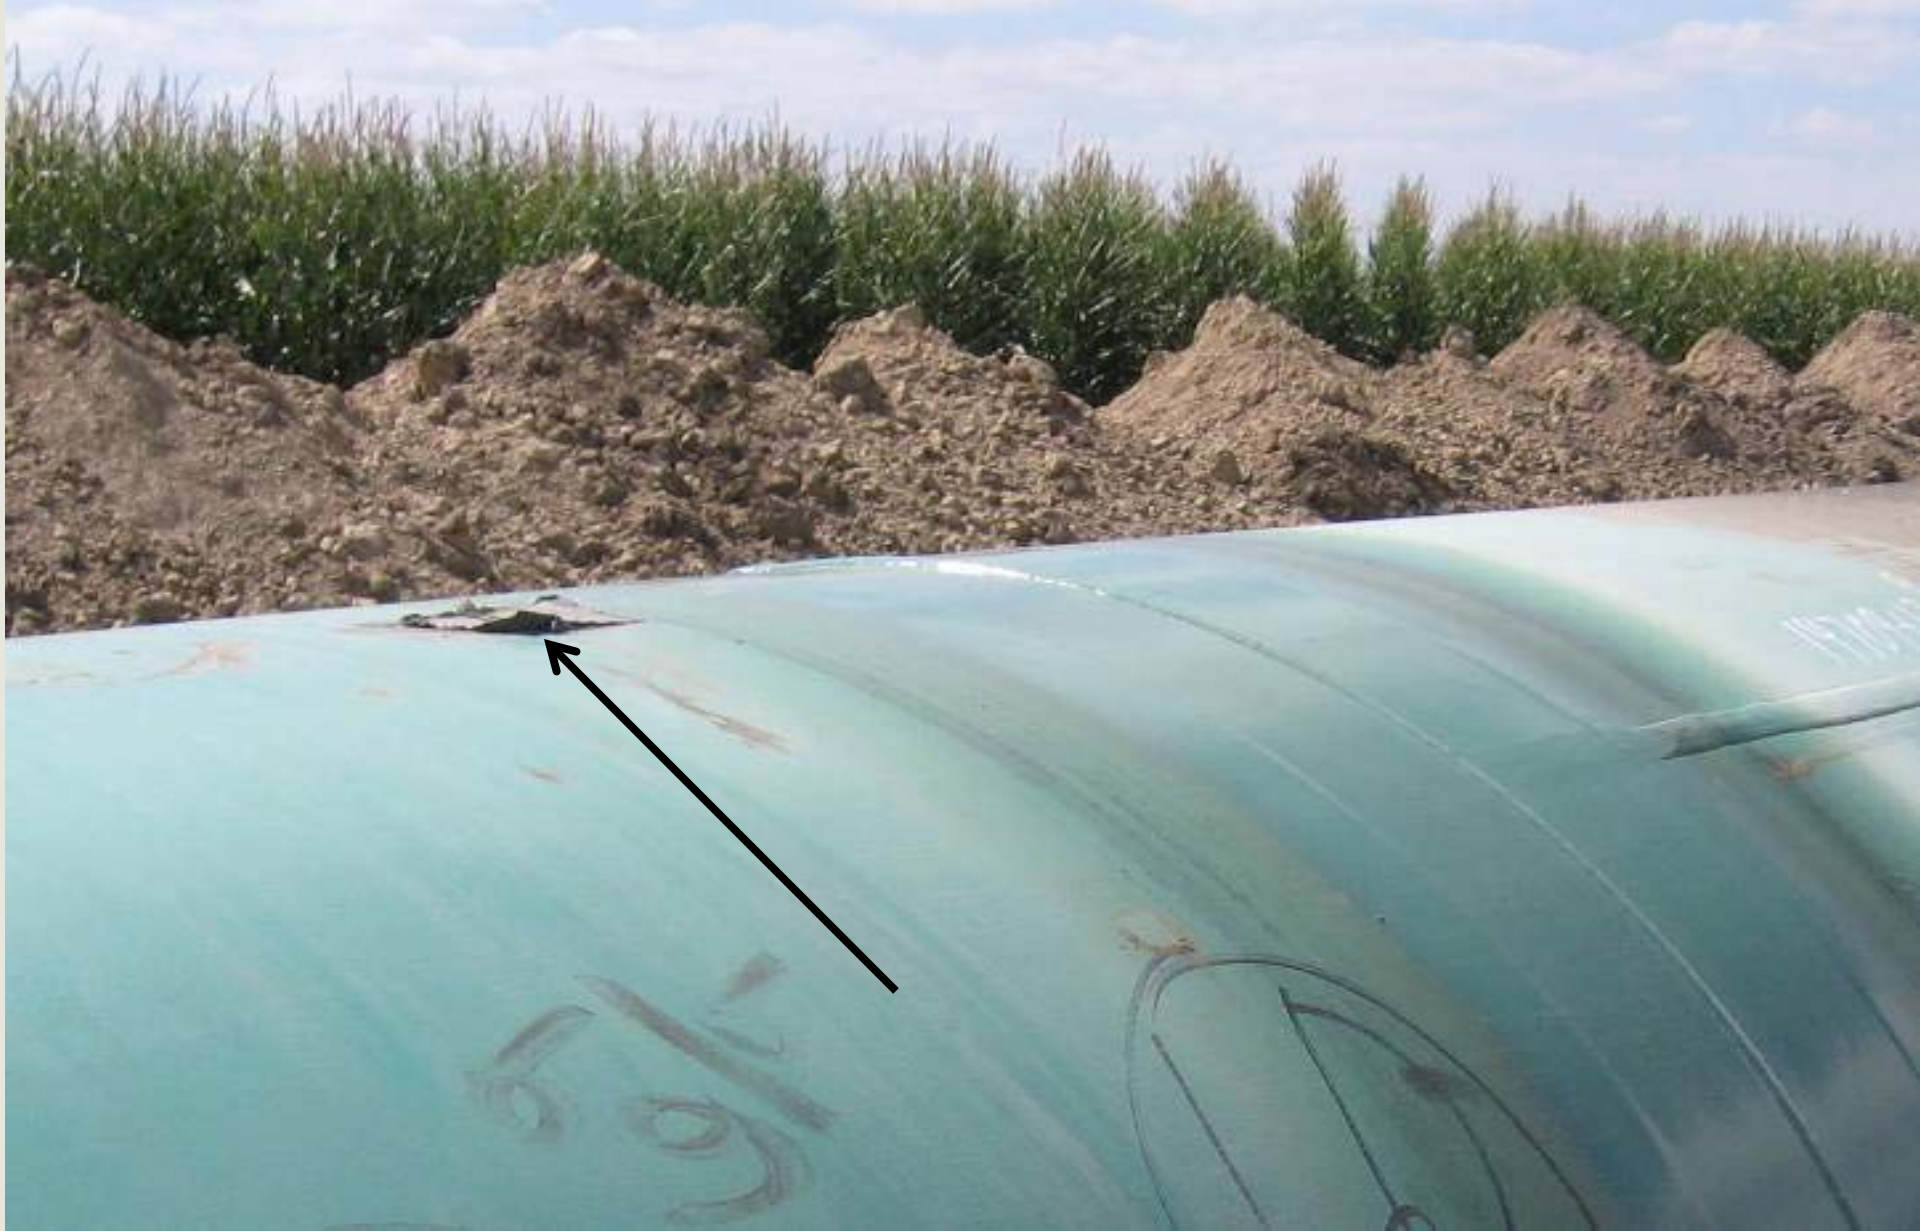
# Duct tape can shield coating holidays

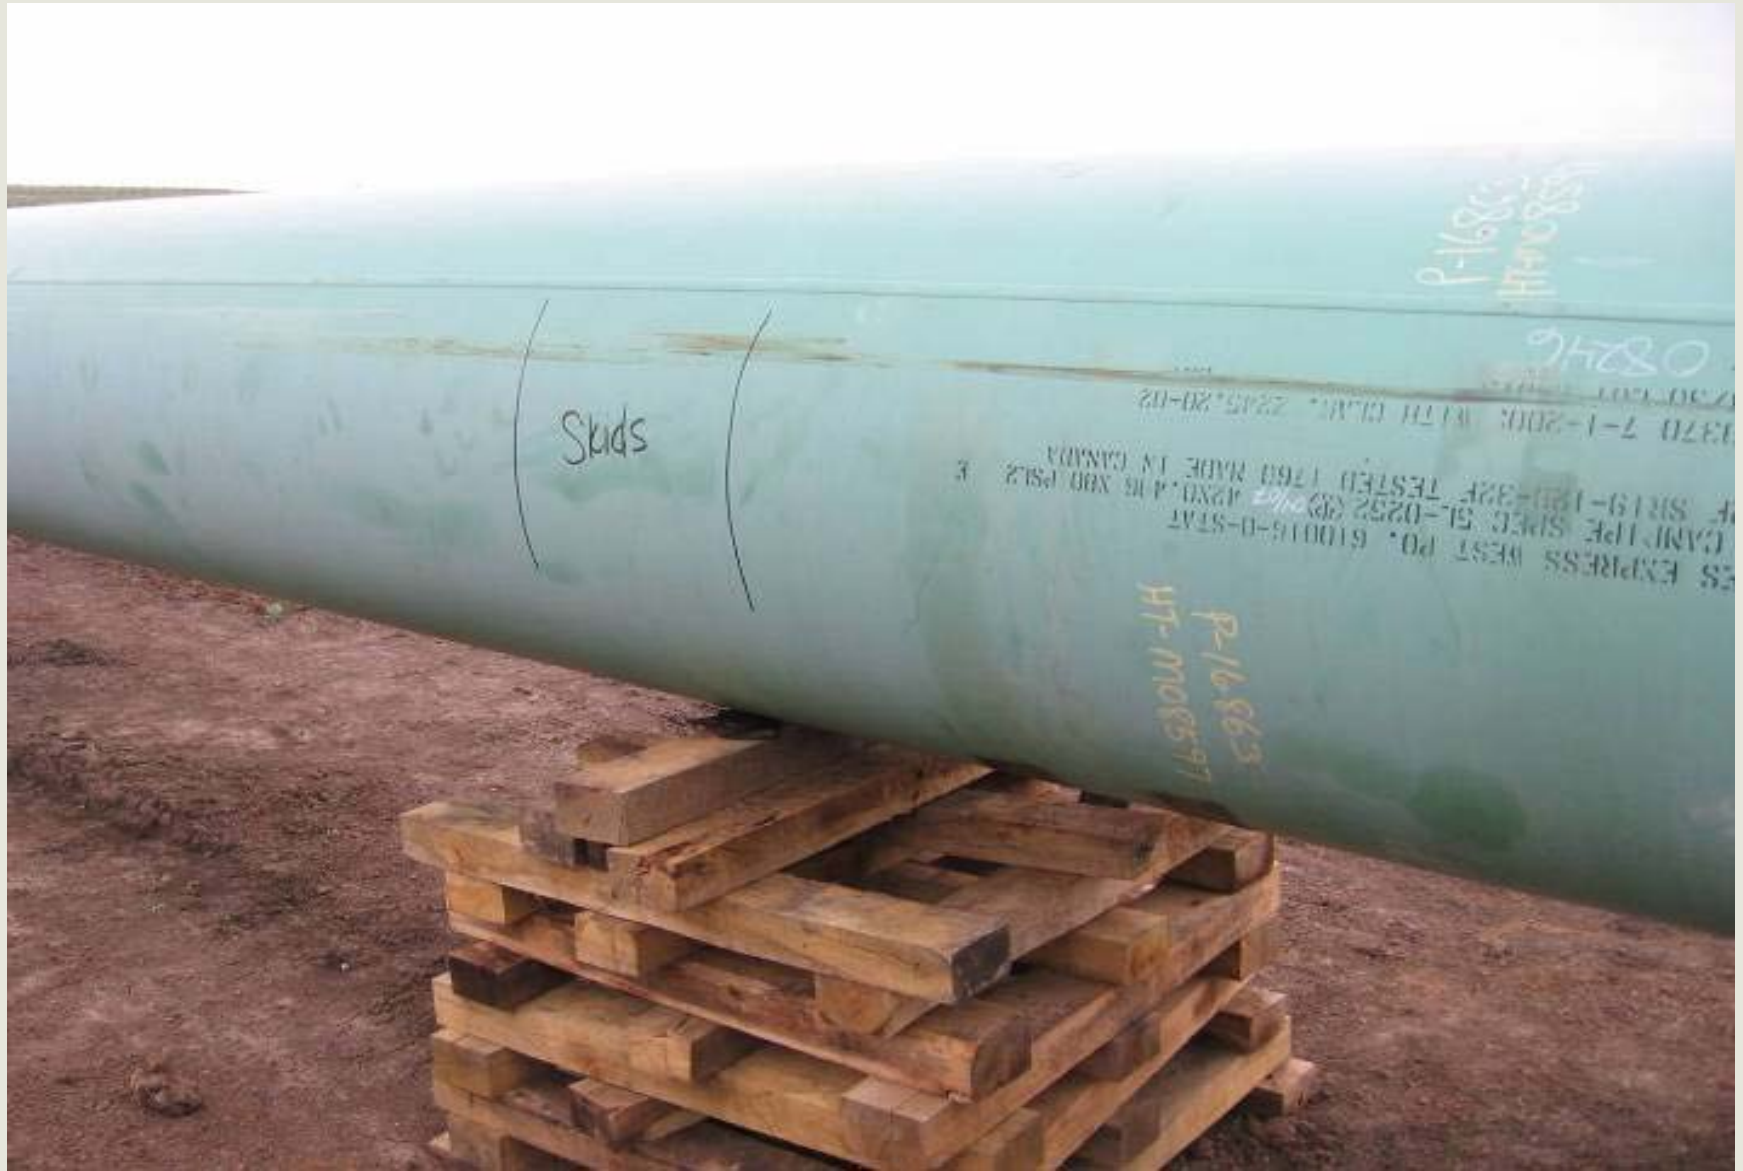
Just jeeping at skids only on lowering in is not usually per construction procedures

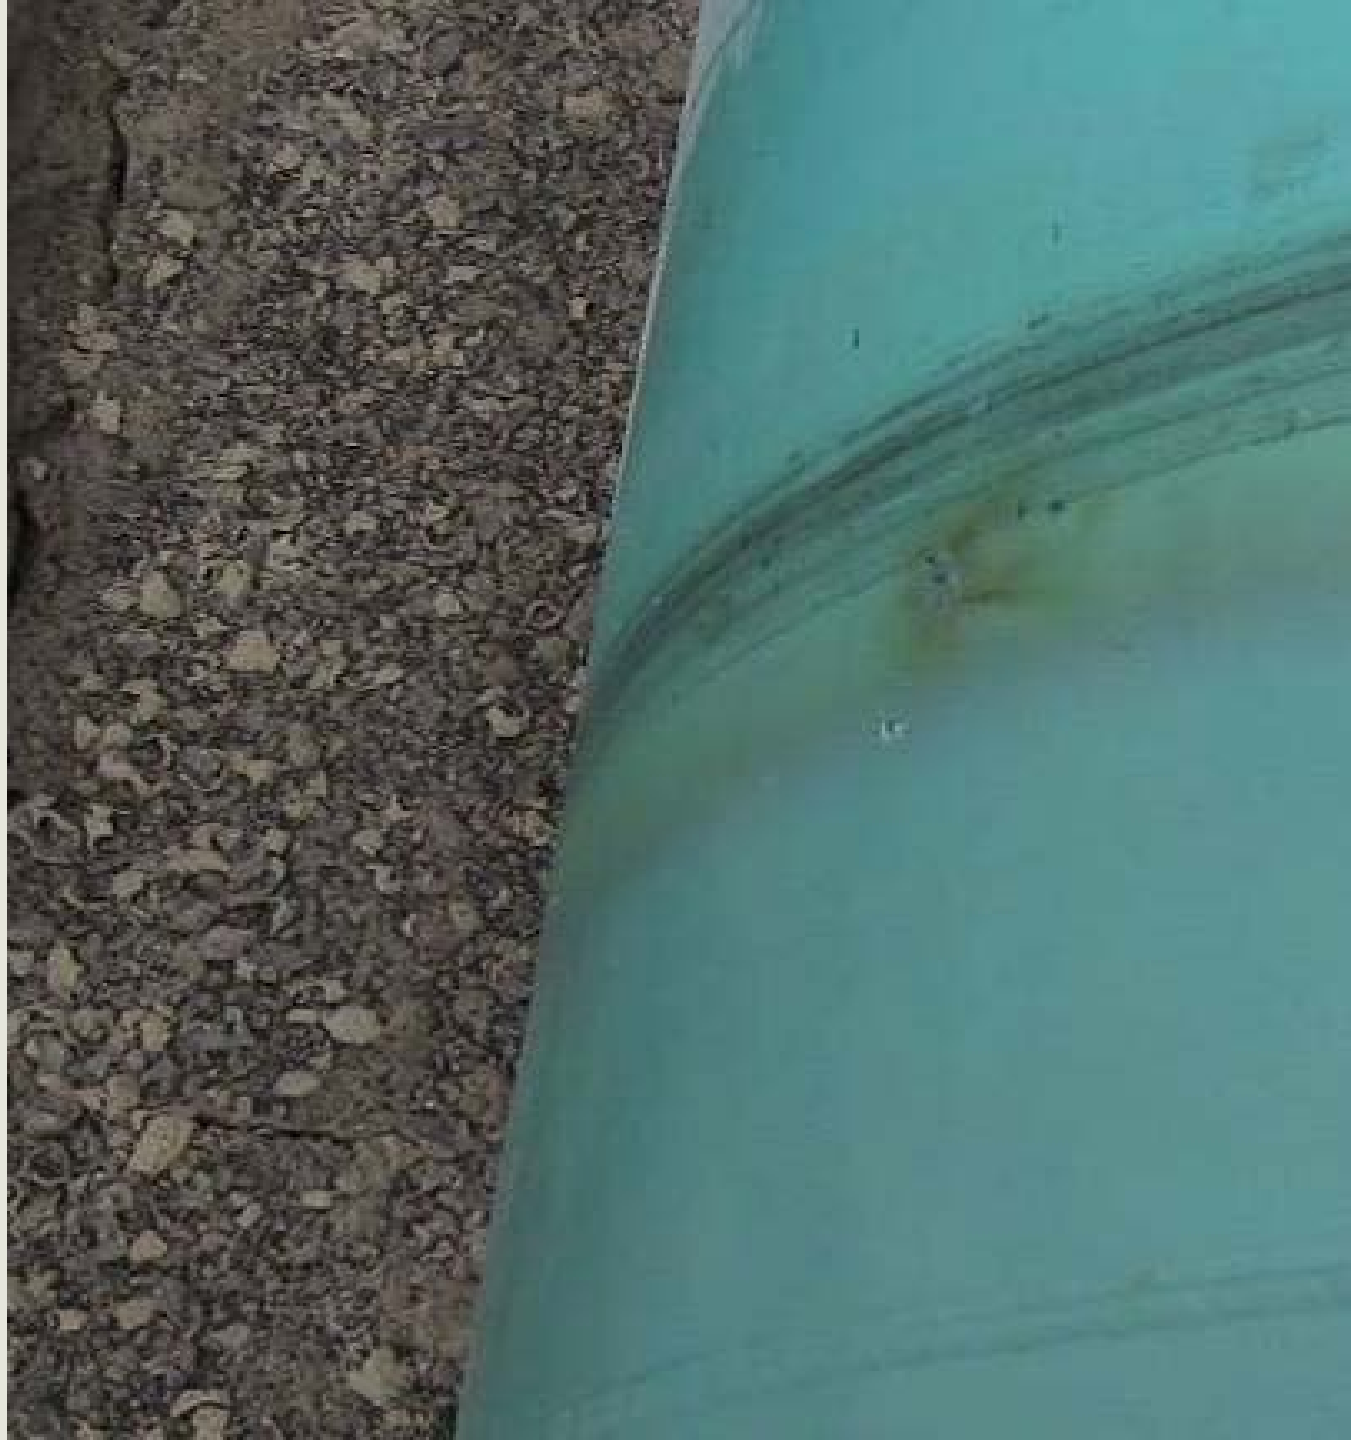
- Look for coating holidays in the ditch.
- Observing these indicates a problem.

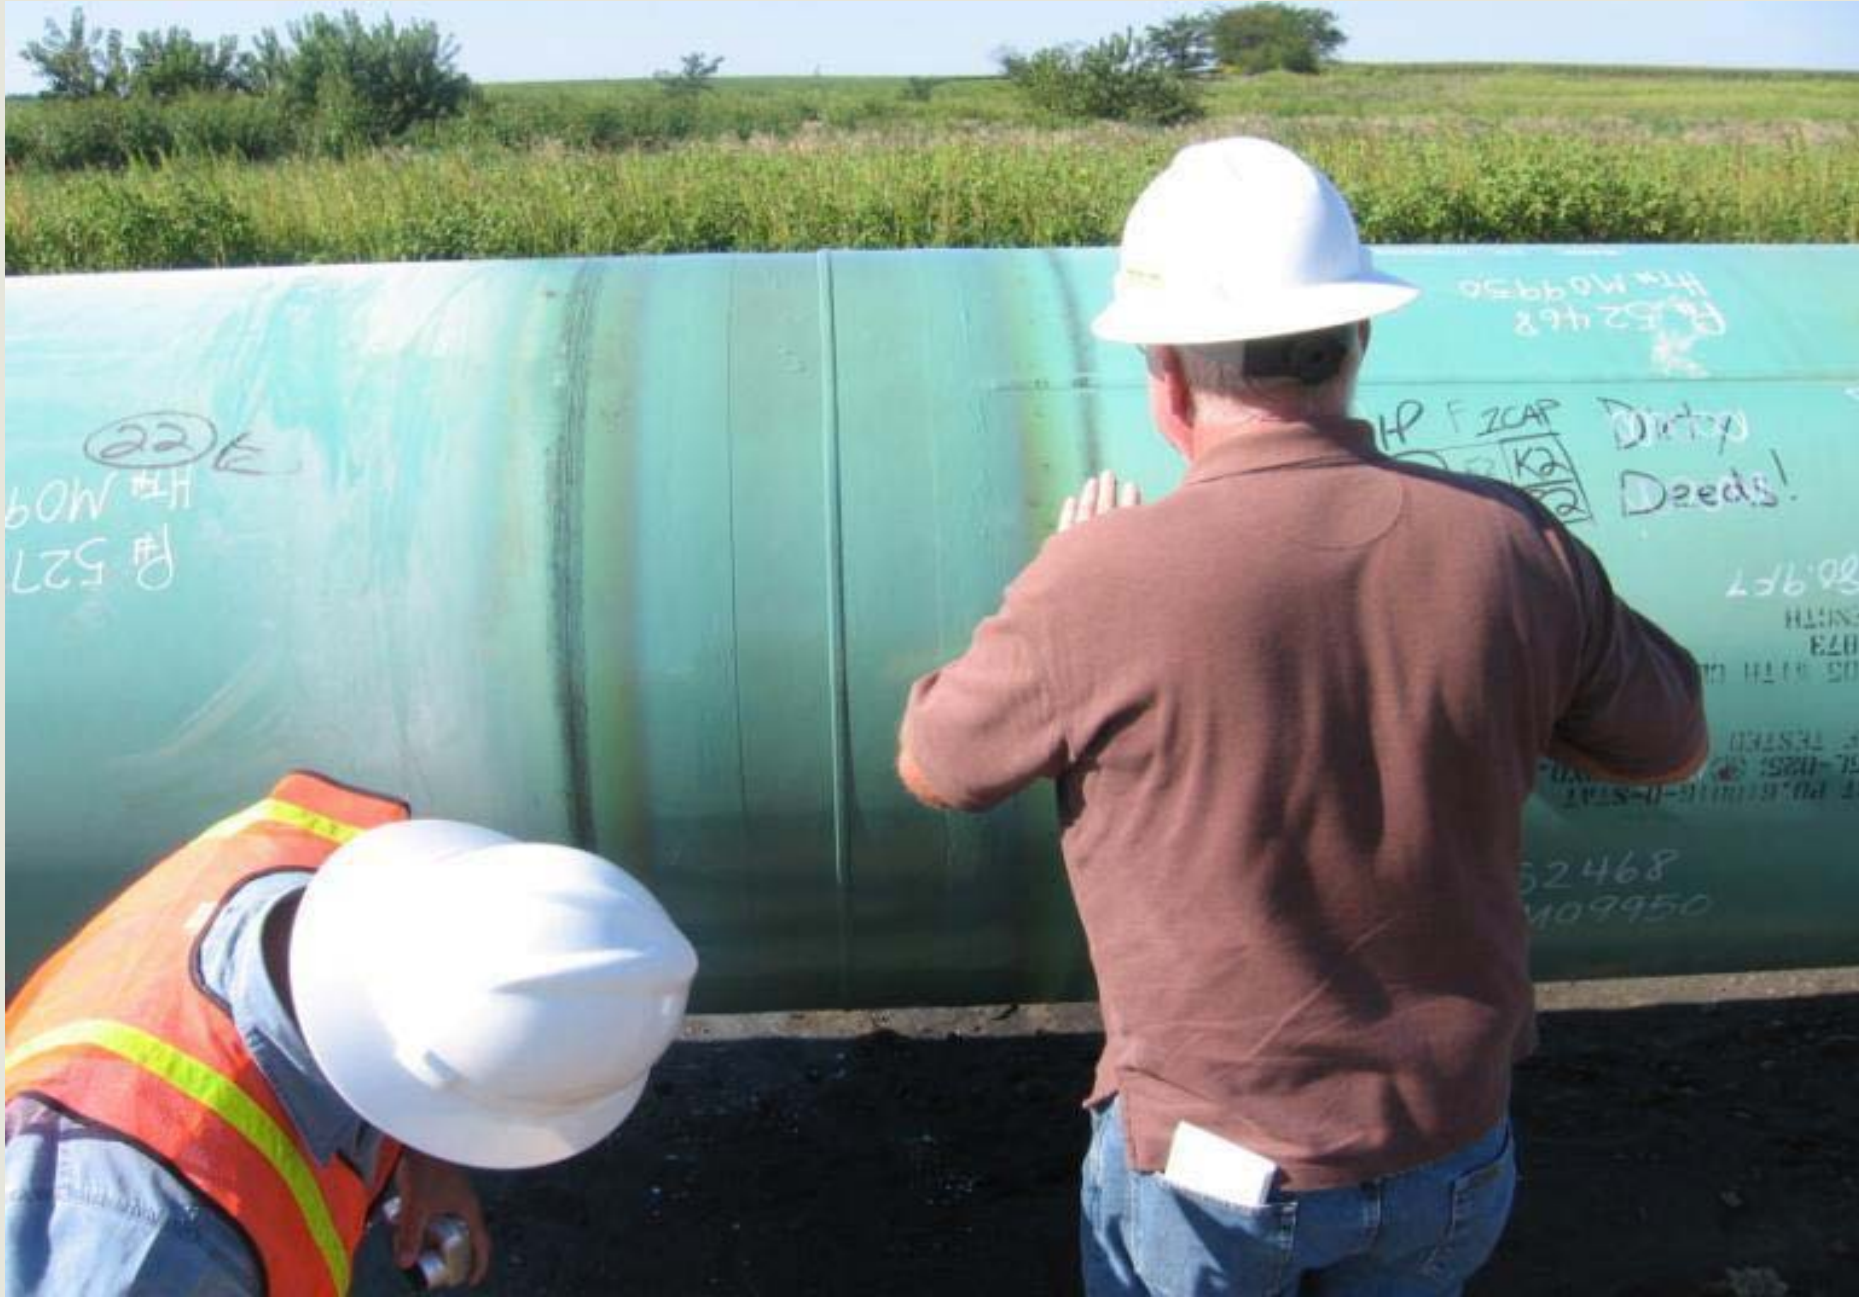
- Insufficient heating (3M procedure specify 425 – 488 degrees F - lower temperatures could mean improper curing)
- Over heating during application can be a problem (the coating looks burnt and is unacceptable)
- Poor sandblasting

425°F to 488°F

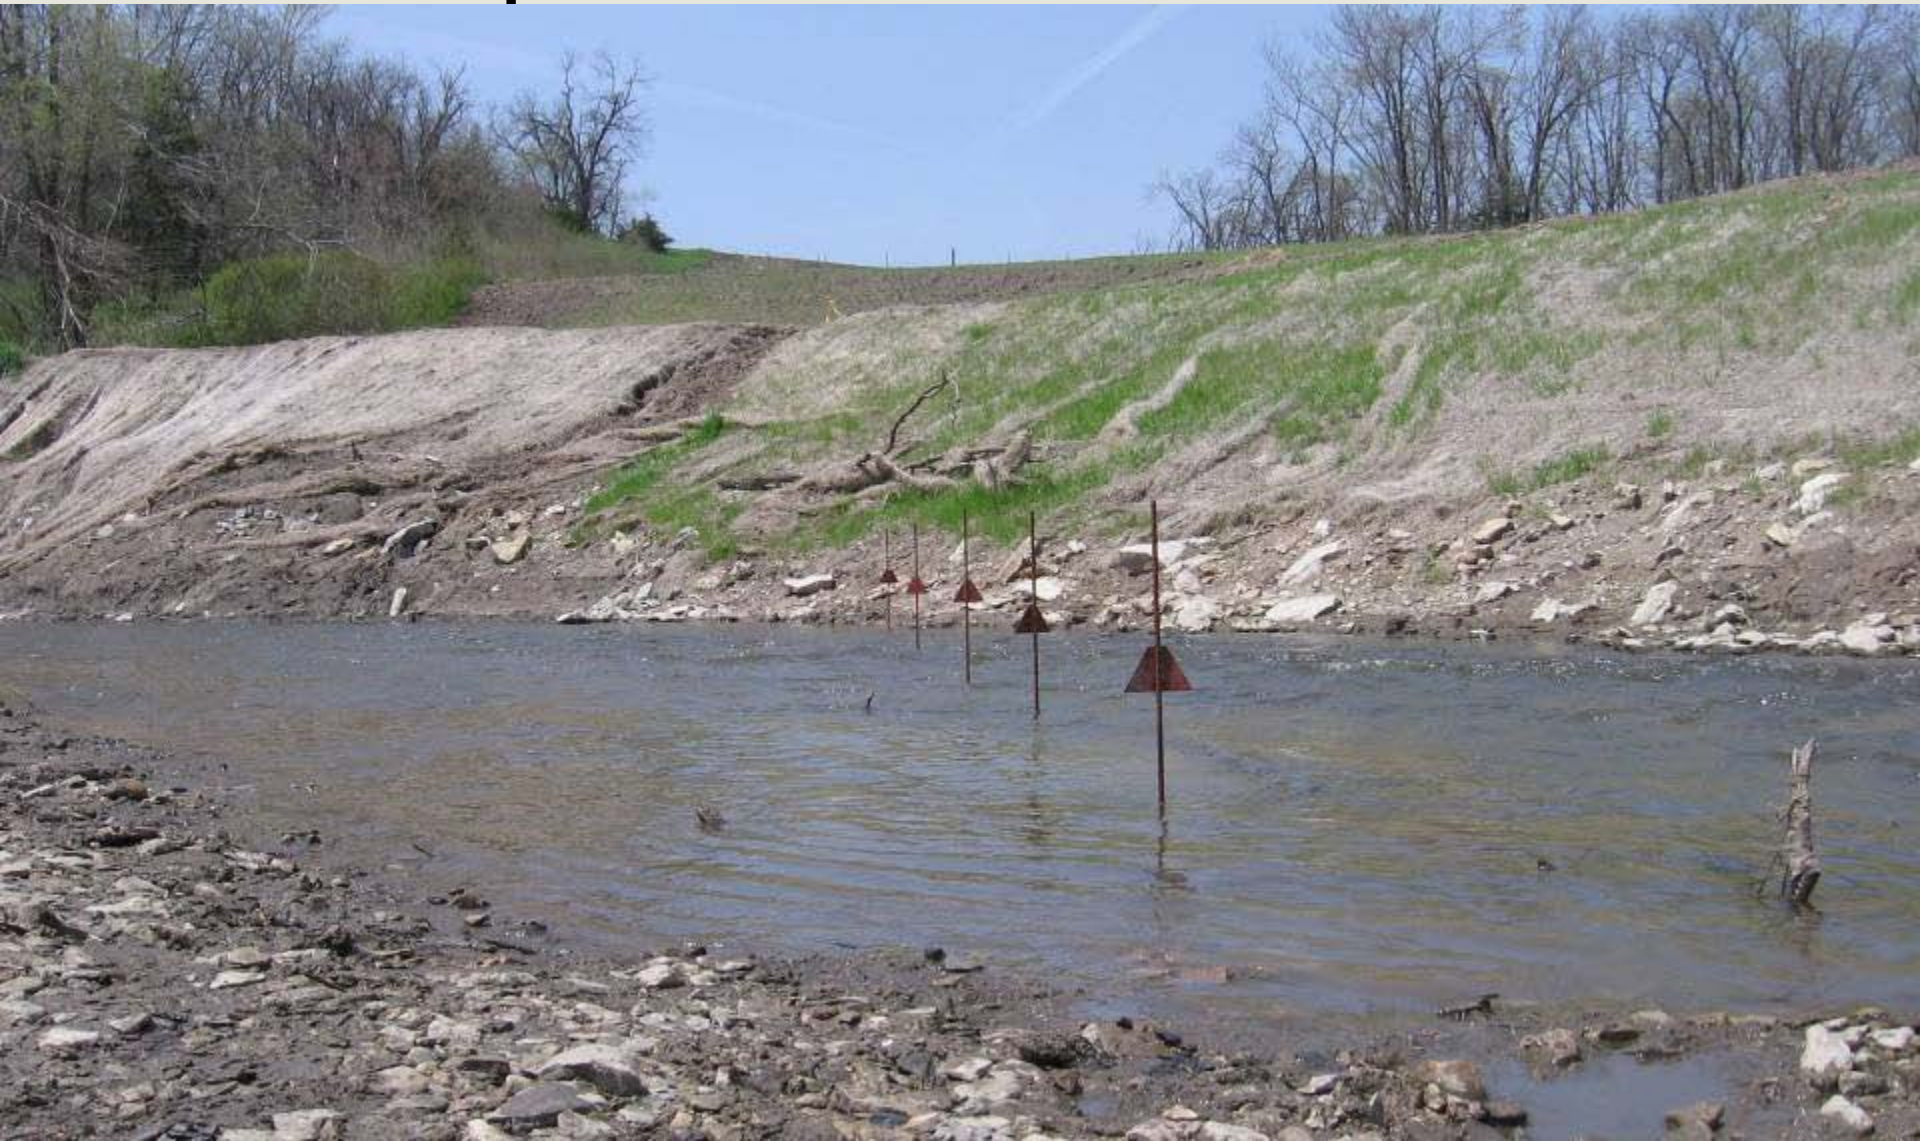
Is the pipeline buried deep enough  
and protected from erosion?

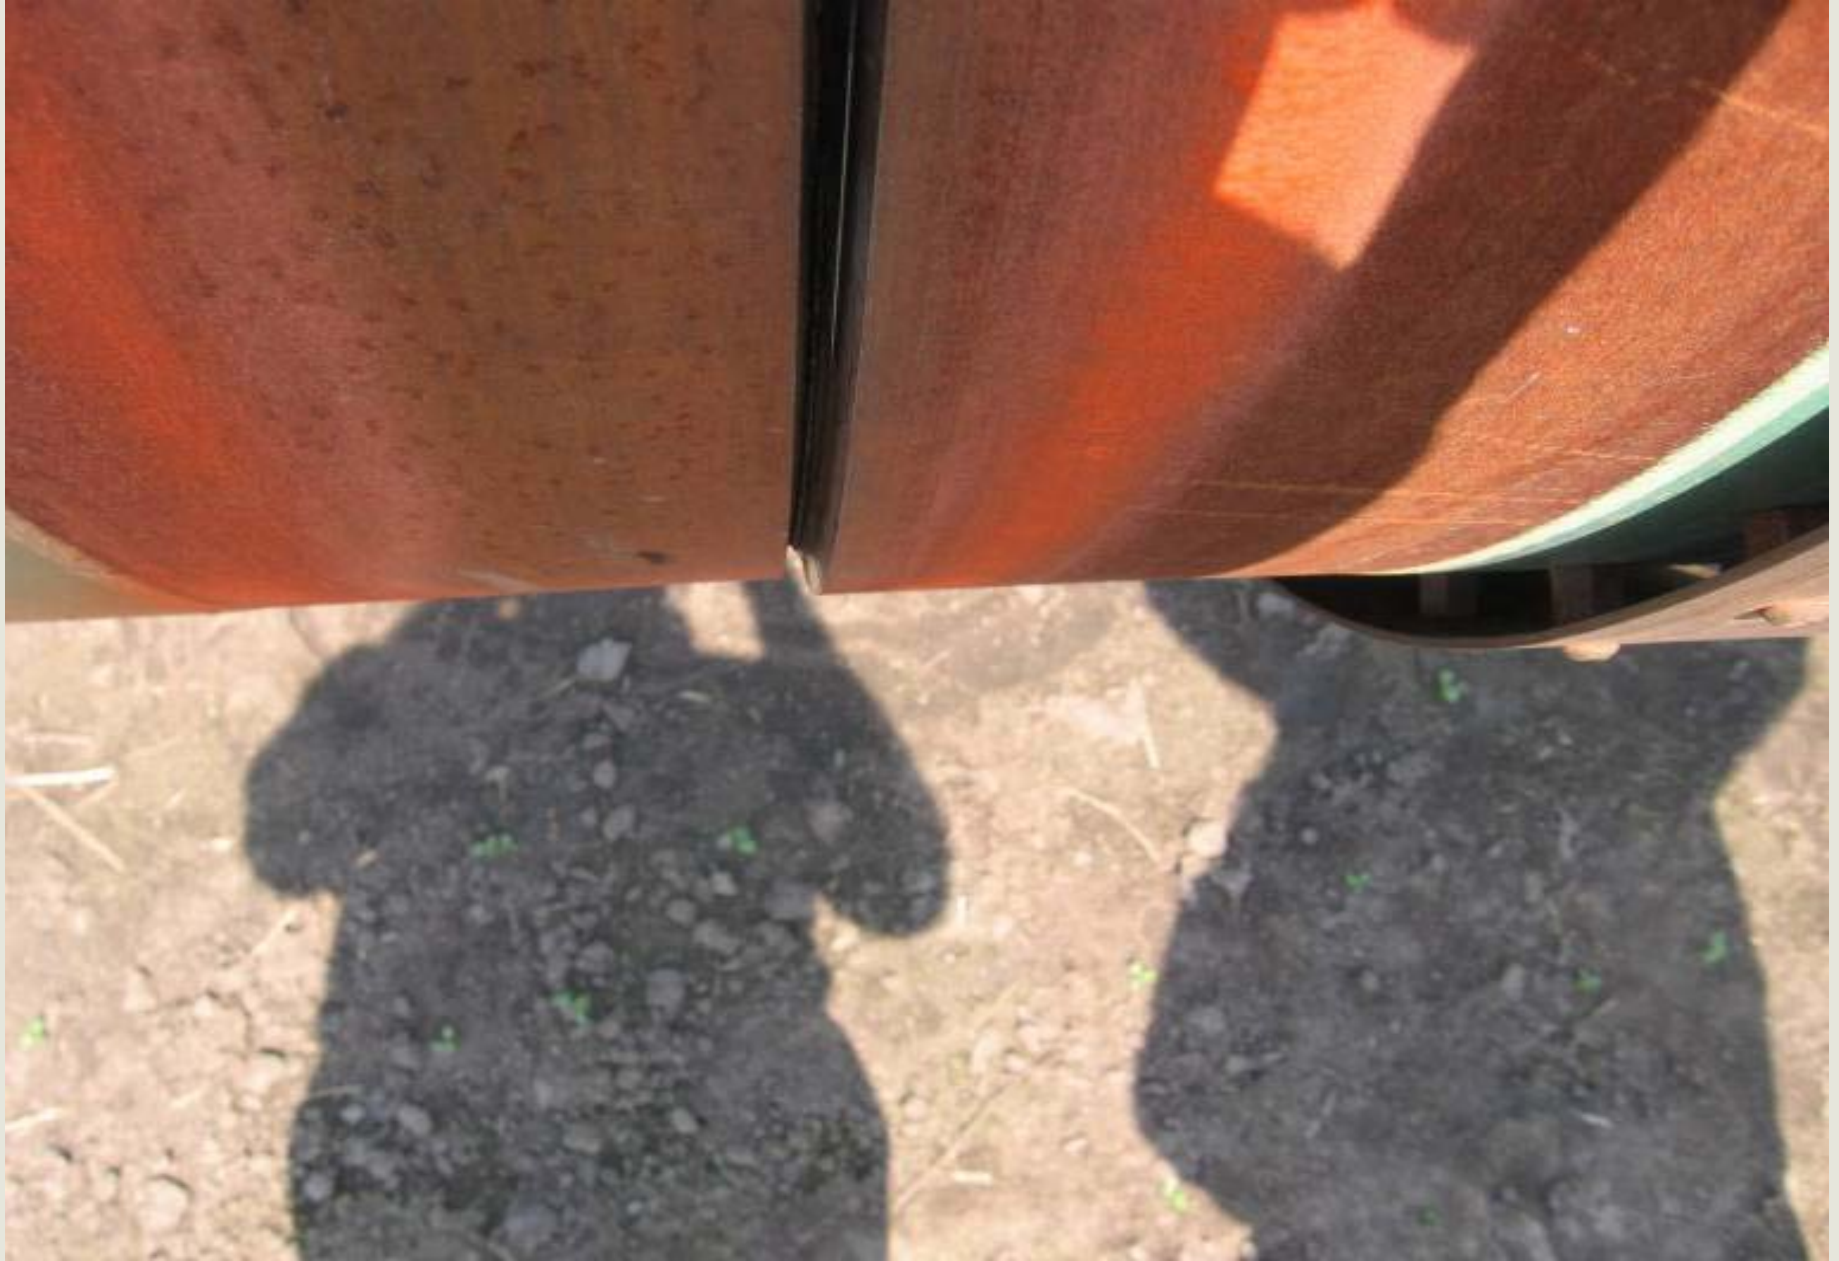
- Causes
- Pipe sizing issues
- Inexperienced welders
- Start up issues
- X-ray or AUT falling behind eliminates timely feed back. Feed back is a valuable tool to improve weld quality.

The welding procedure allows how much high-low?
