OCC  
Pipeline Safety Seminar  
September 2011

Construction Issues

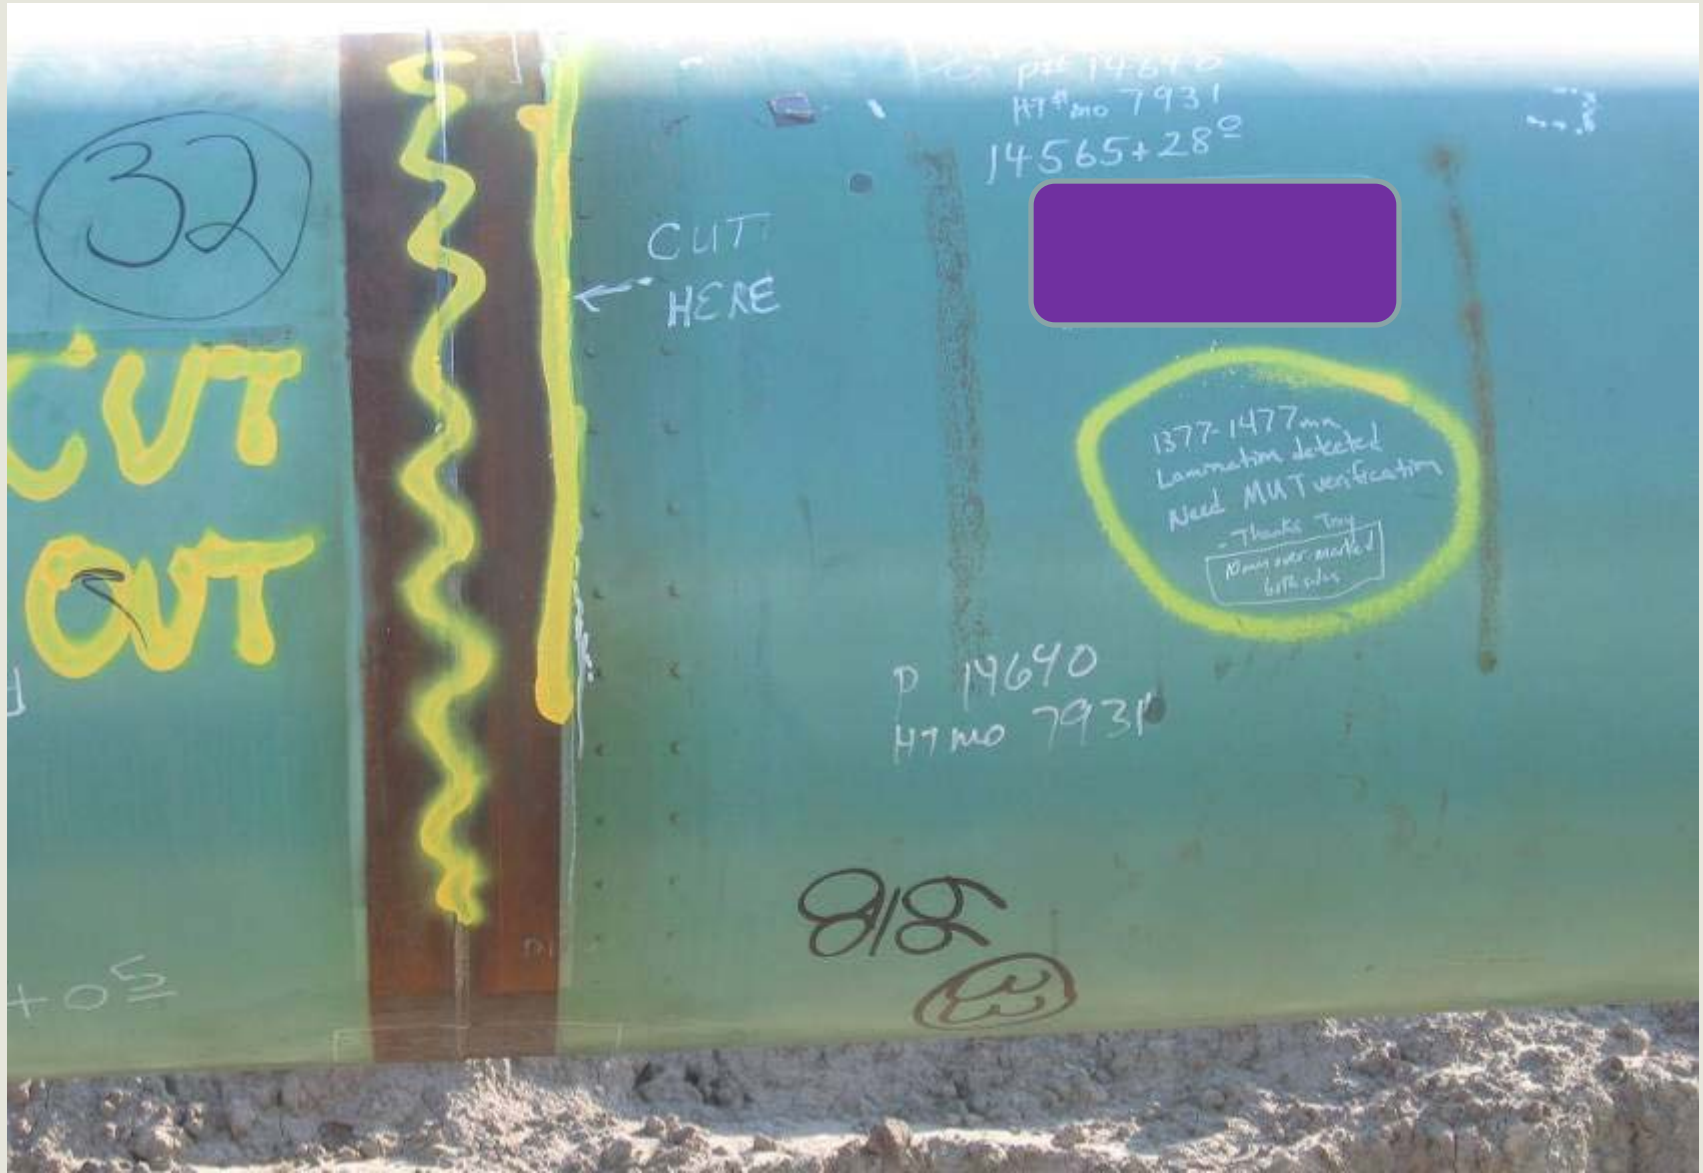
Laminations can be an issue especially associated with an 80% waiver

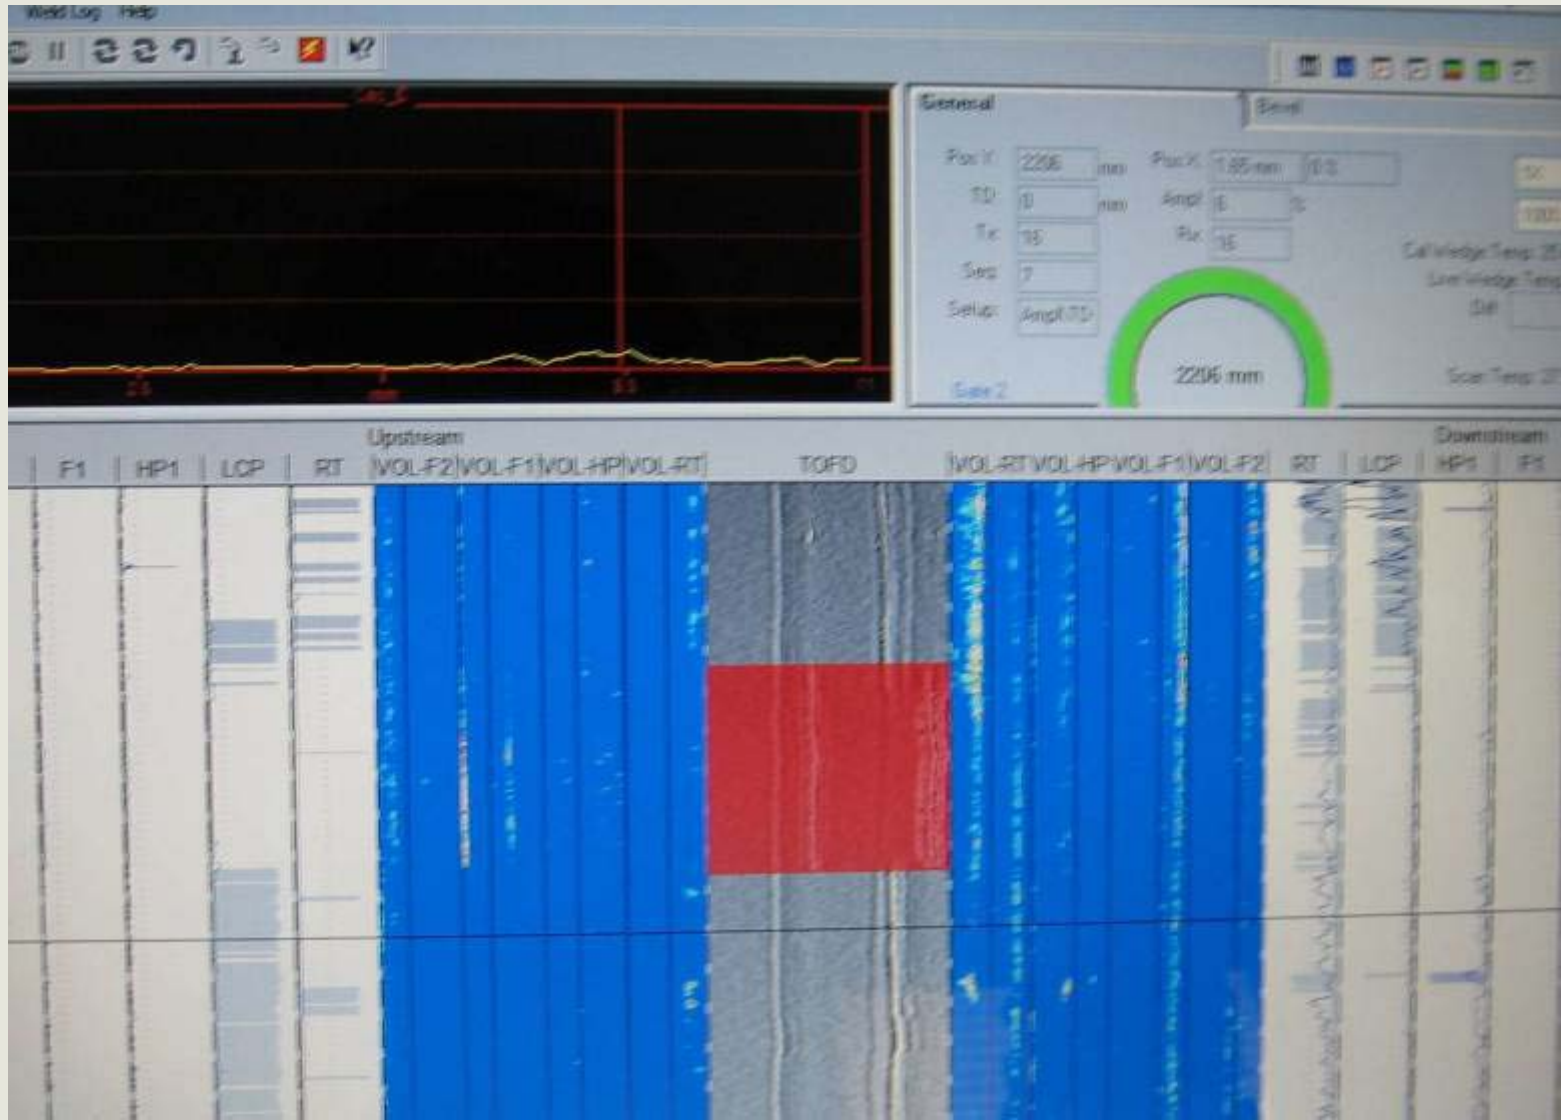
# AUT, automated ultrasonic testing, easily shows laminations

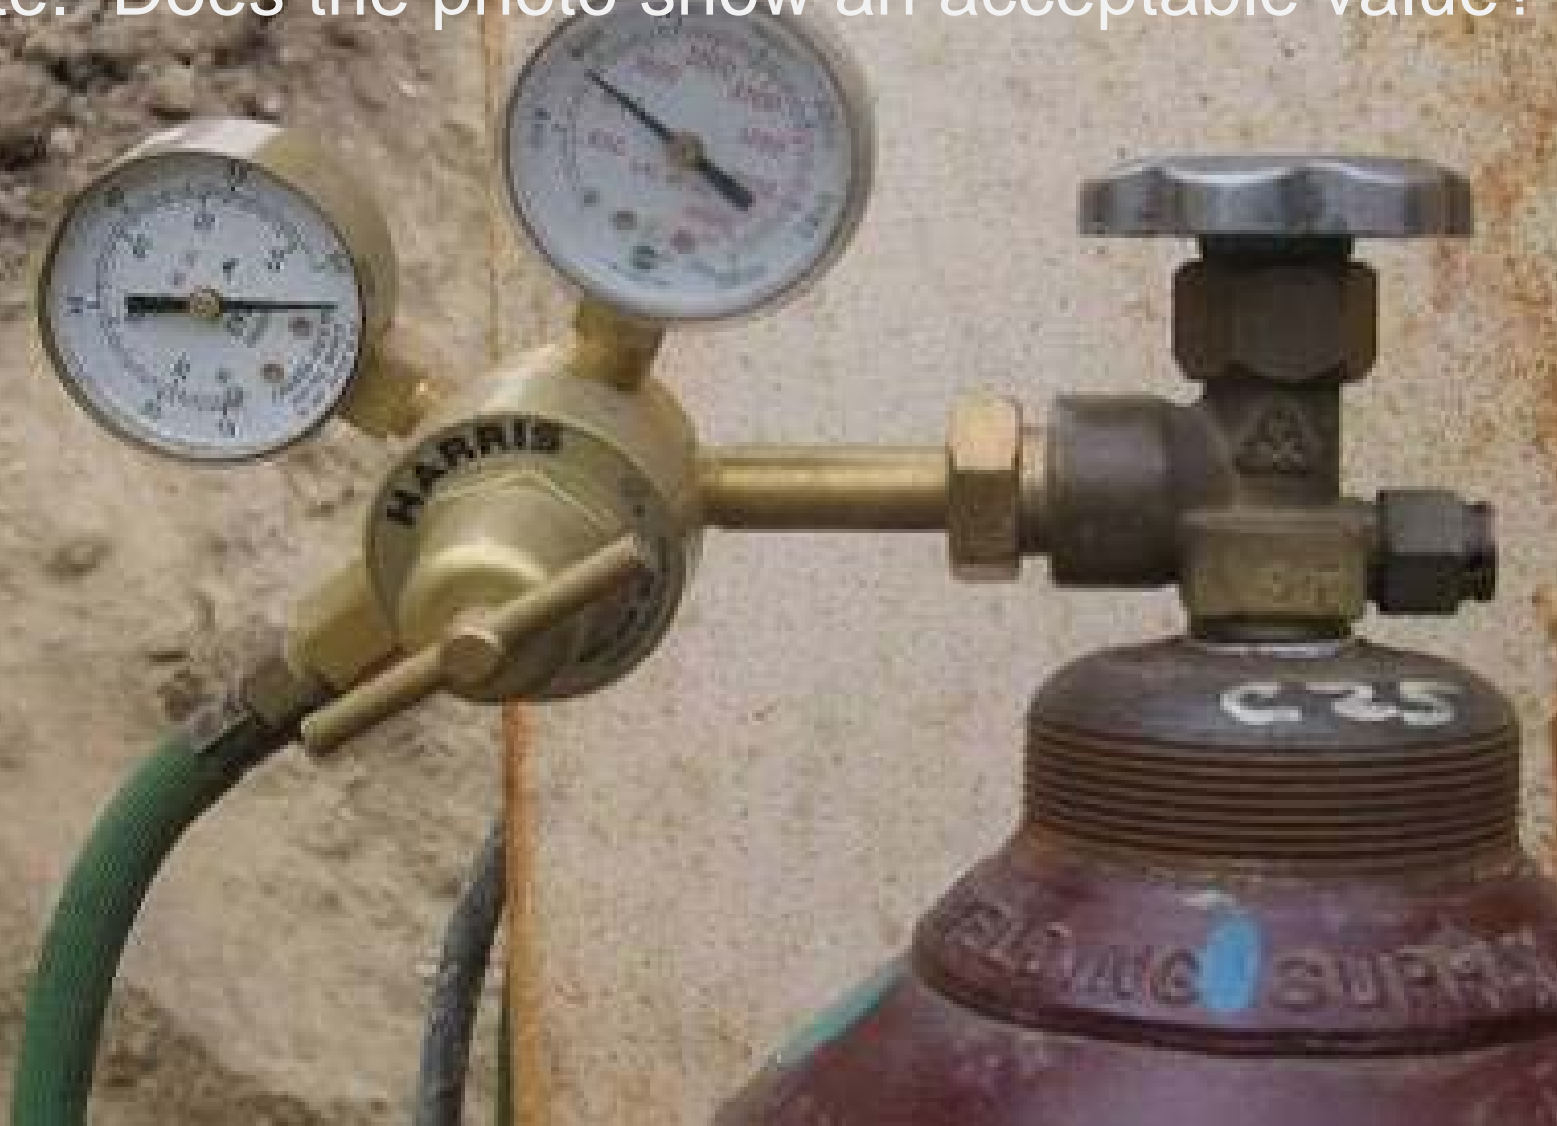
The procedure states 20 – 40 cfh shielding gas flow rate. Does the photo show an acceptable value? (No)

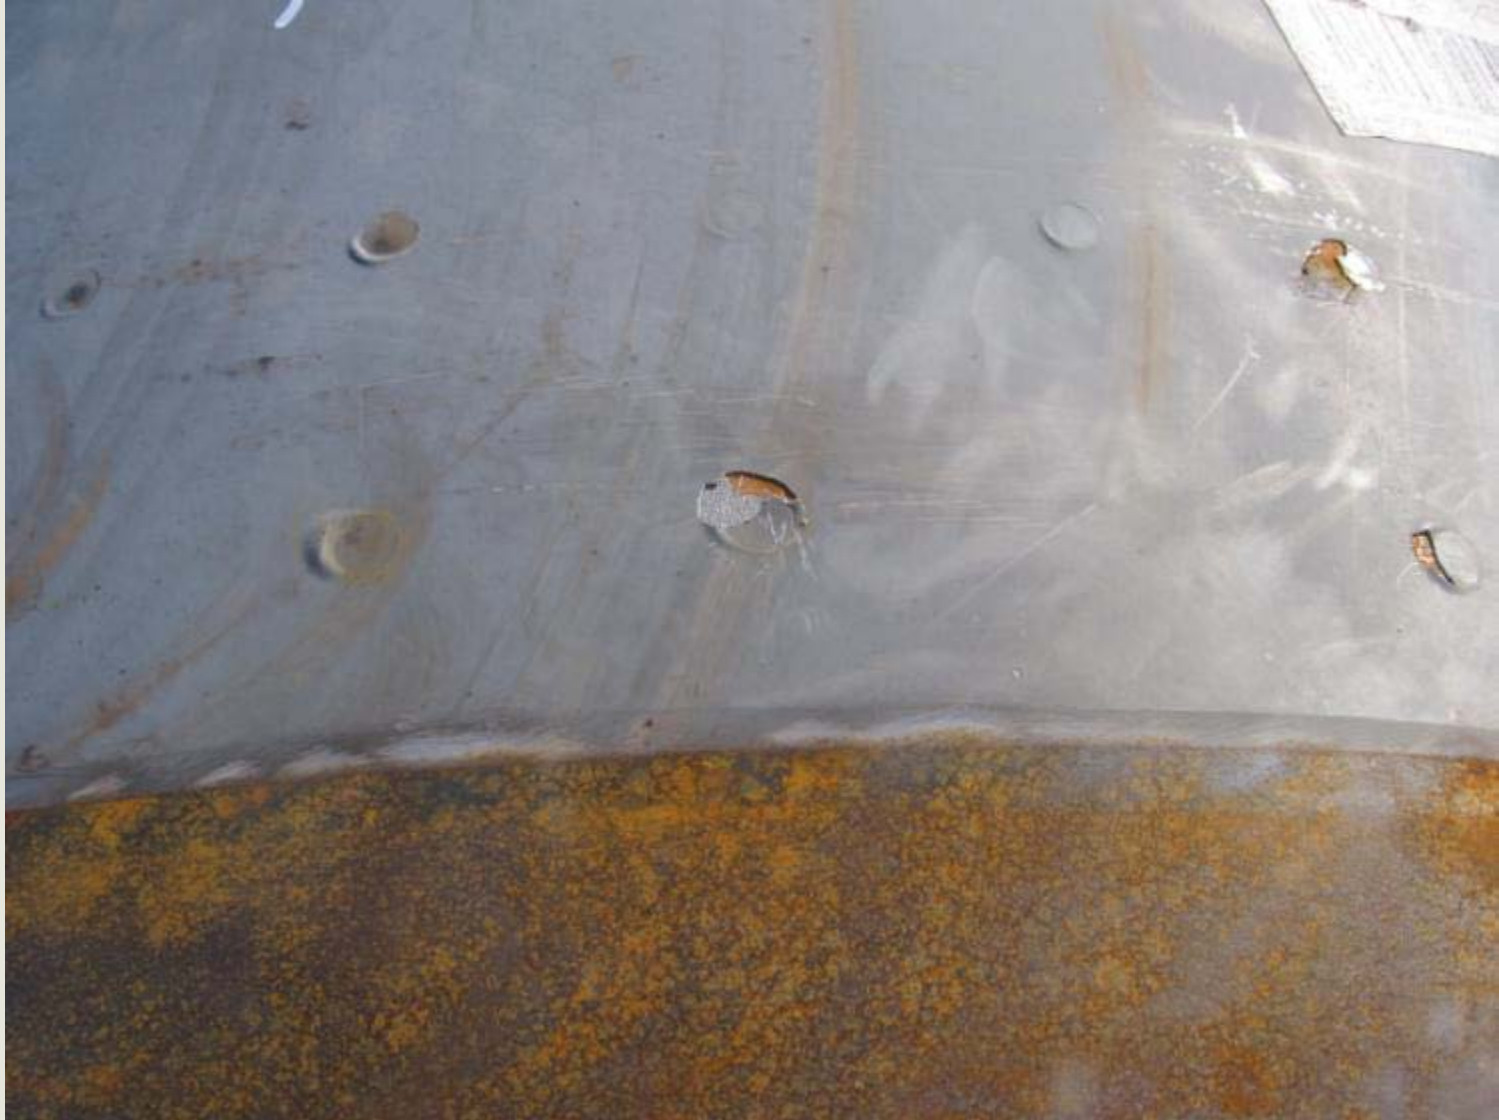
# Welding Band Damage to Coating

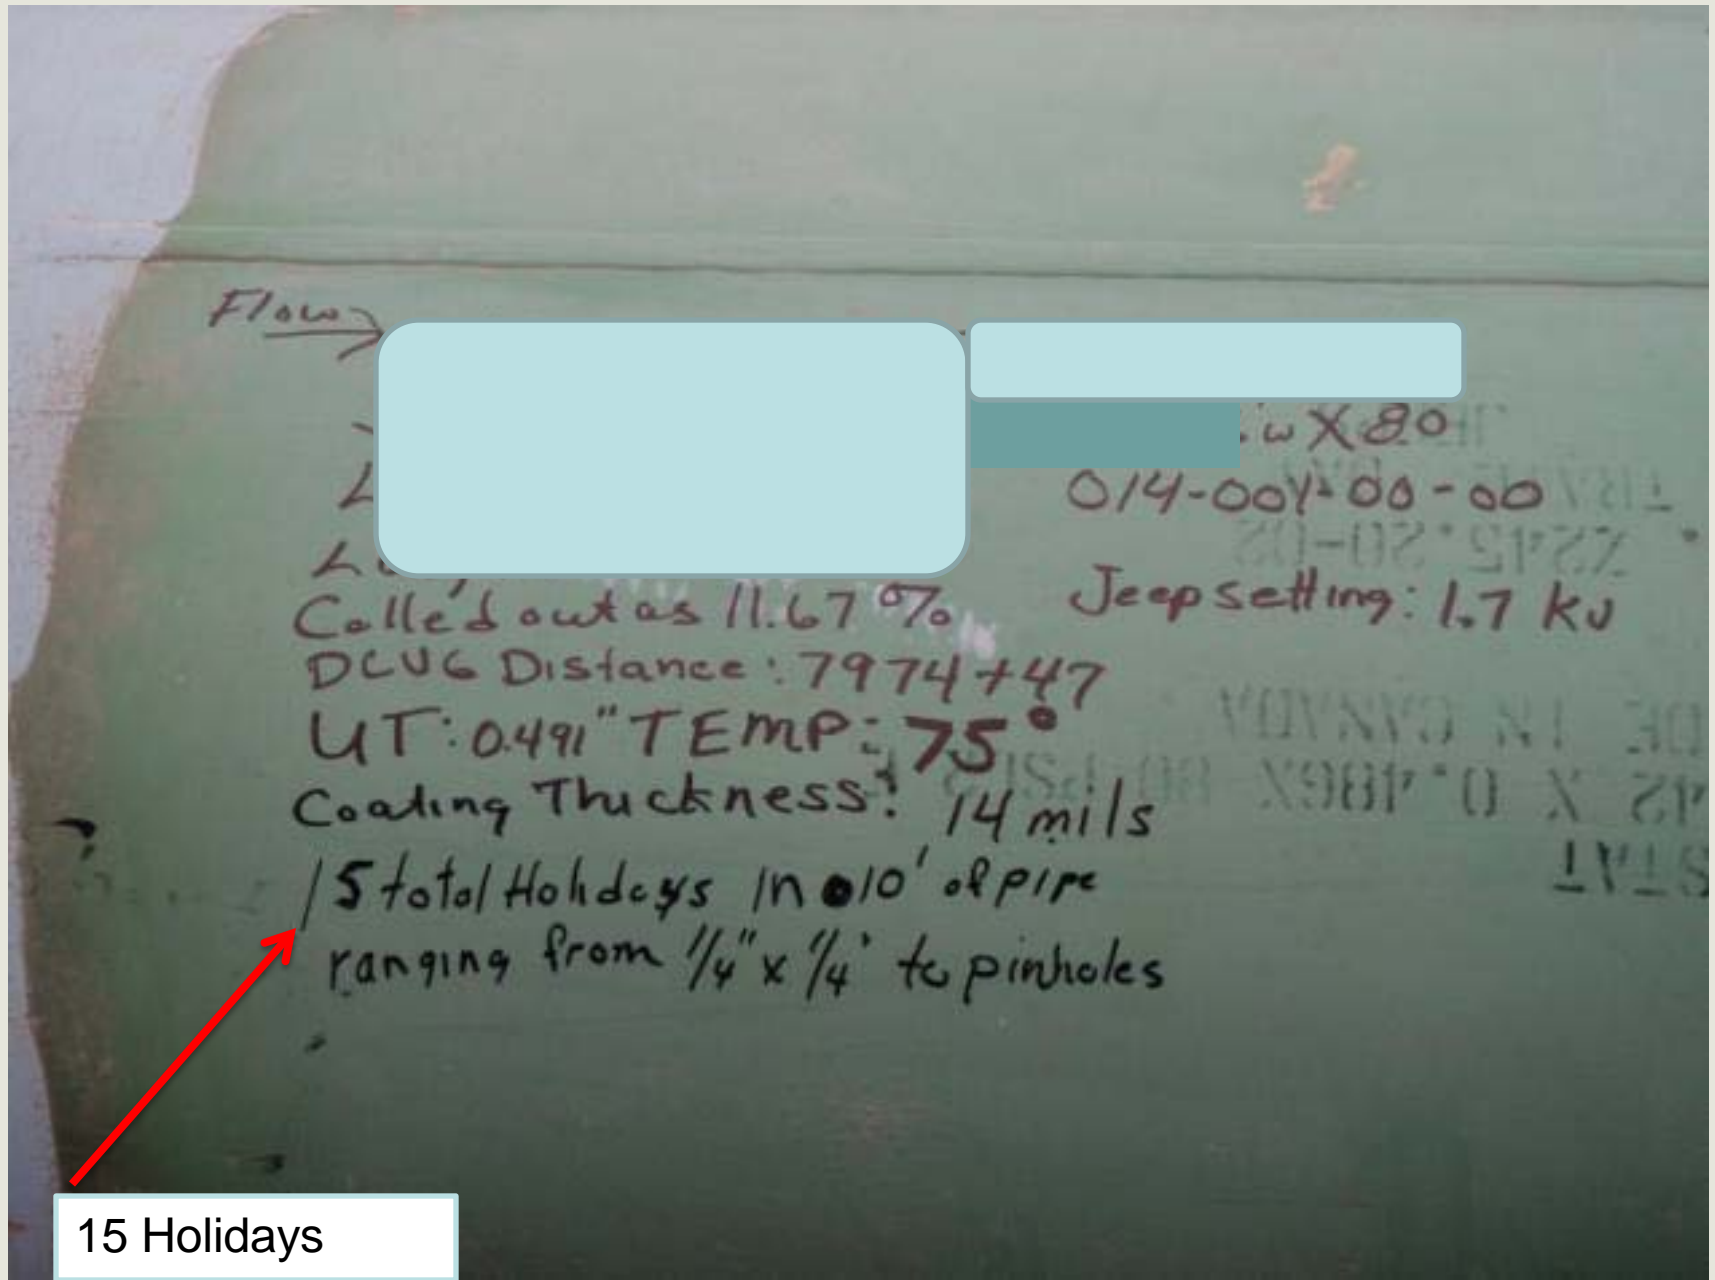
15 Holidays

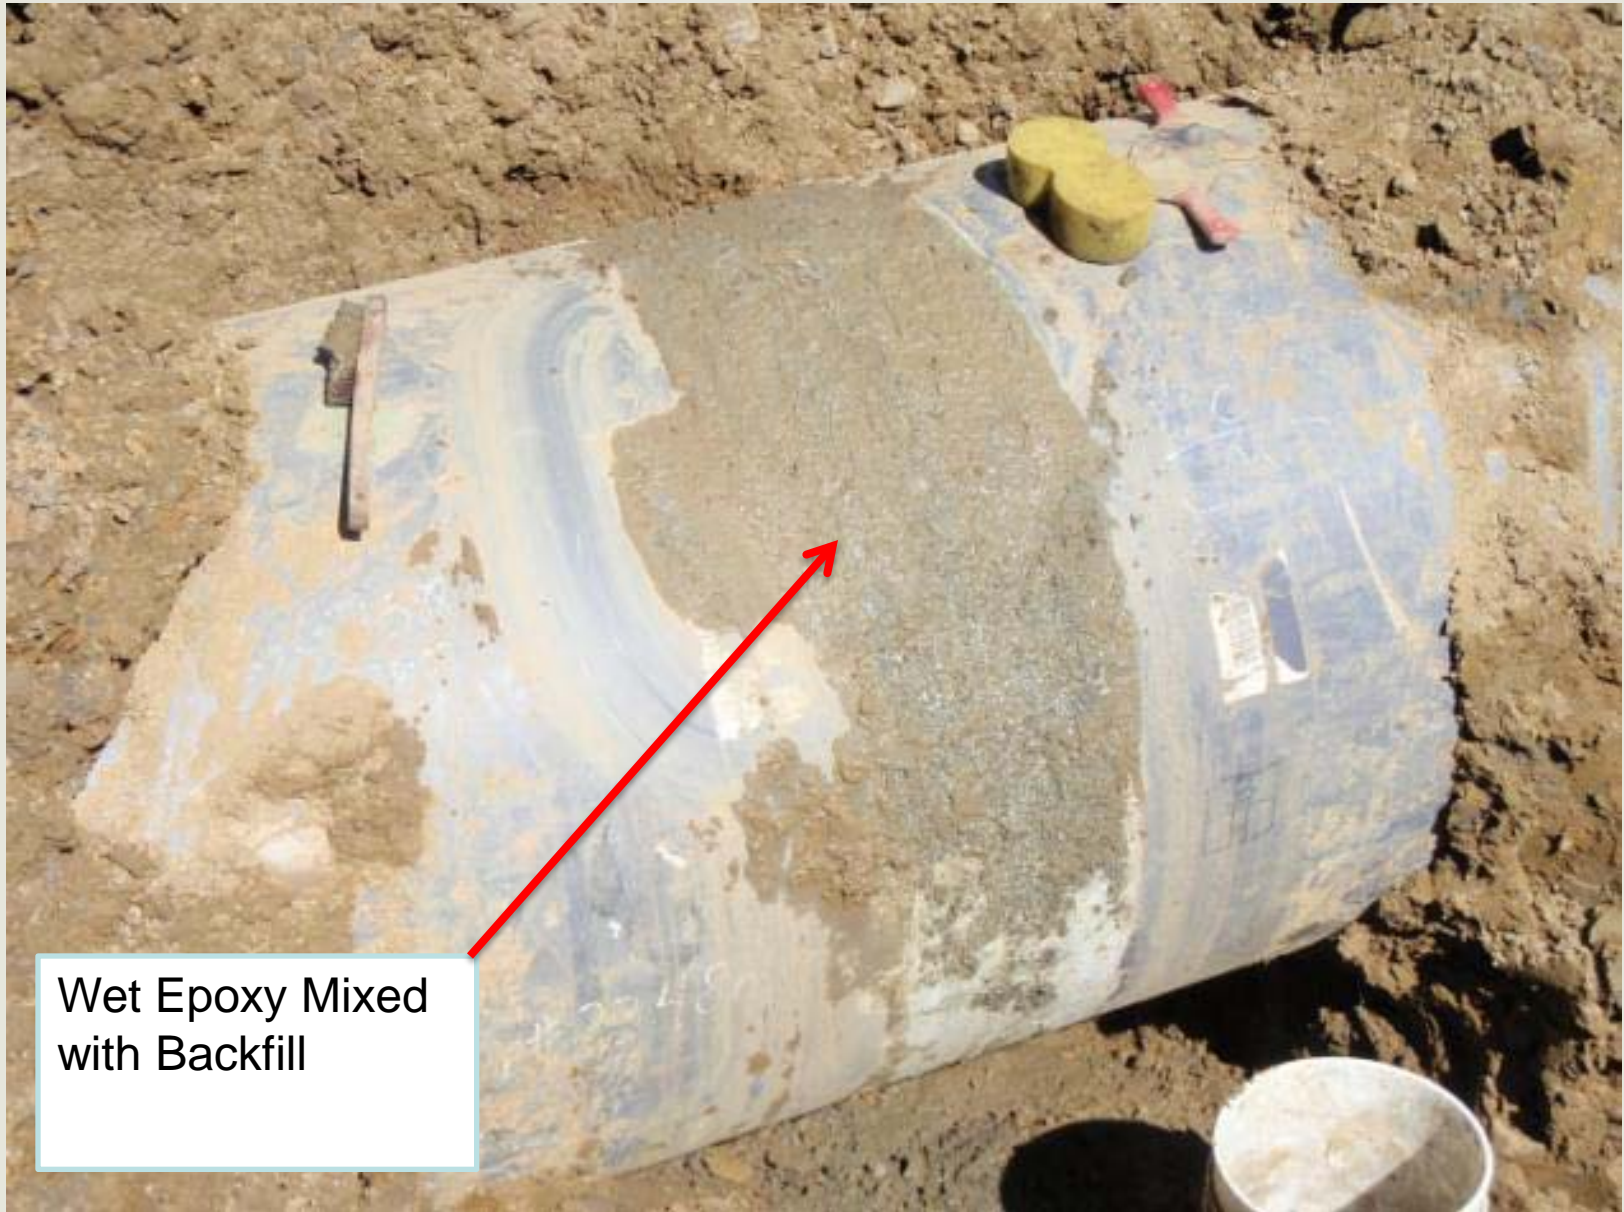
# DCVG Dig on First Phase – Girth Weld Coating Mixed with Backfill

Wet Epoxy Mixed  
with Backfill

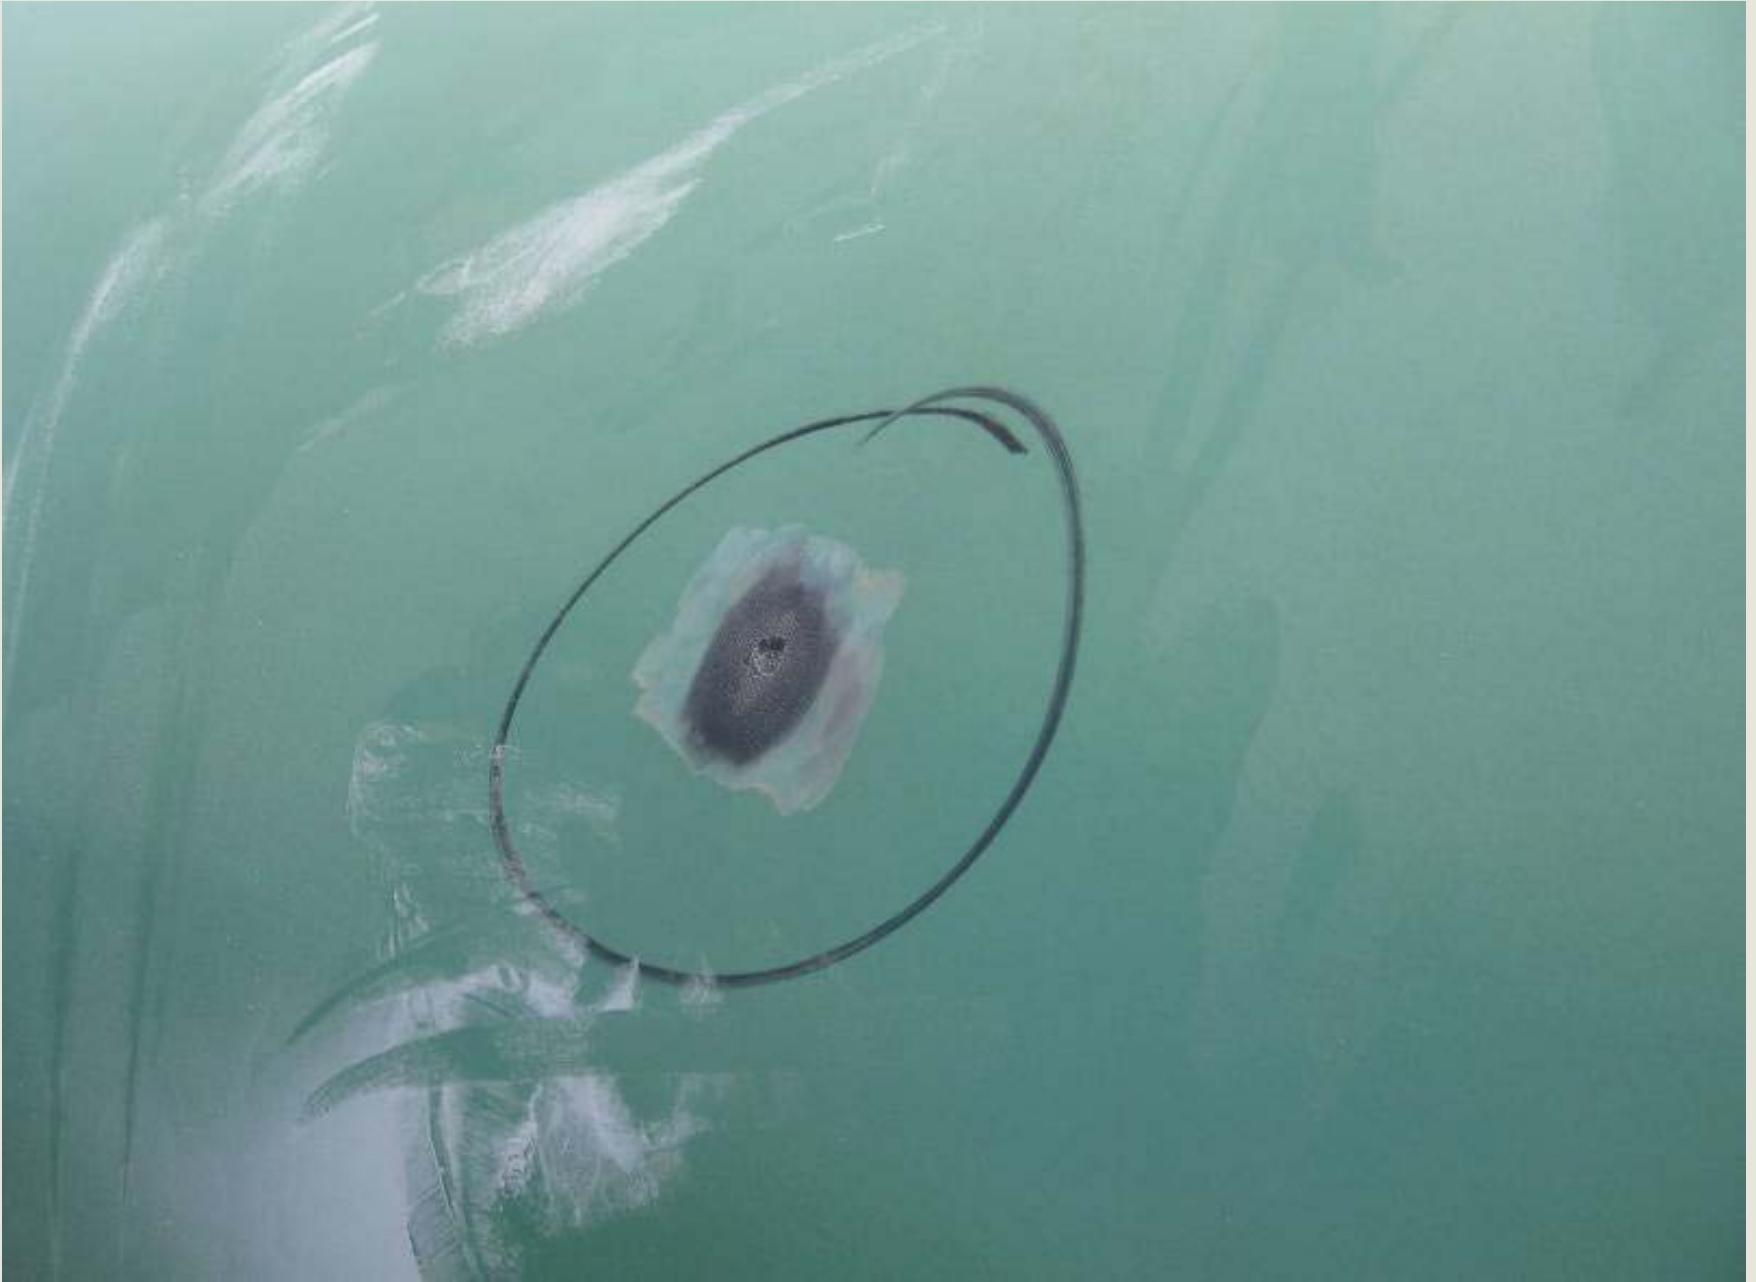
Pipe Defect – Does remaining wall thickness meet requirements of API 5L?

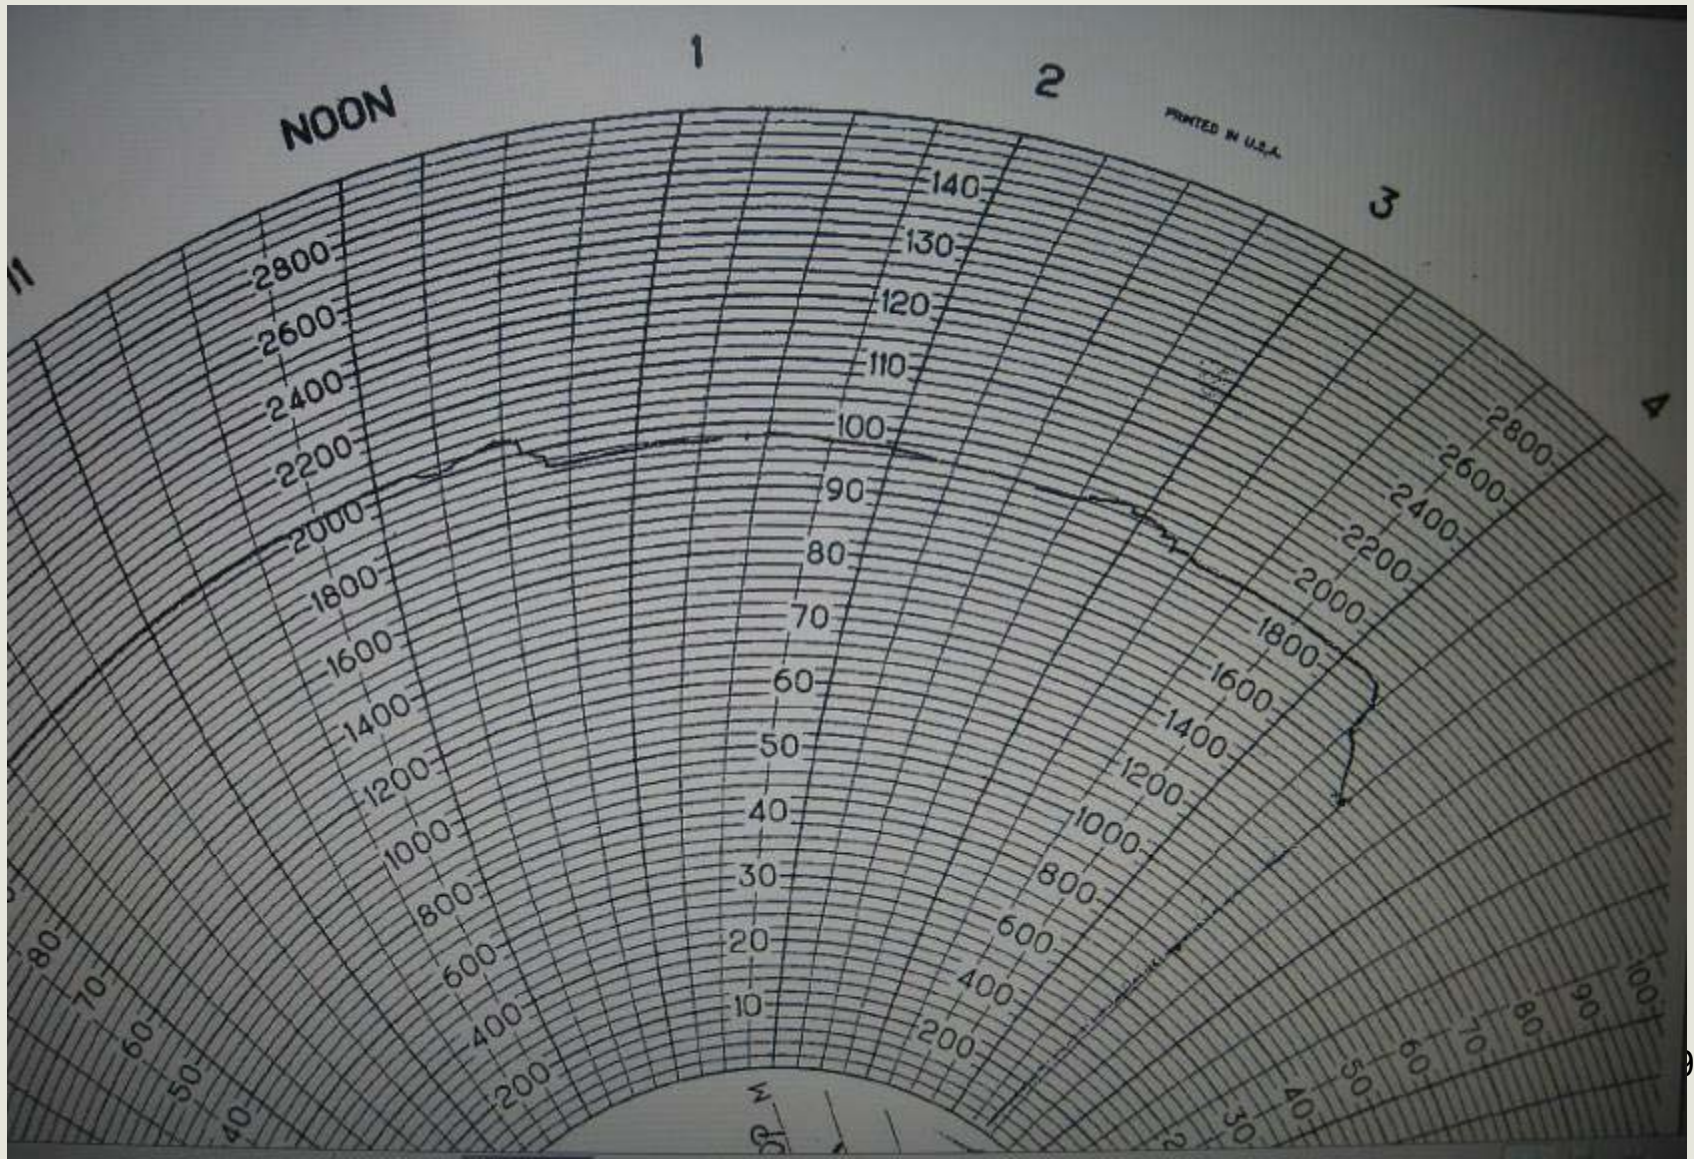
- Procedures should include provisions for cold weather testing (if not see next slide)
- Pressures should be maintained at least 8 hours for buried piping. Any pressure decline should be investigated. A second pressure test may be warranted. (See chart of failed test)

Chart shows pressure loss last 3 ½ hours

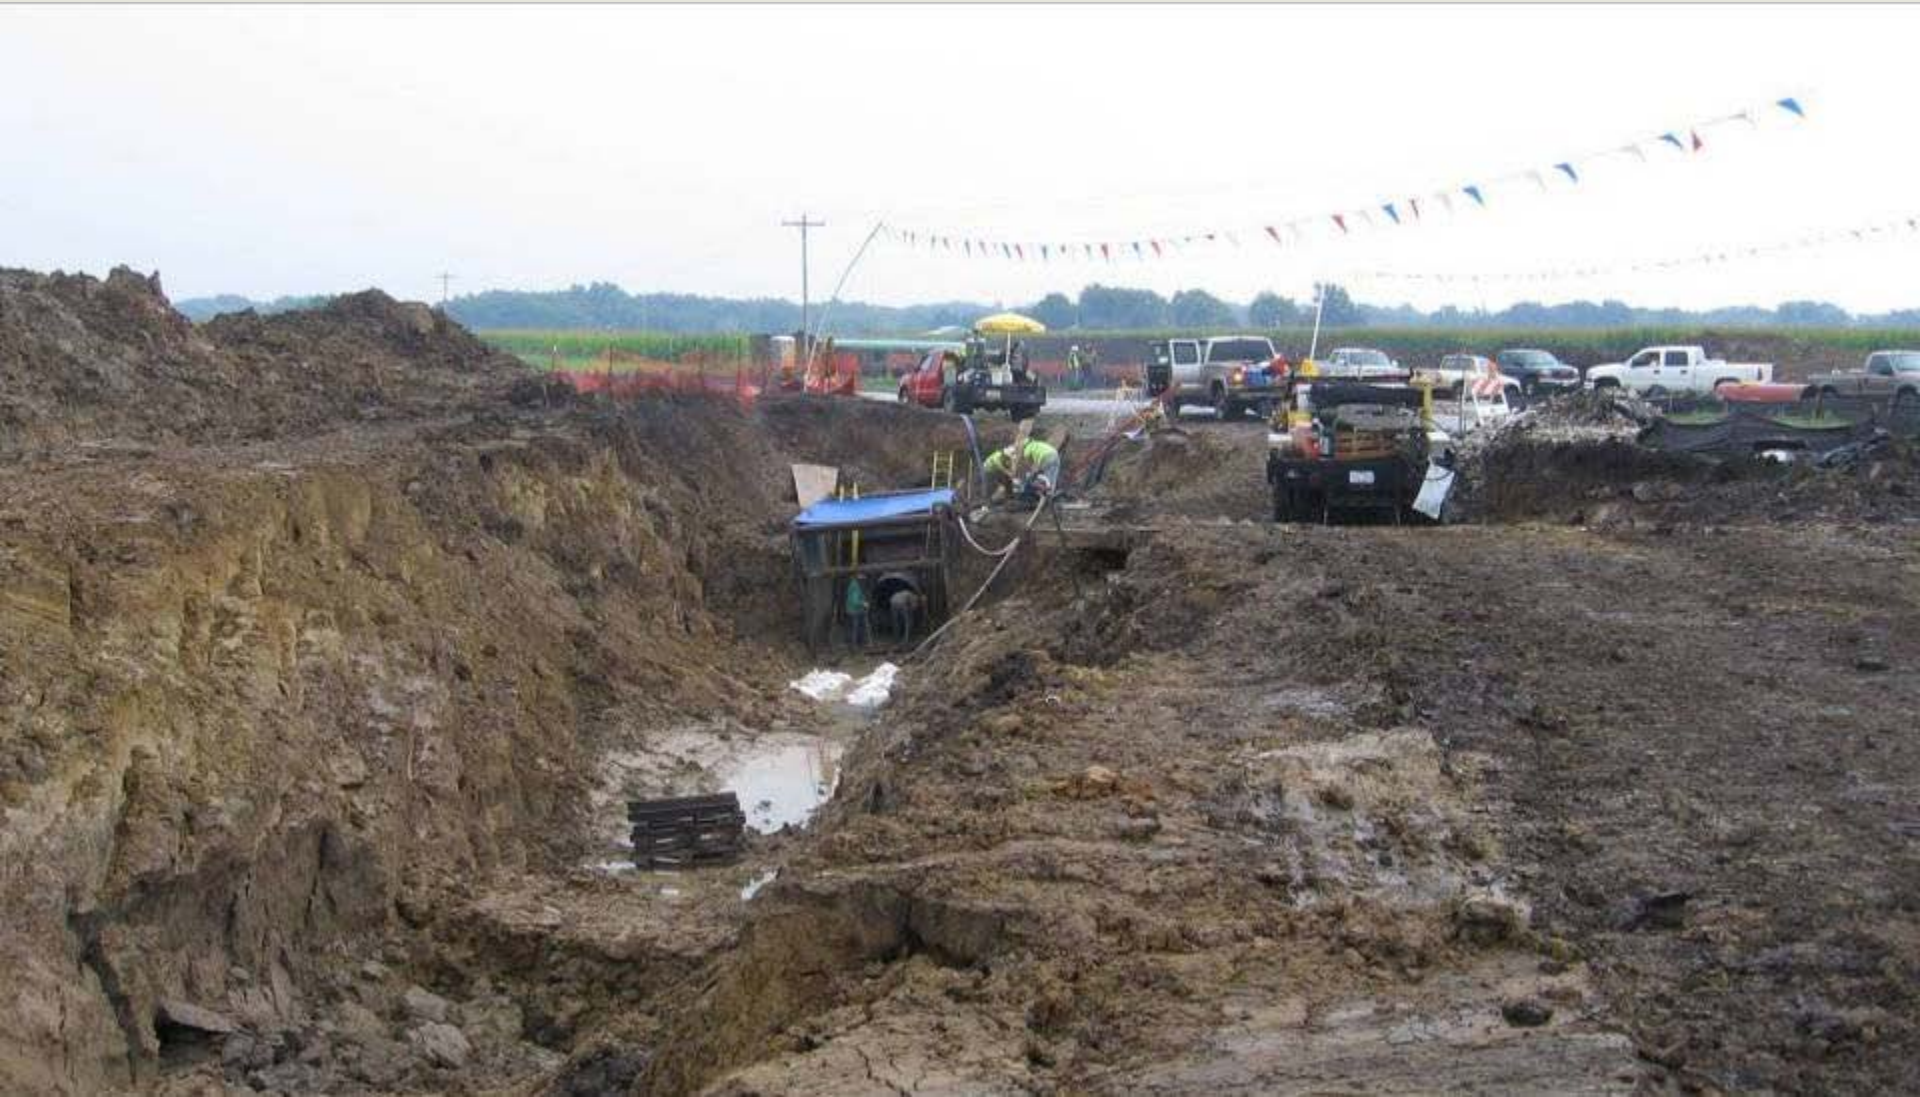
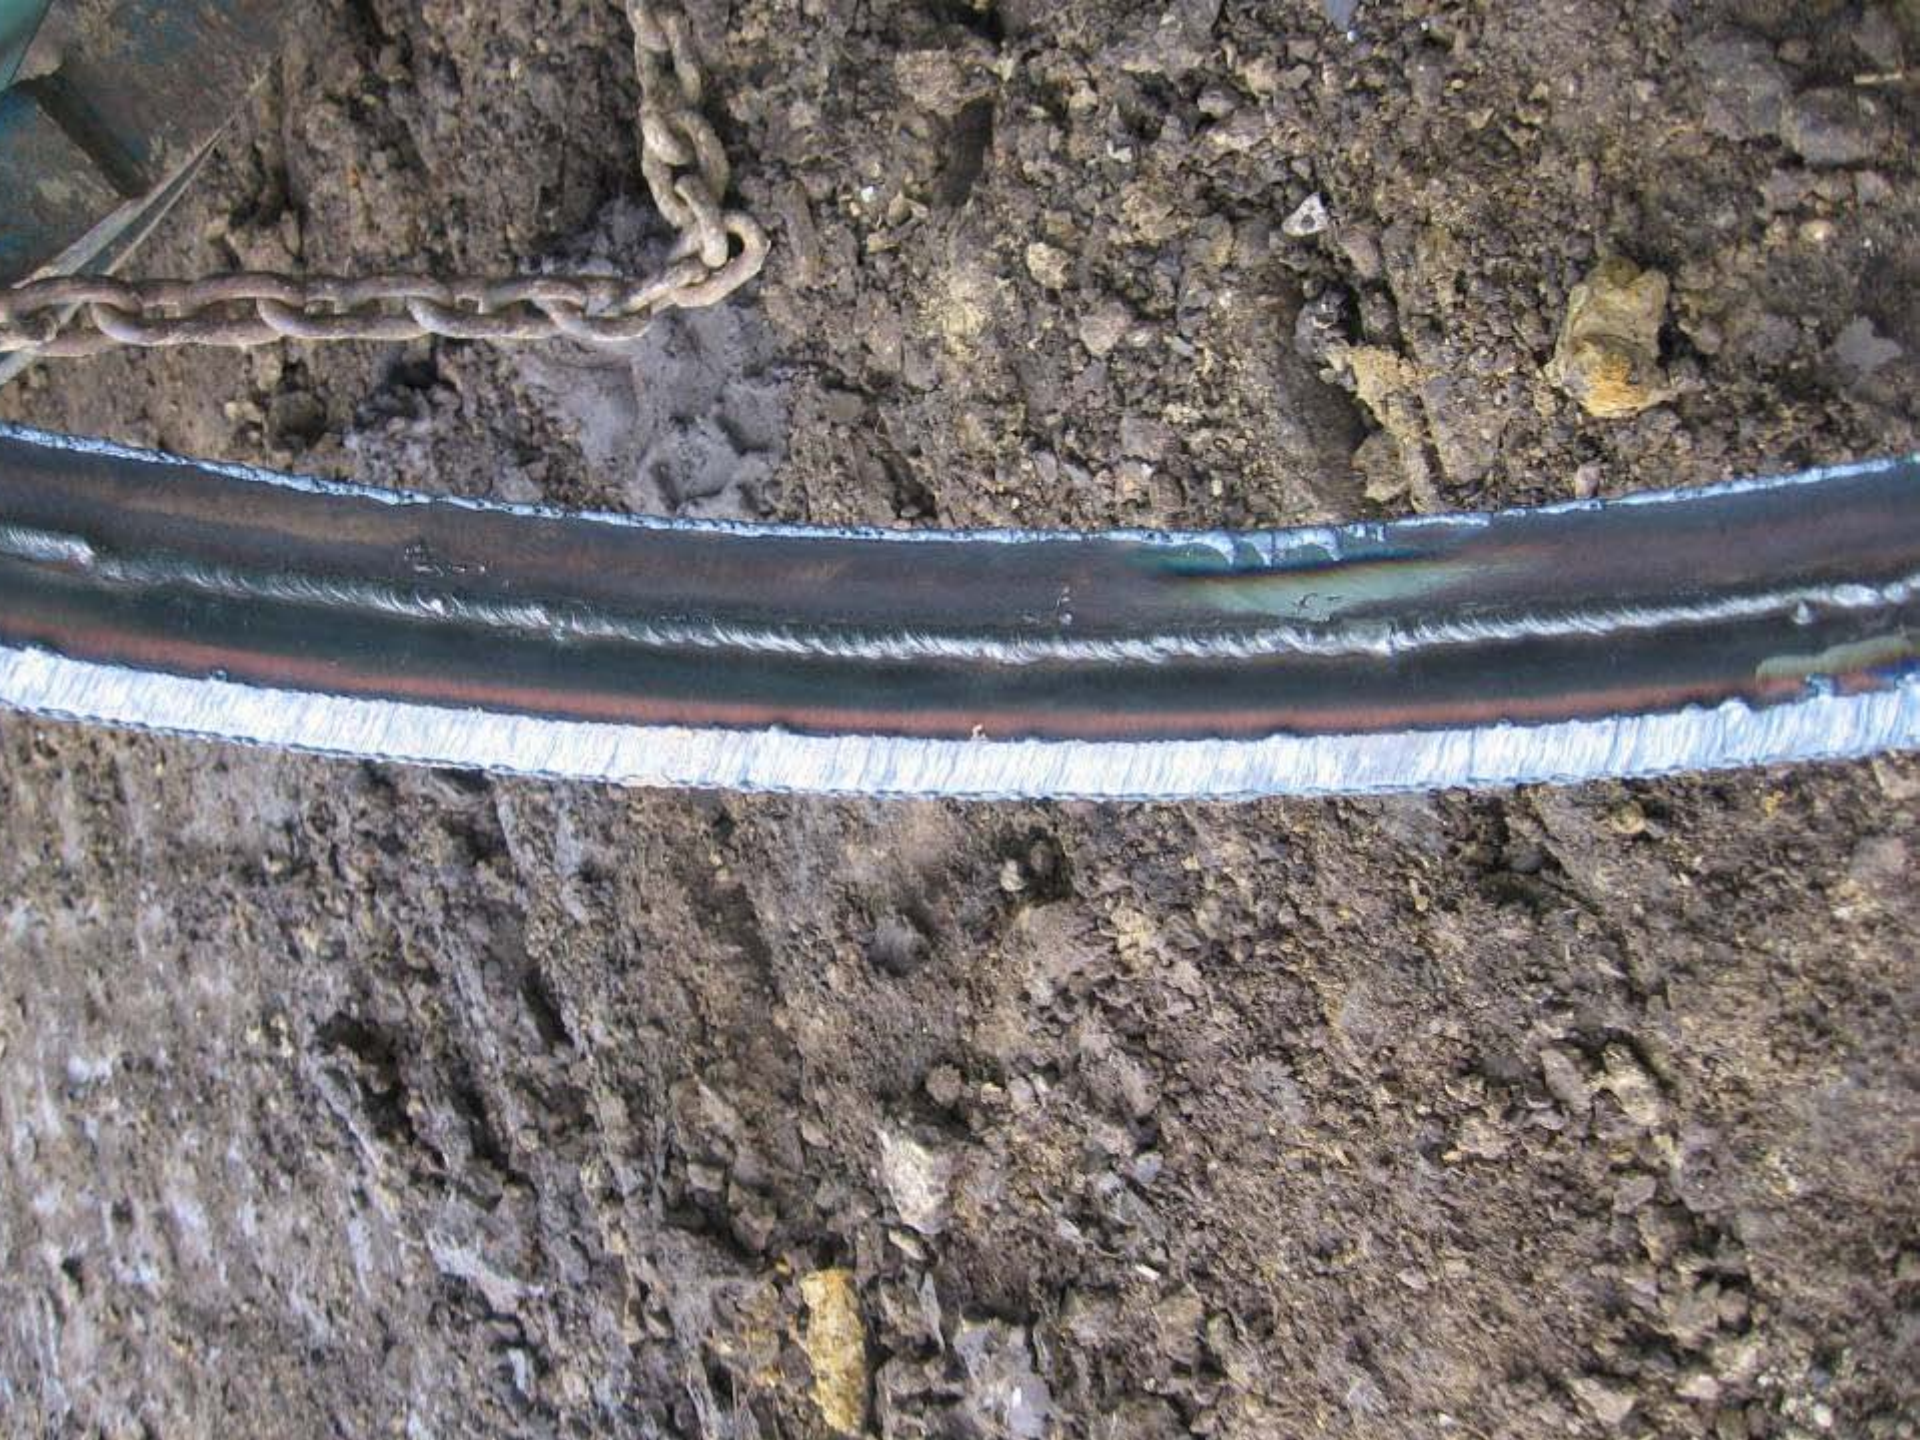
- Arc burns are not acceptable on high pressure gas pipelines and liquid pipelines.
- The following slides show that arc burns can happen during internal back welding.

The external weld was completed in the trench box. Then the welder crawled inside and completed the back weld. This was a transition weld between 0.740 and 0.486 wall thickness pipe. The welder struck the arc multiple times inside the pipe and missed the bevel multiple times.
