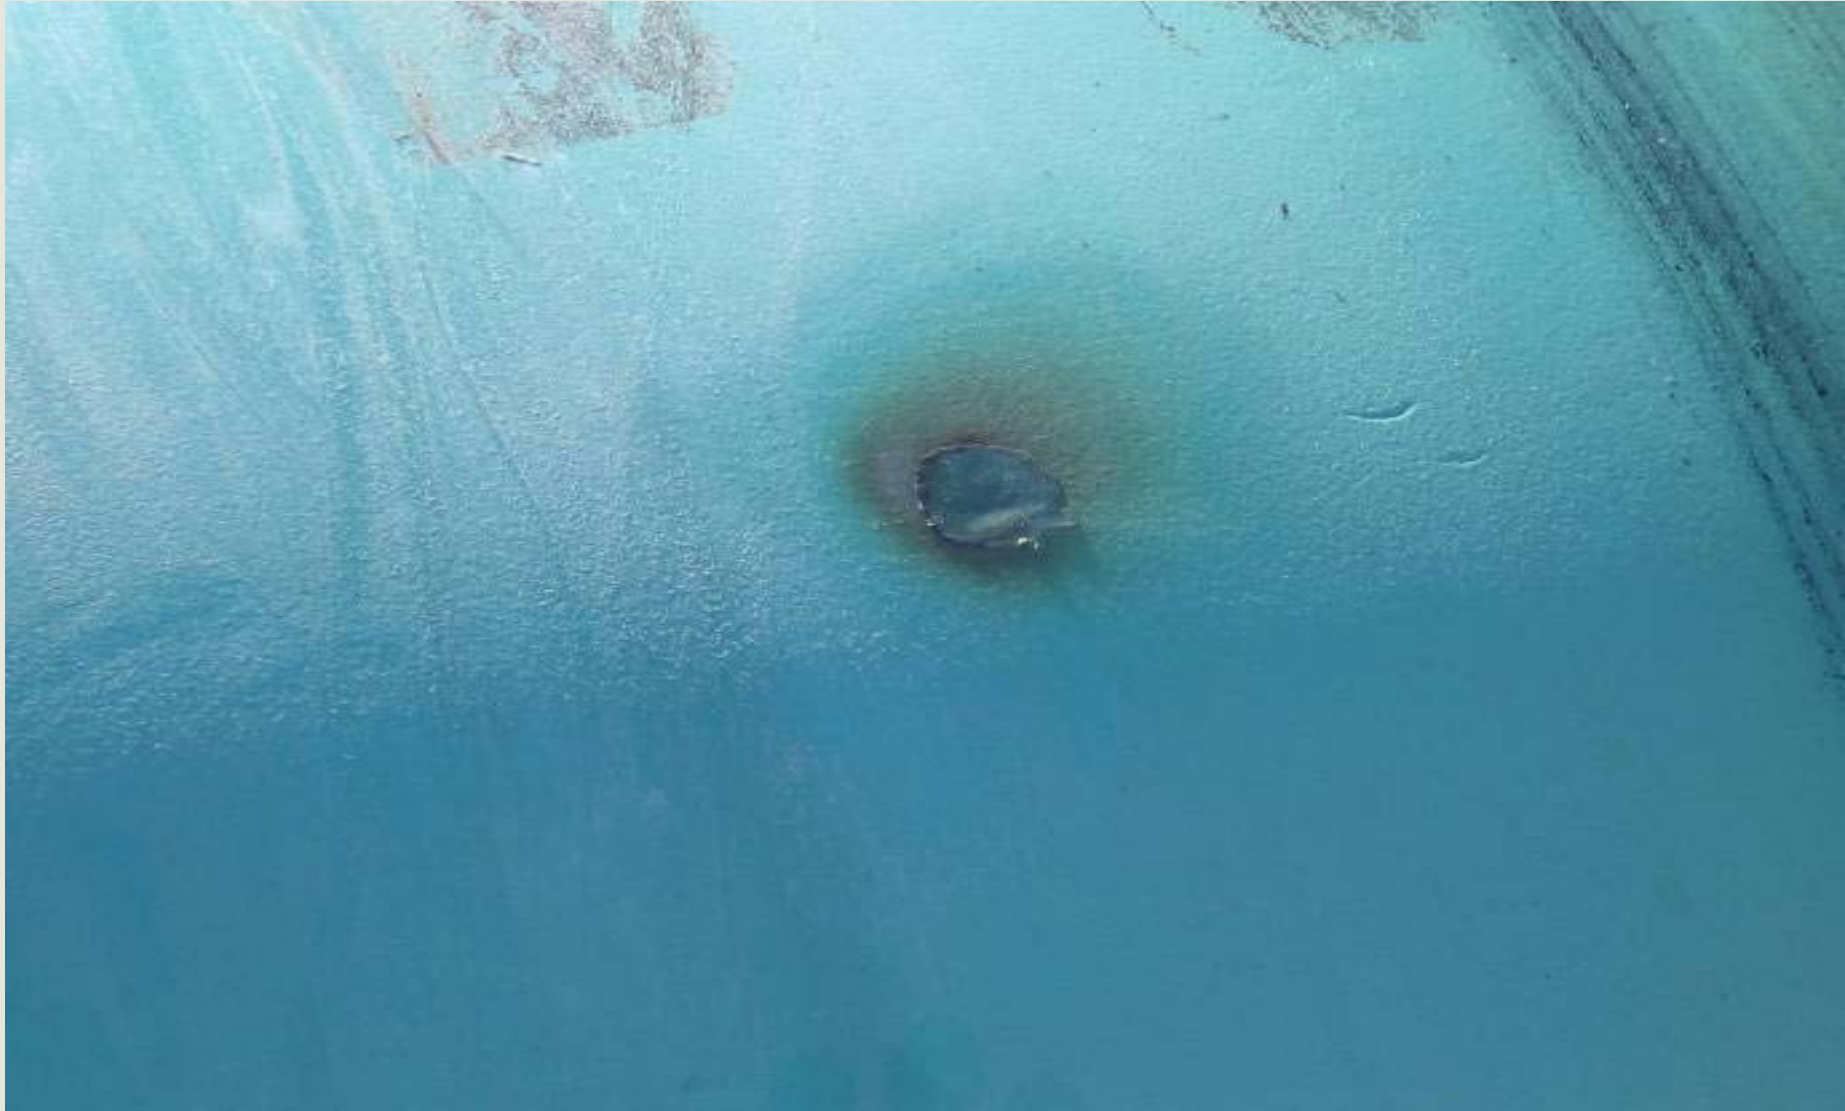
Good patch stick application - notice heated/discolored area around patch, this indicates that the pipe was heated before and during patch stick application
