TARGETED BROWNFIELD ASSESSMENT

PERRY ARMORY

ASTM E 1527-05
Phase I Environmental Site Assessment
All Appropriate Inquiry

March 16, 2010

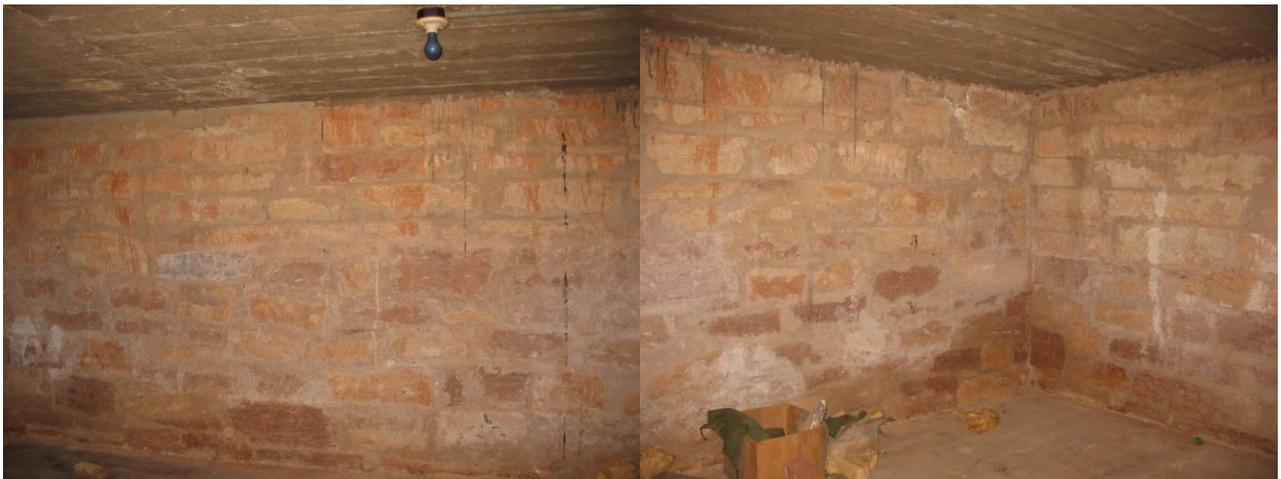
Indoor firing range; sand removed (Photos: KP)

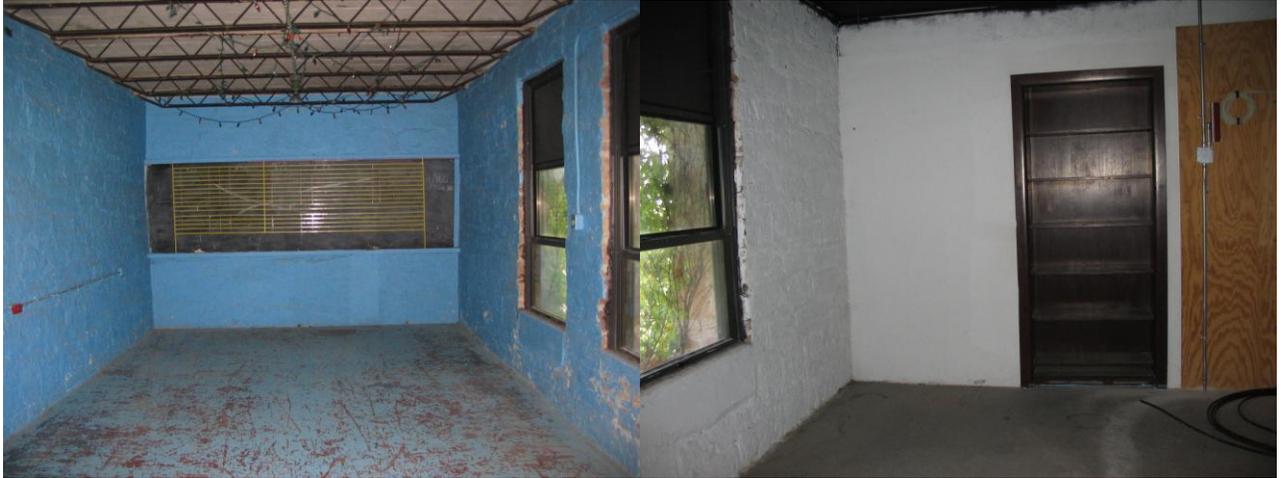
Communications storage room and office; paint peeling (Photos: KP)

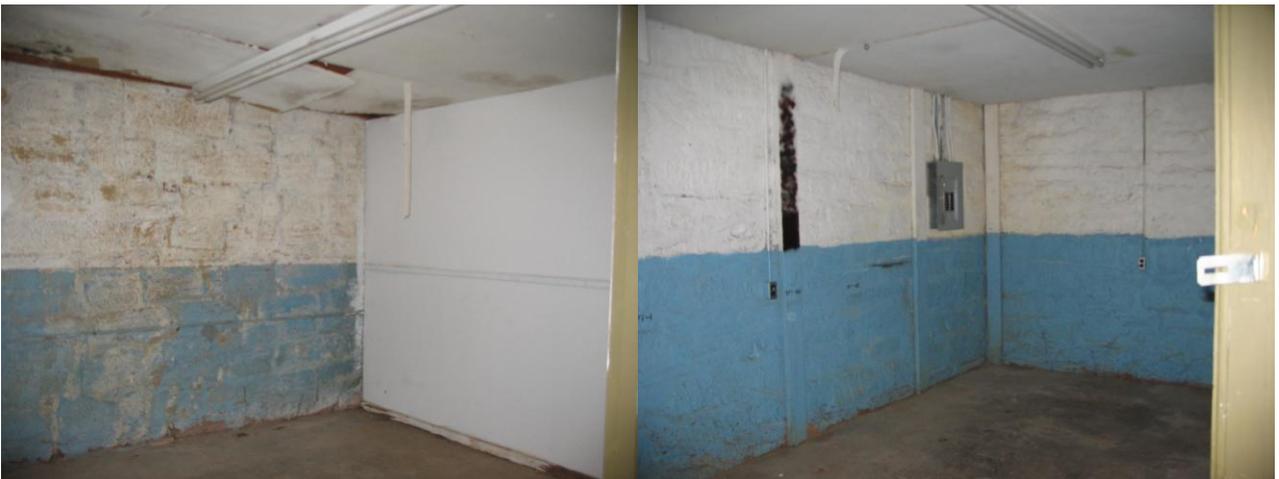
Storage room with peeling/flaking paint (Photos: KP)

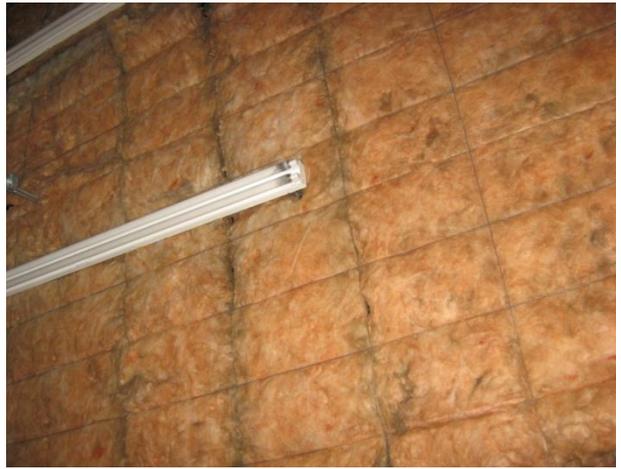
Insulation in office.

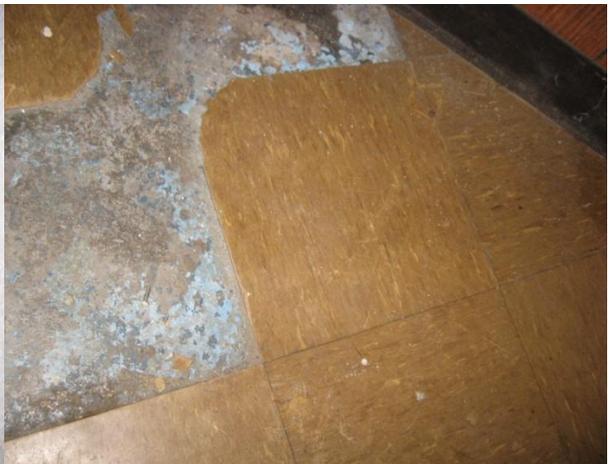
9 X 9 tile in classroom.

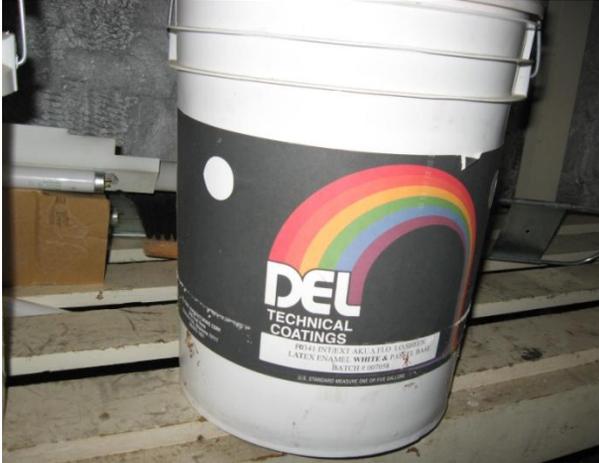
Paint in maintenance closet.

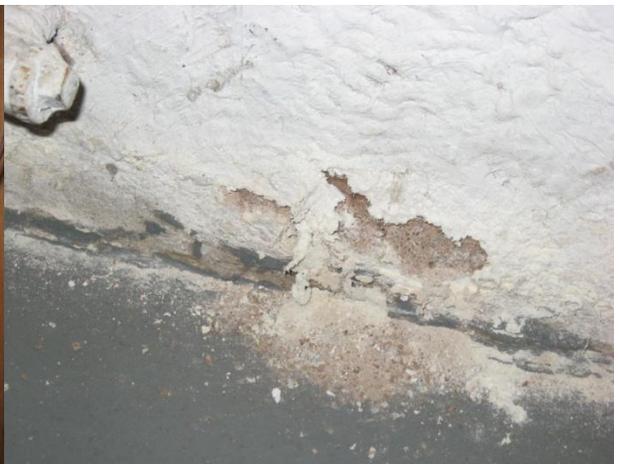
Residue from chipped sandstone wall down south hallway.

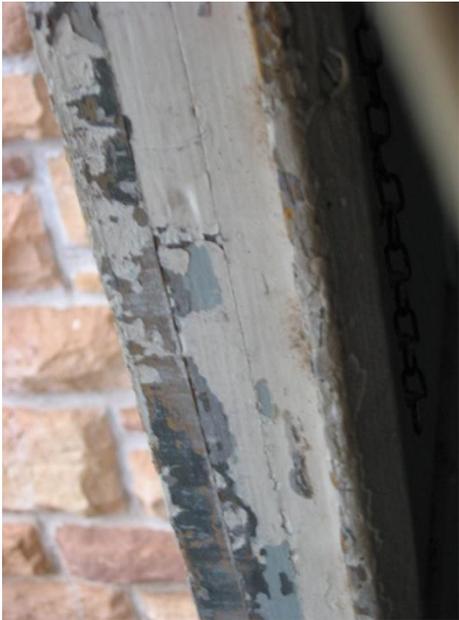
Right: Peeling paint on door frame.
