OCC  
Pipeline Safety Seminar  
September 2011

Construction Issues

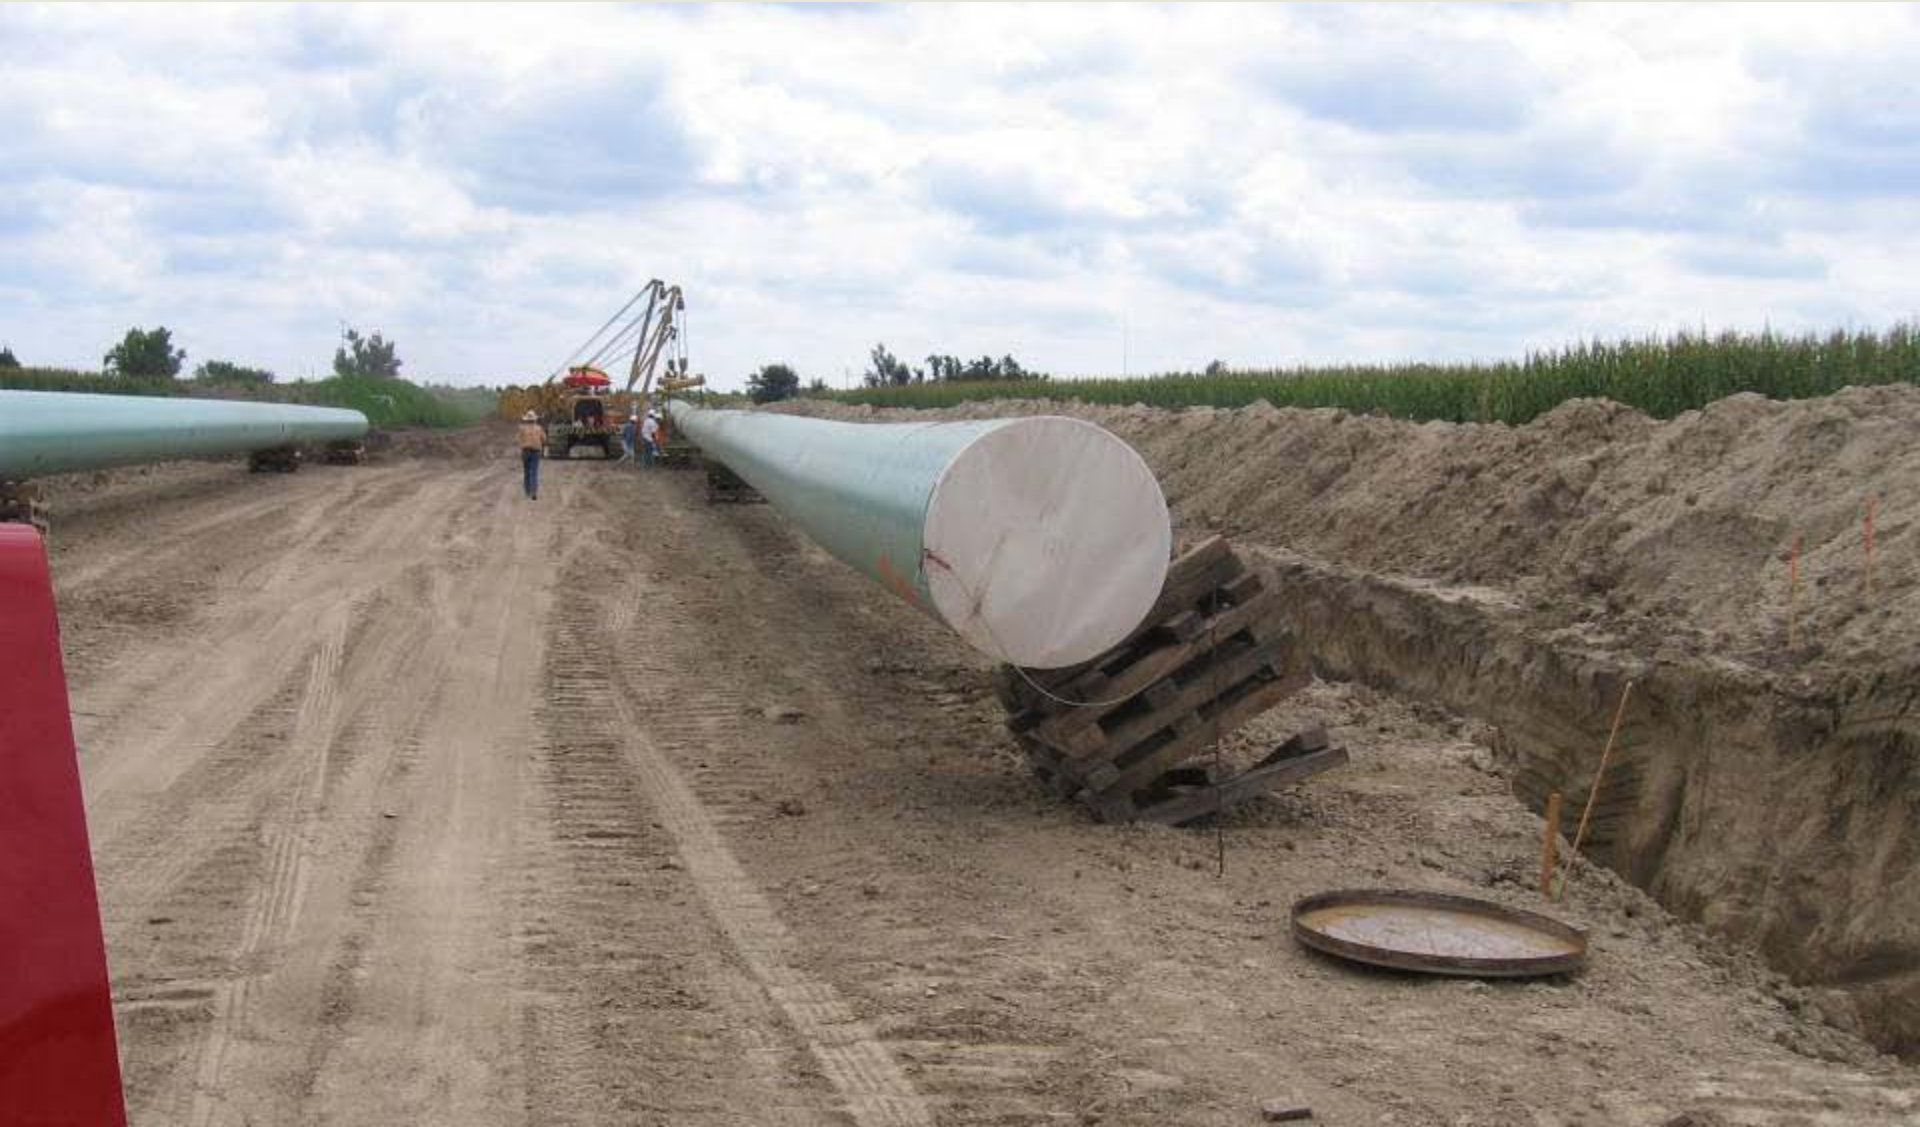
Pipe on skids can move and fall.  
You want to park where!

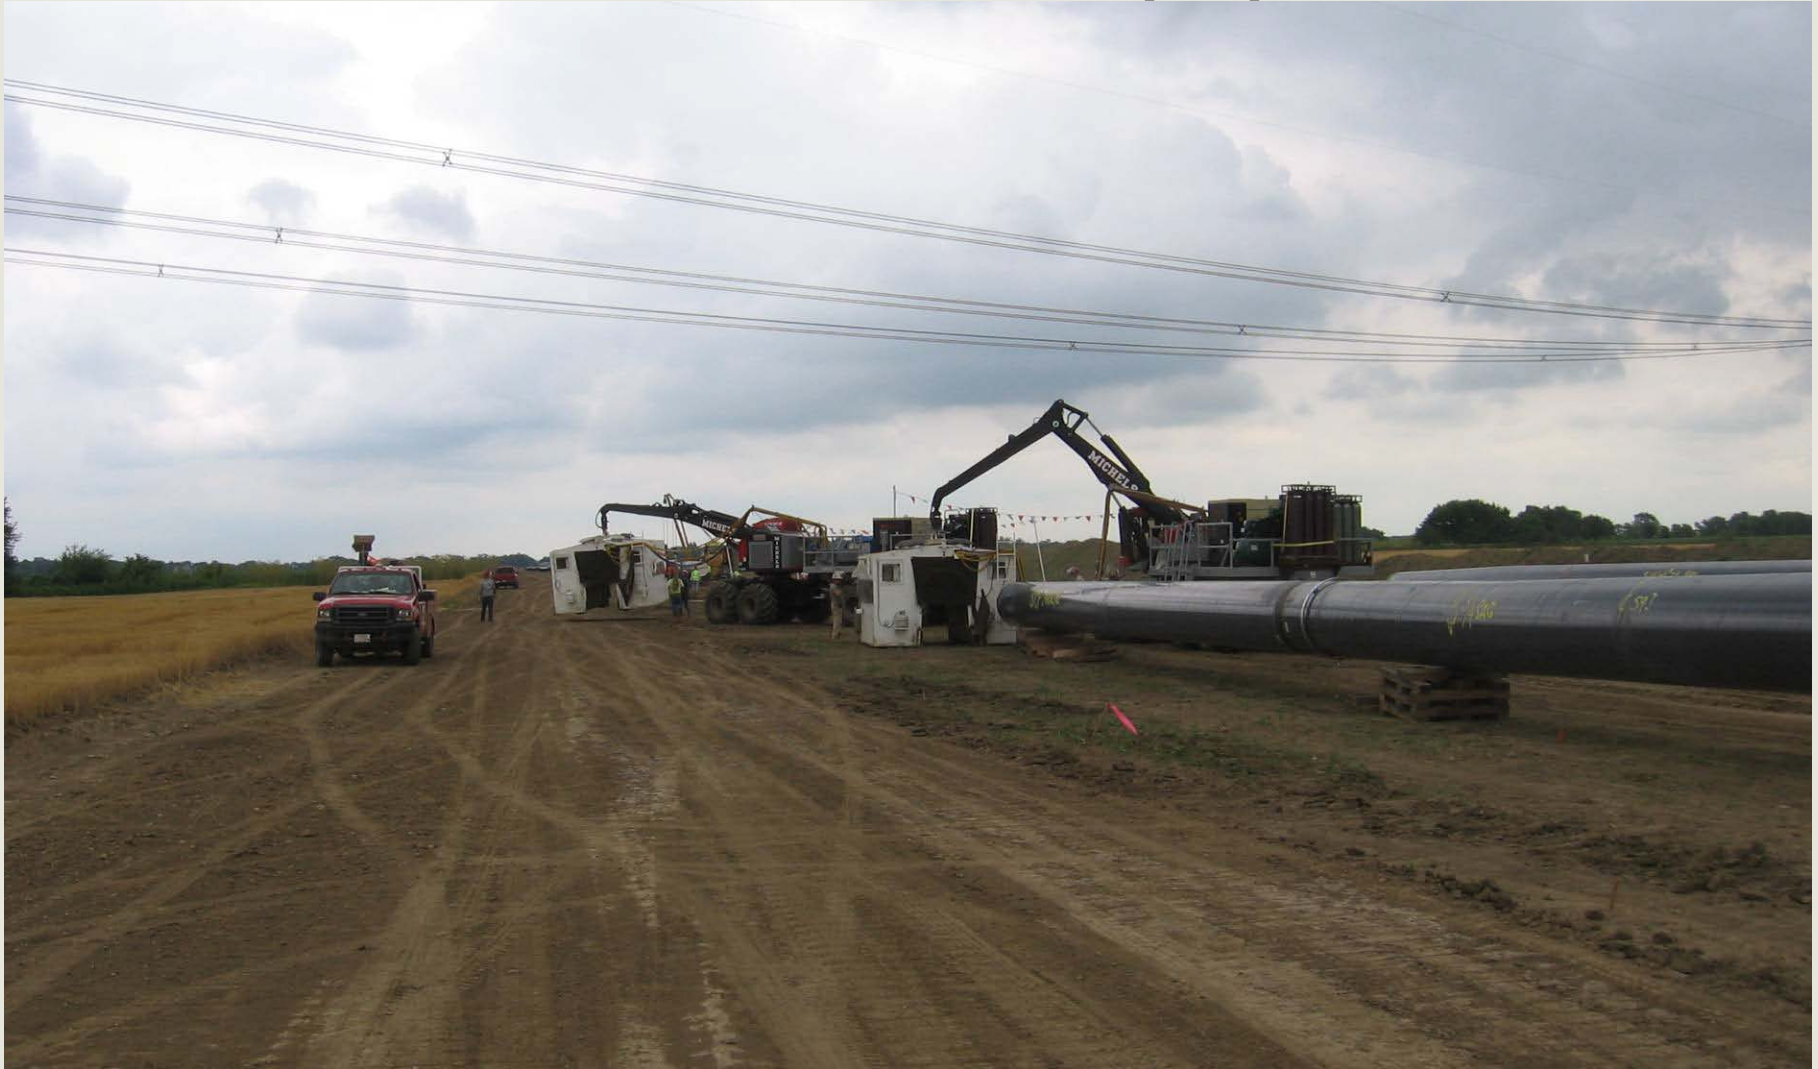
Do you want to be under these wires or near this equipment?

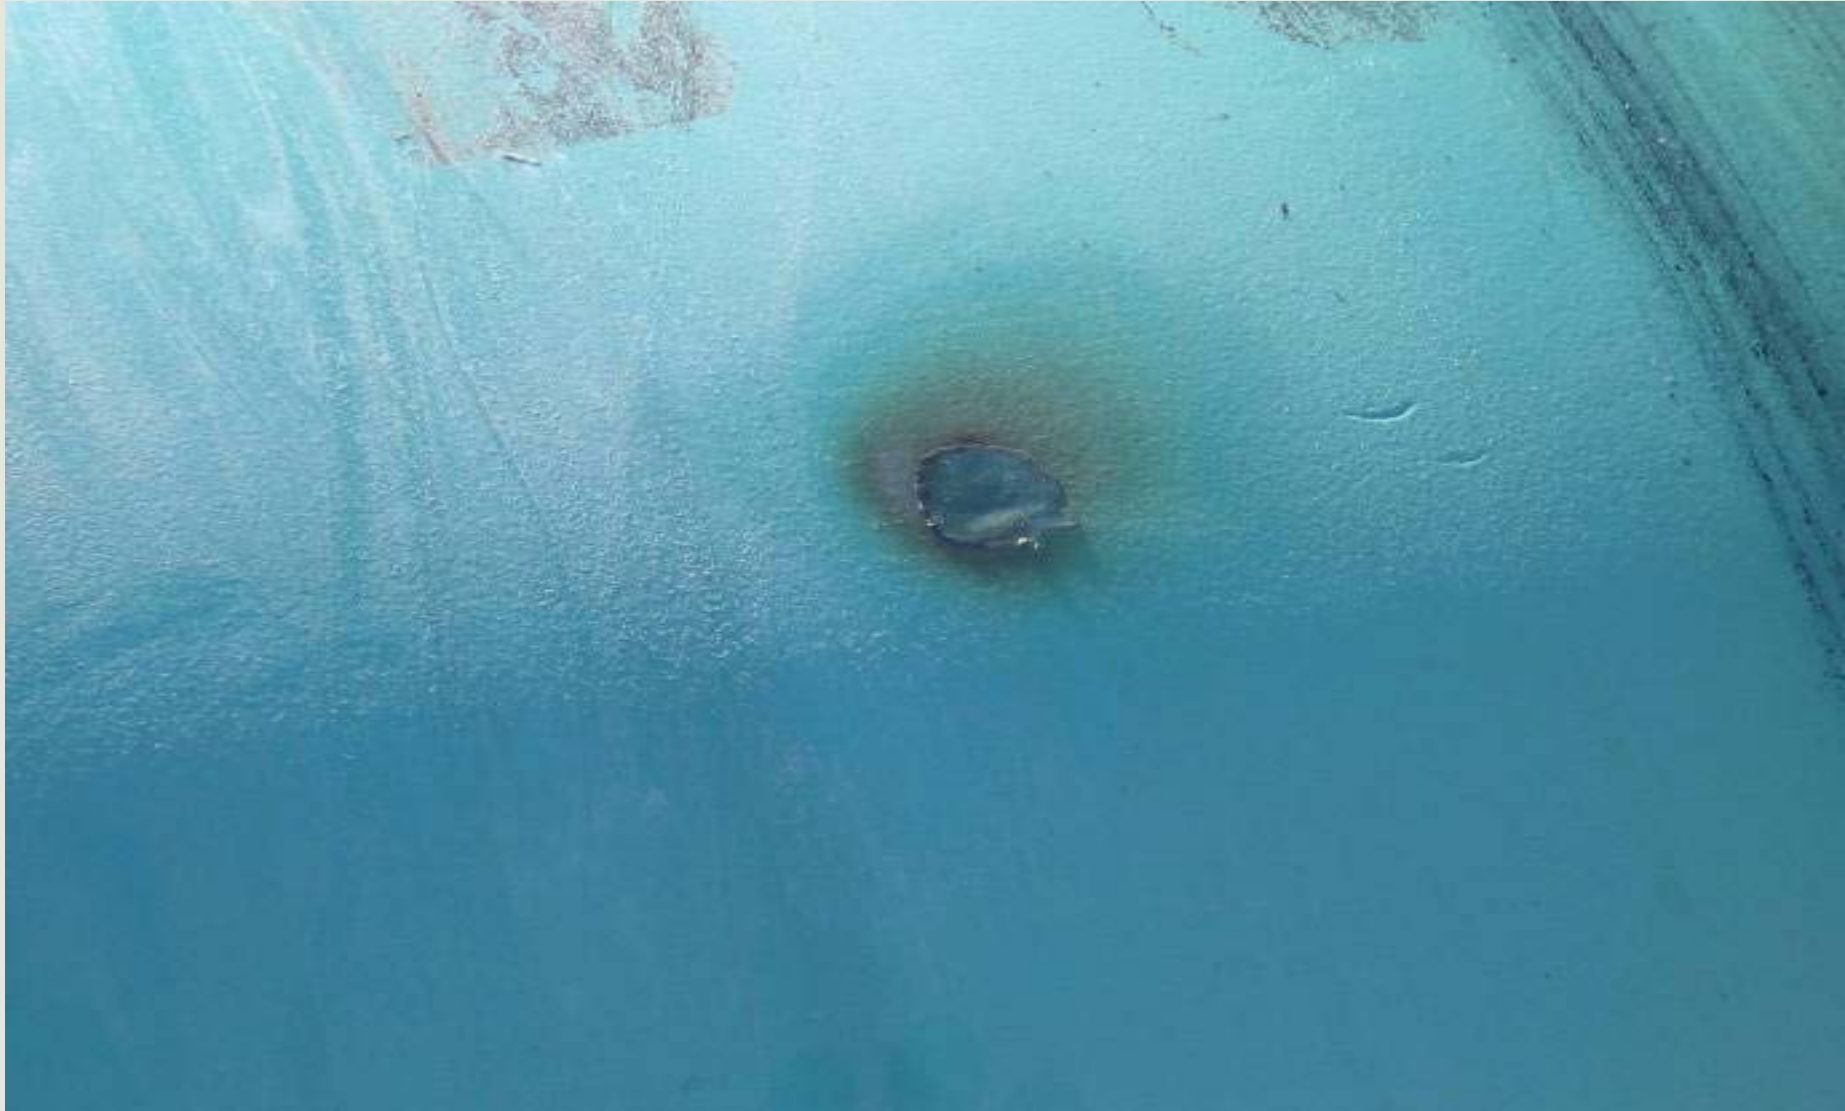
Good patch stick application - notice heated/discolored area around patch, this indicates that the pipe was heated before and during patch stick application

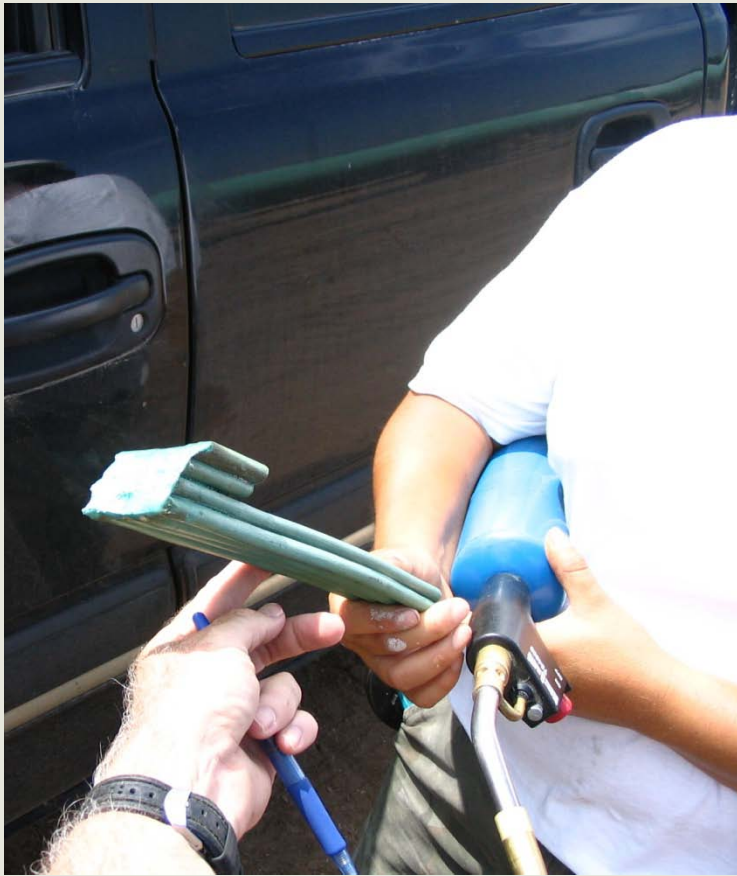
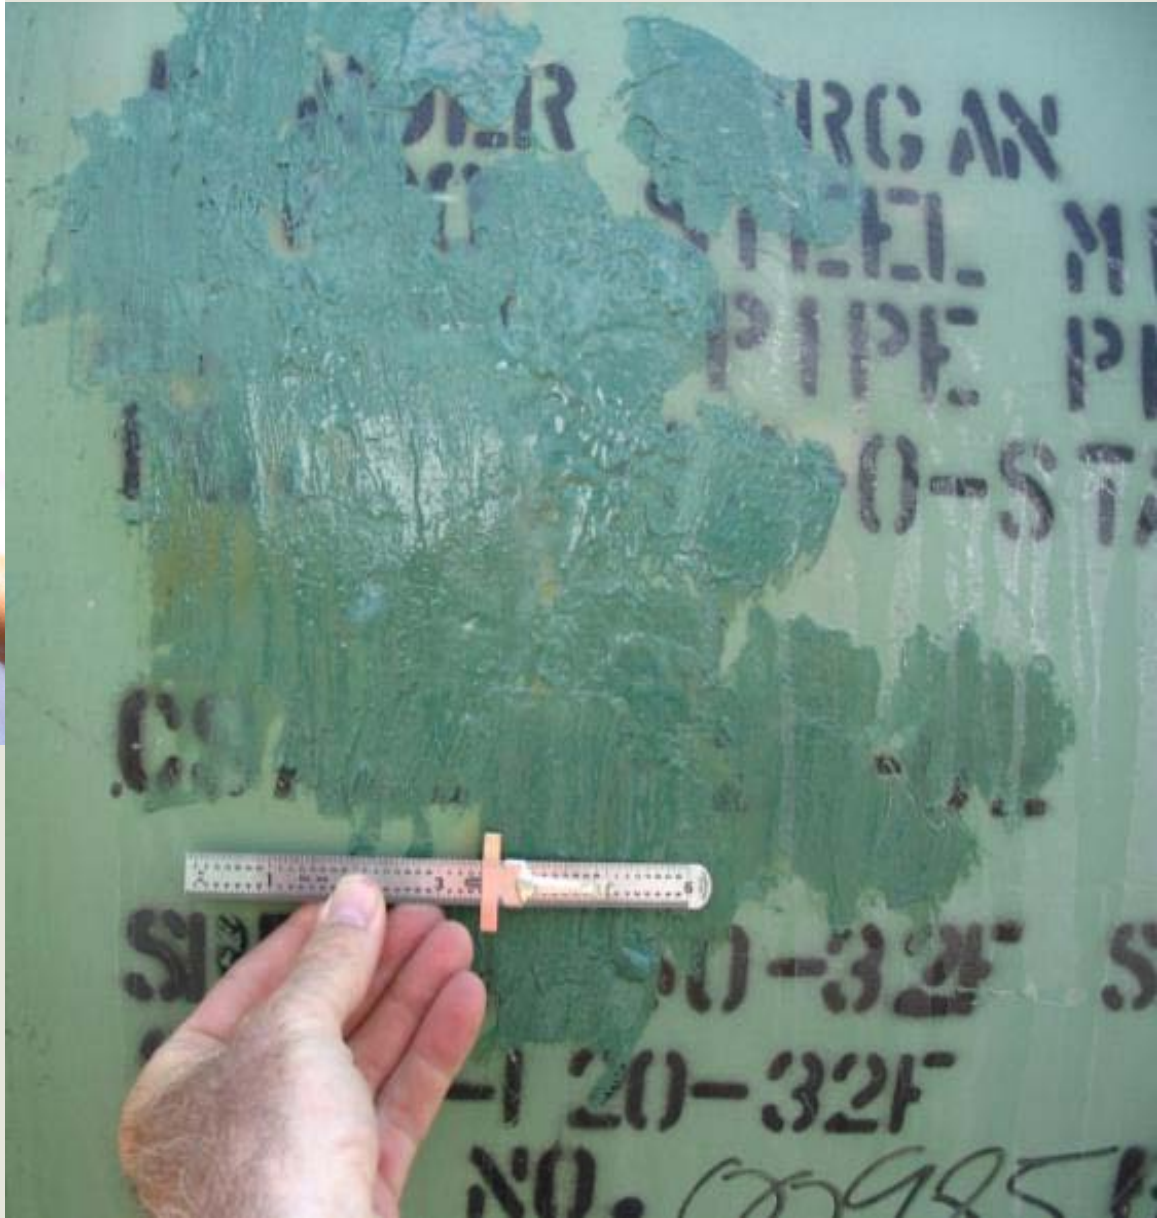
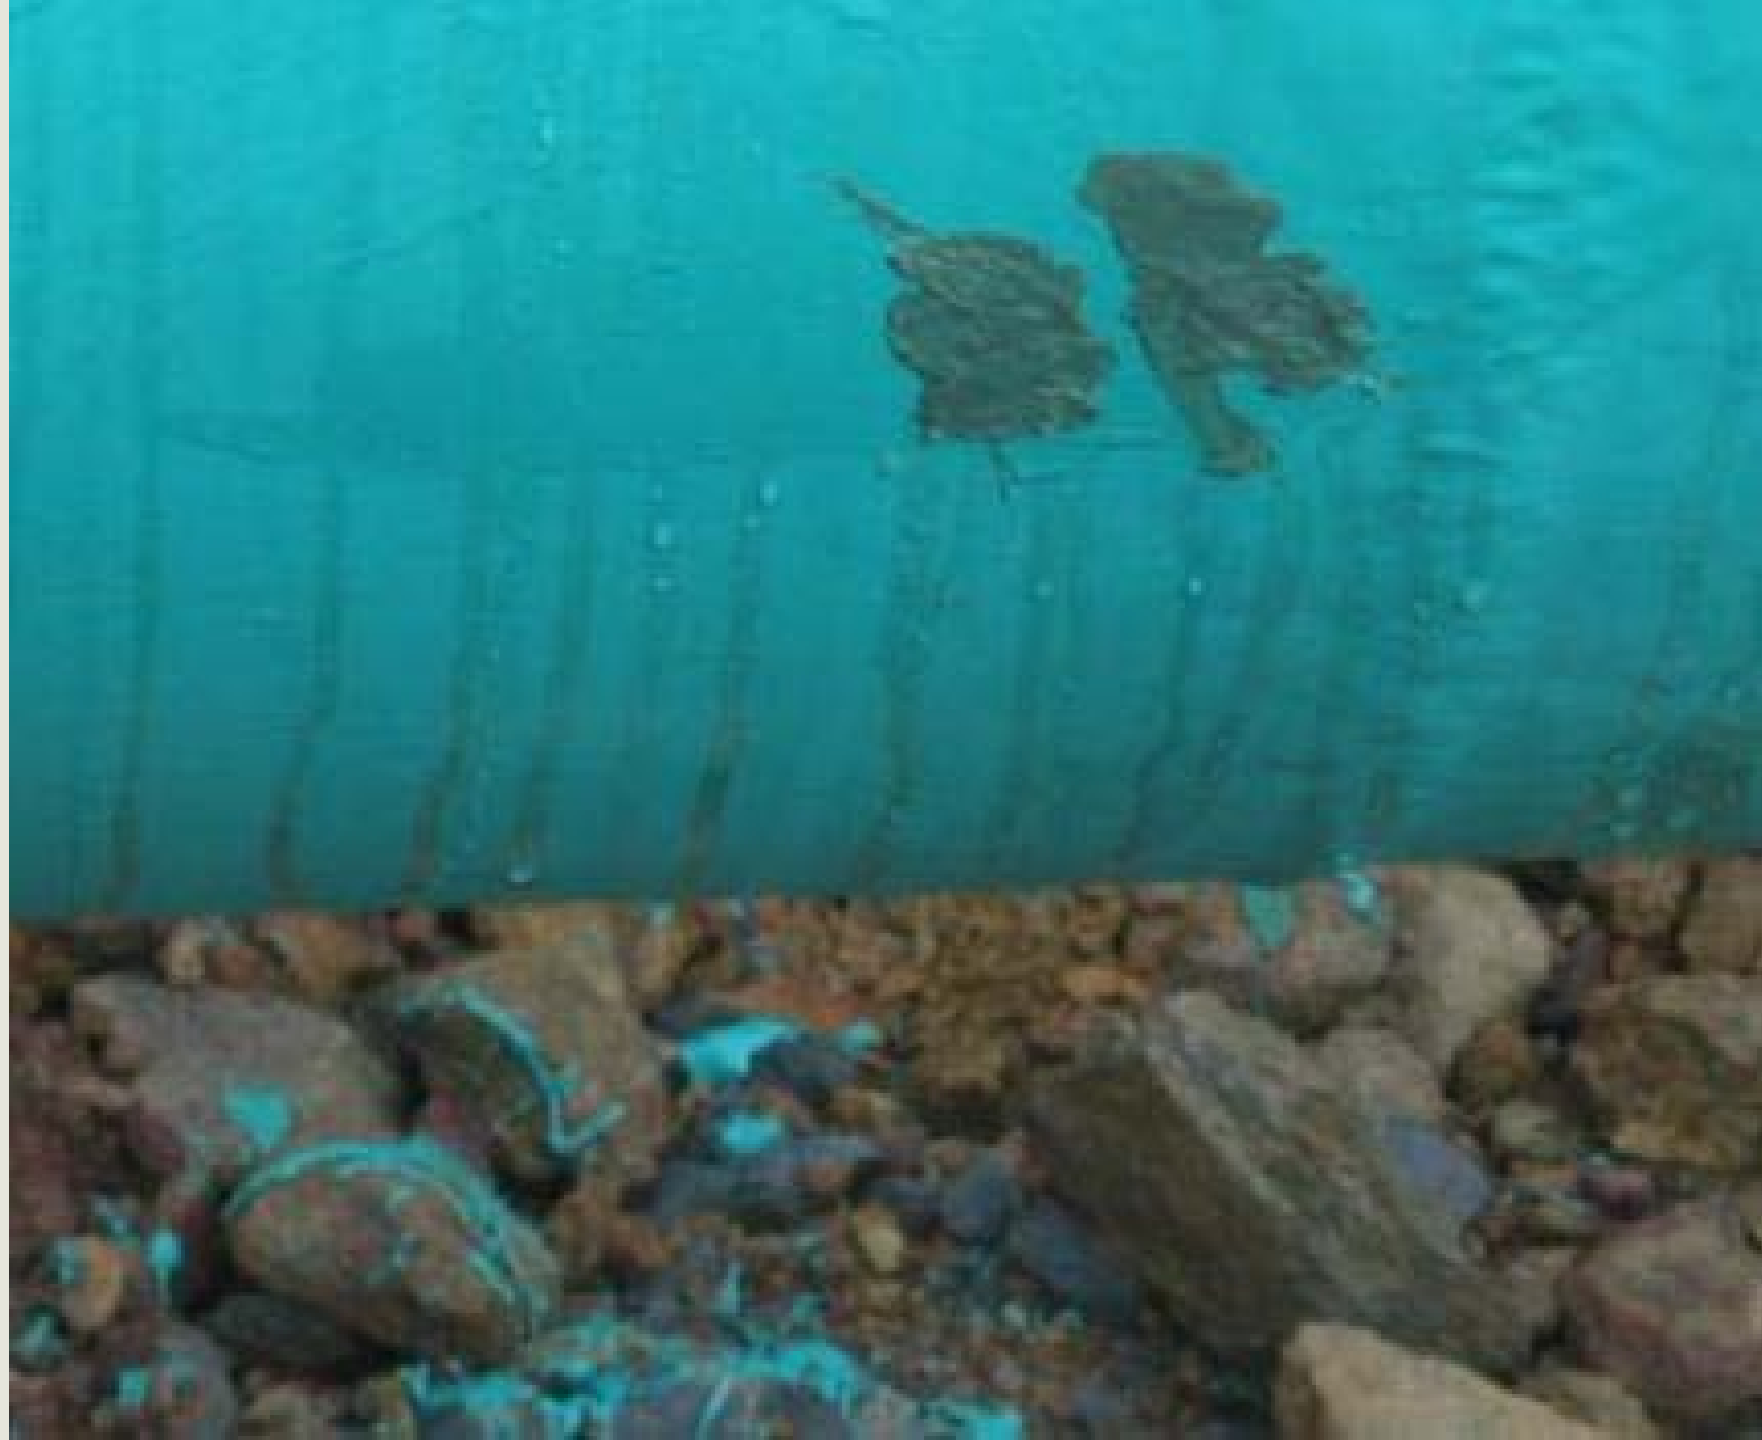
Seriously!!!!

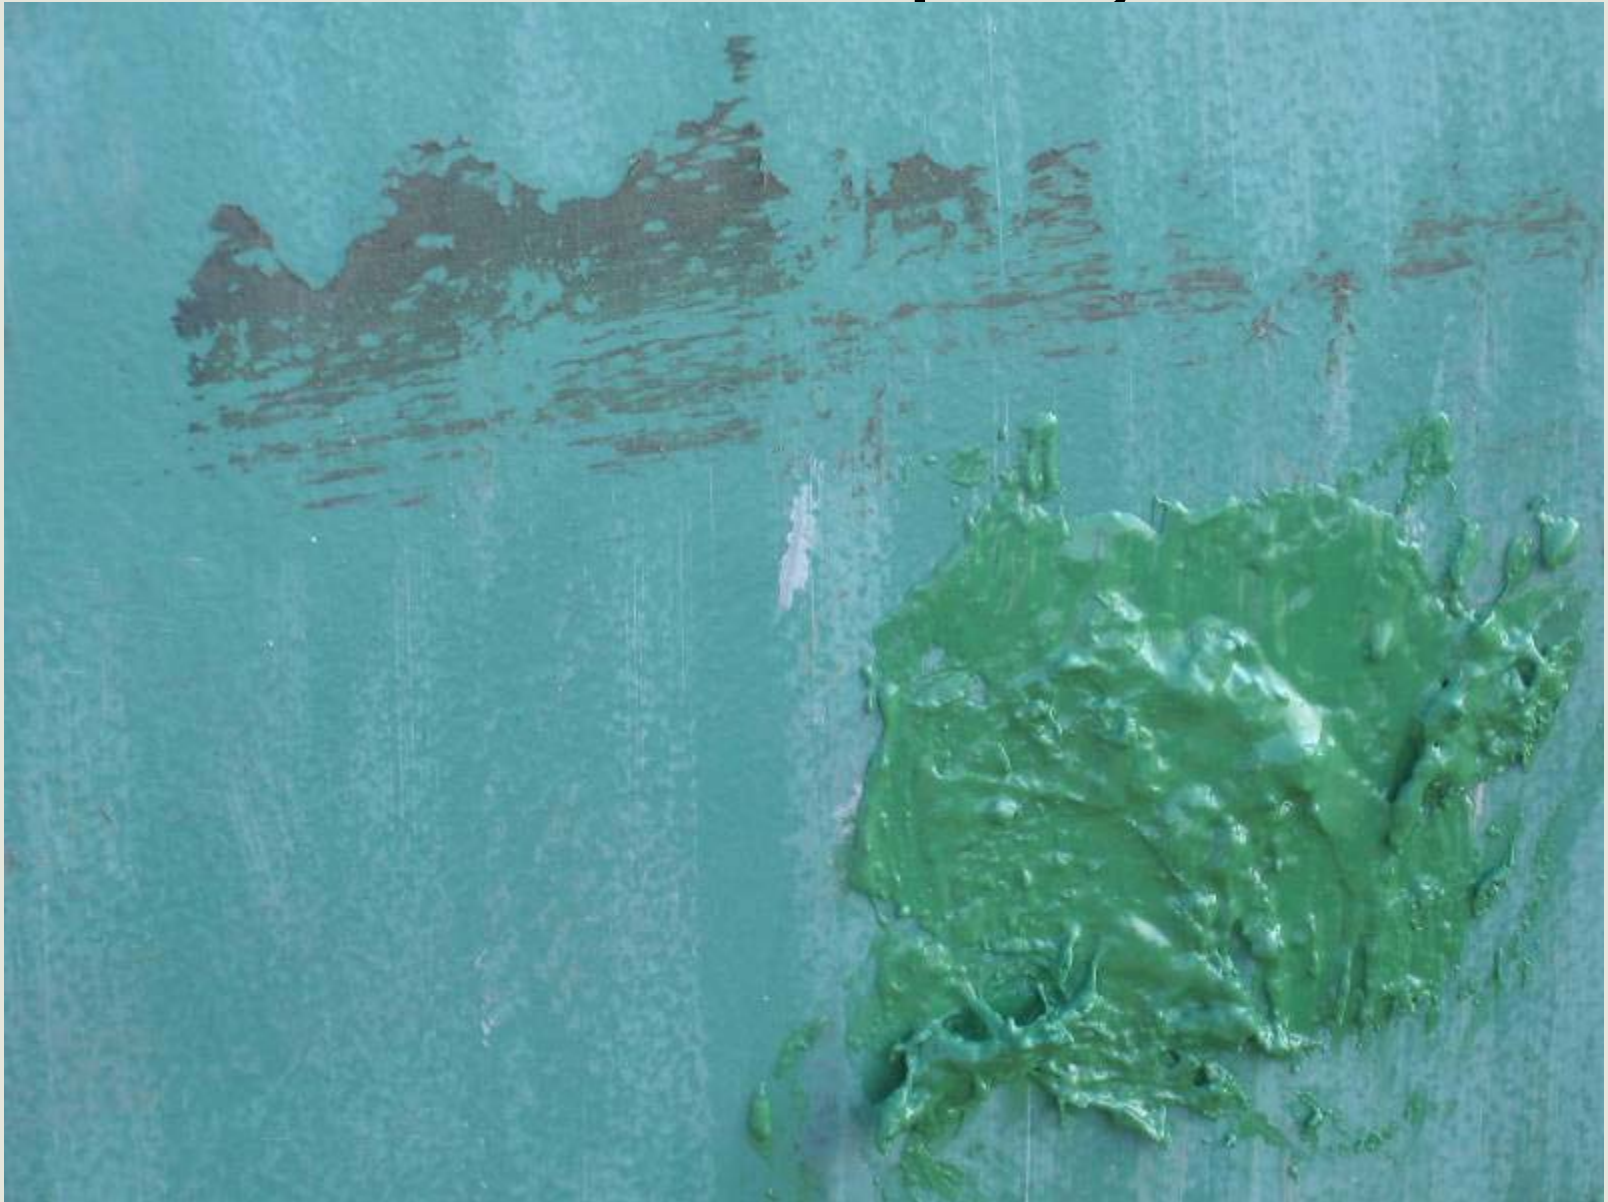
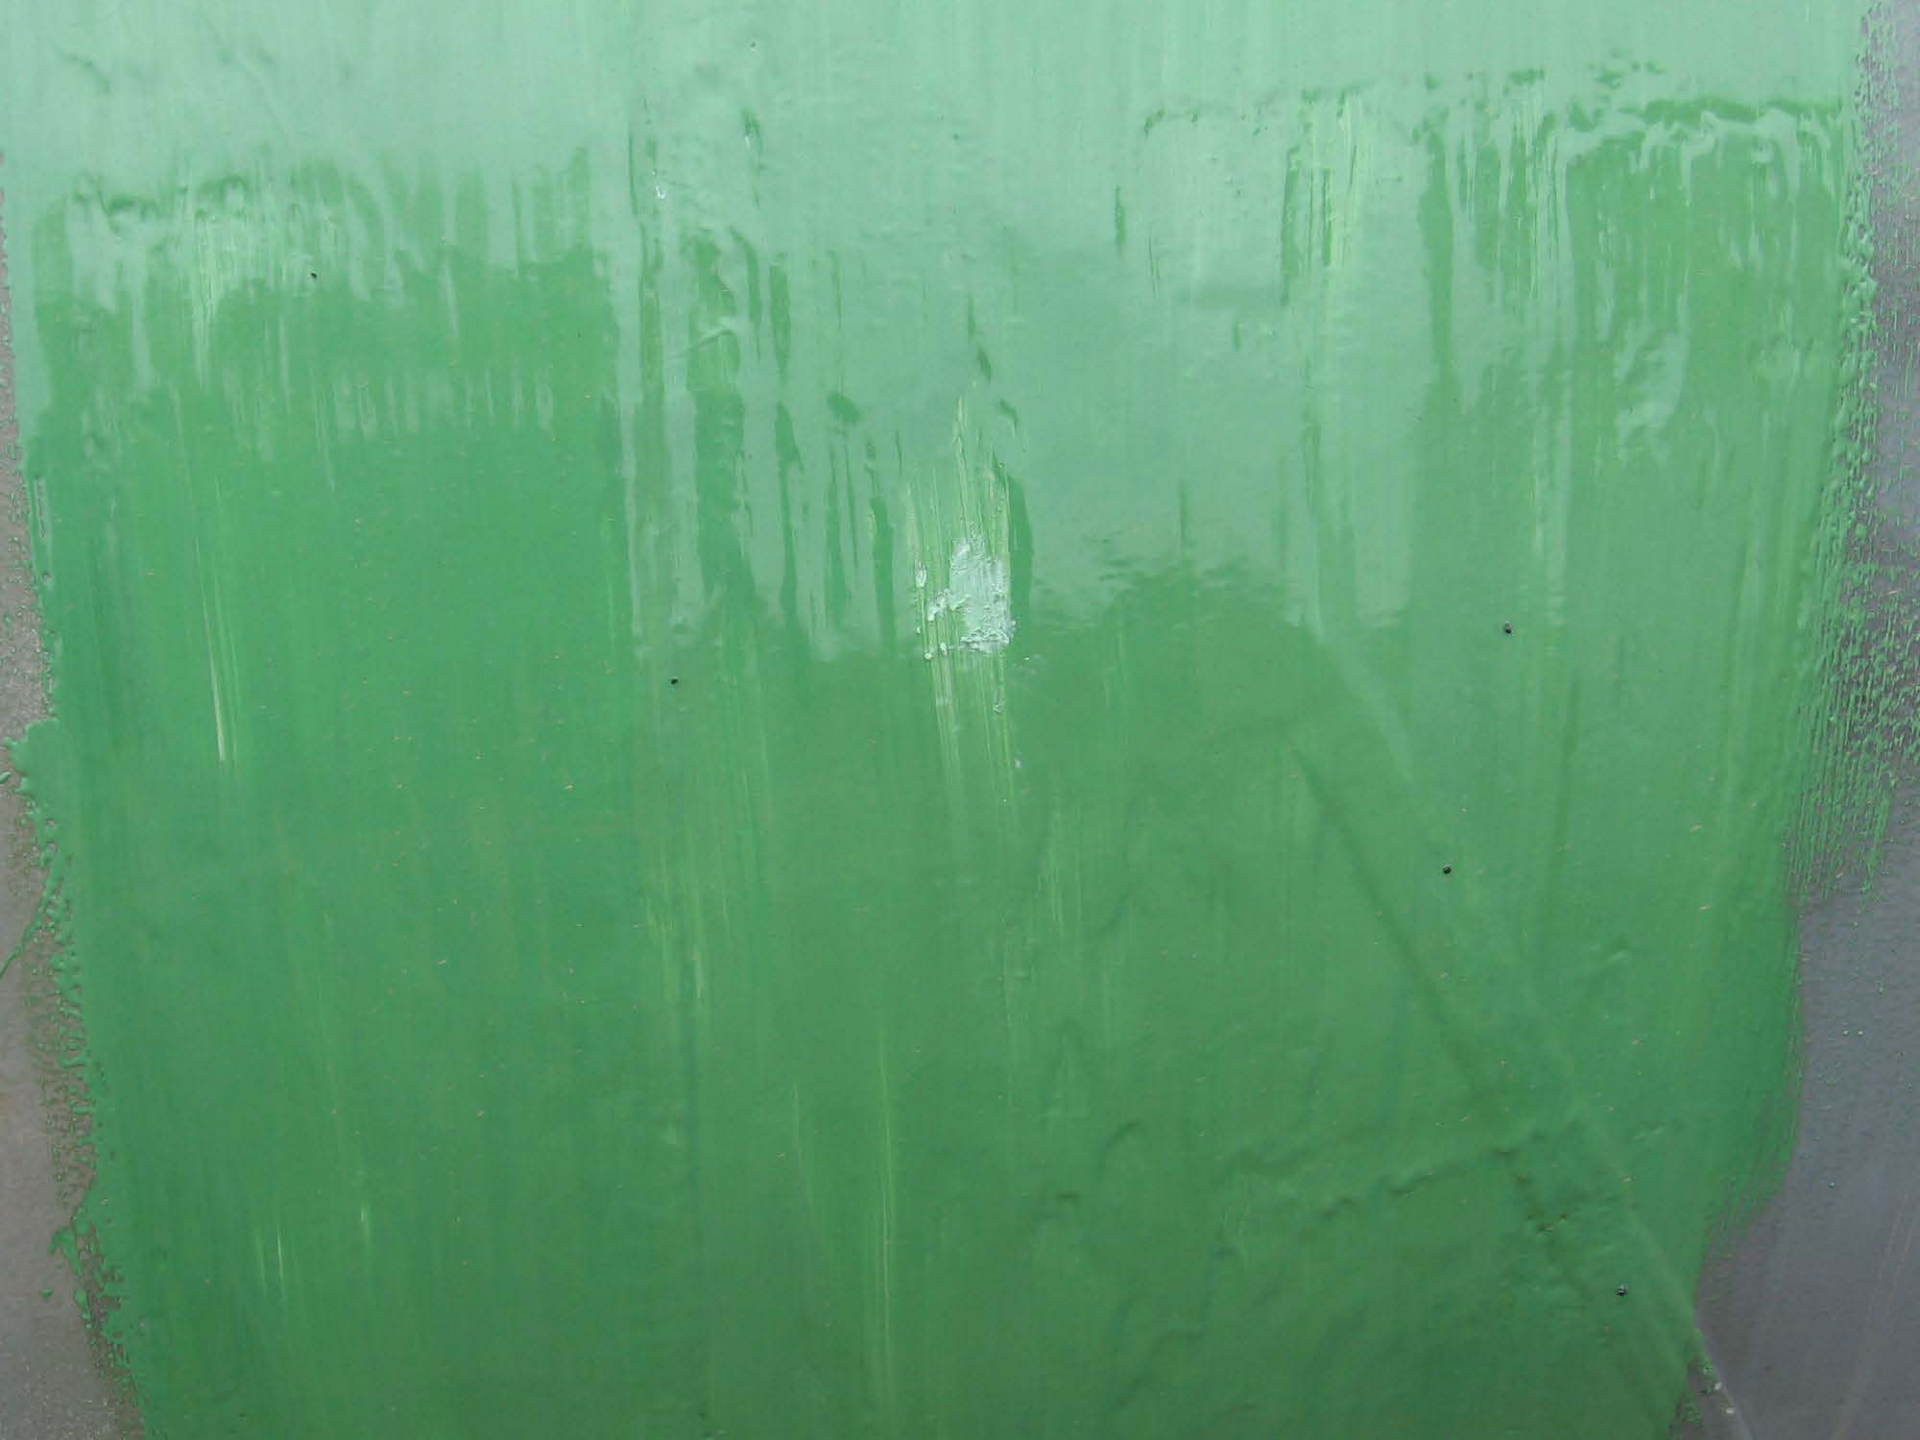
# 2 Part Epoxy

- Follow manufacturers instructions
- Preparation required (Sanding = anchor pattern)
- Thoroughly mix product
- Use promptly
- If products starts to cure before application the repair presents the appearance of the next slide

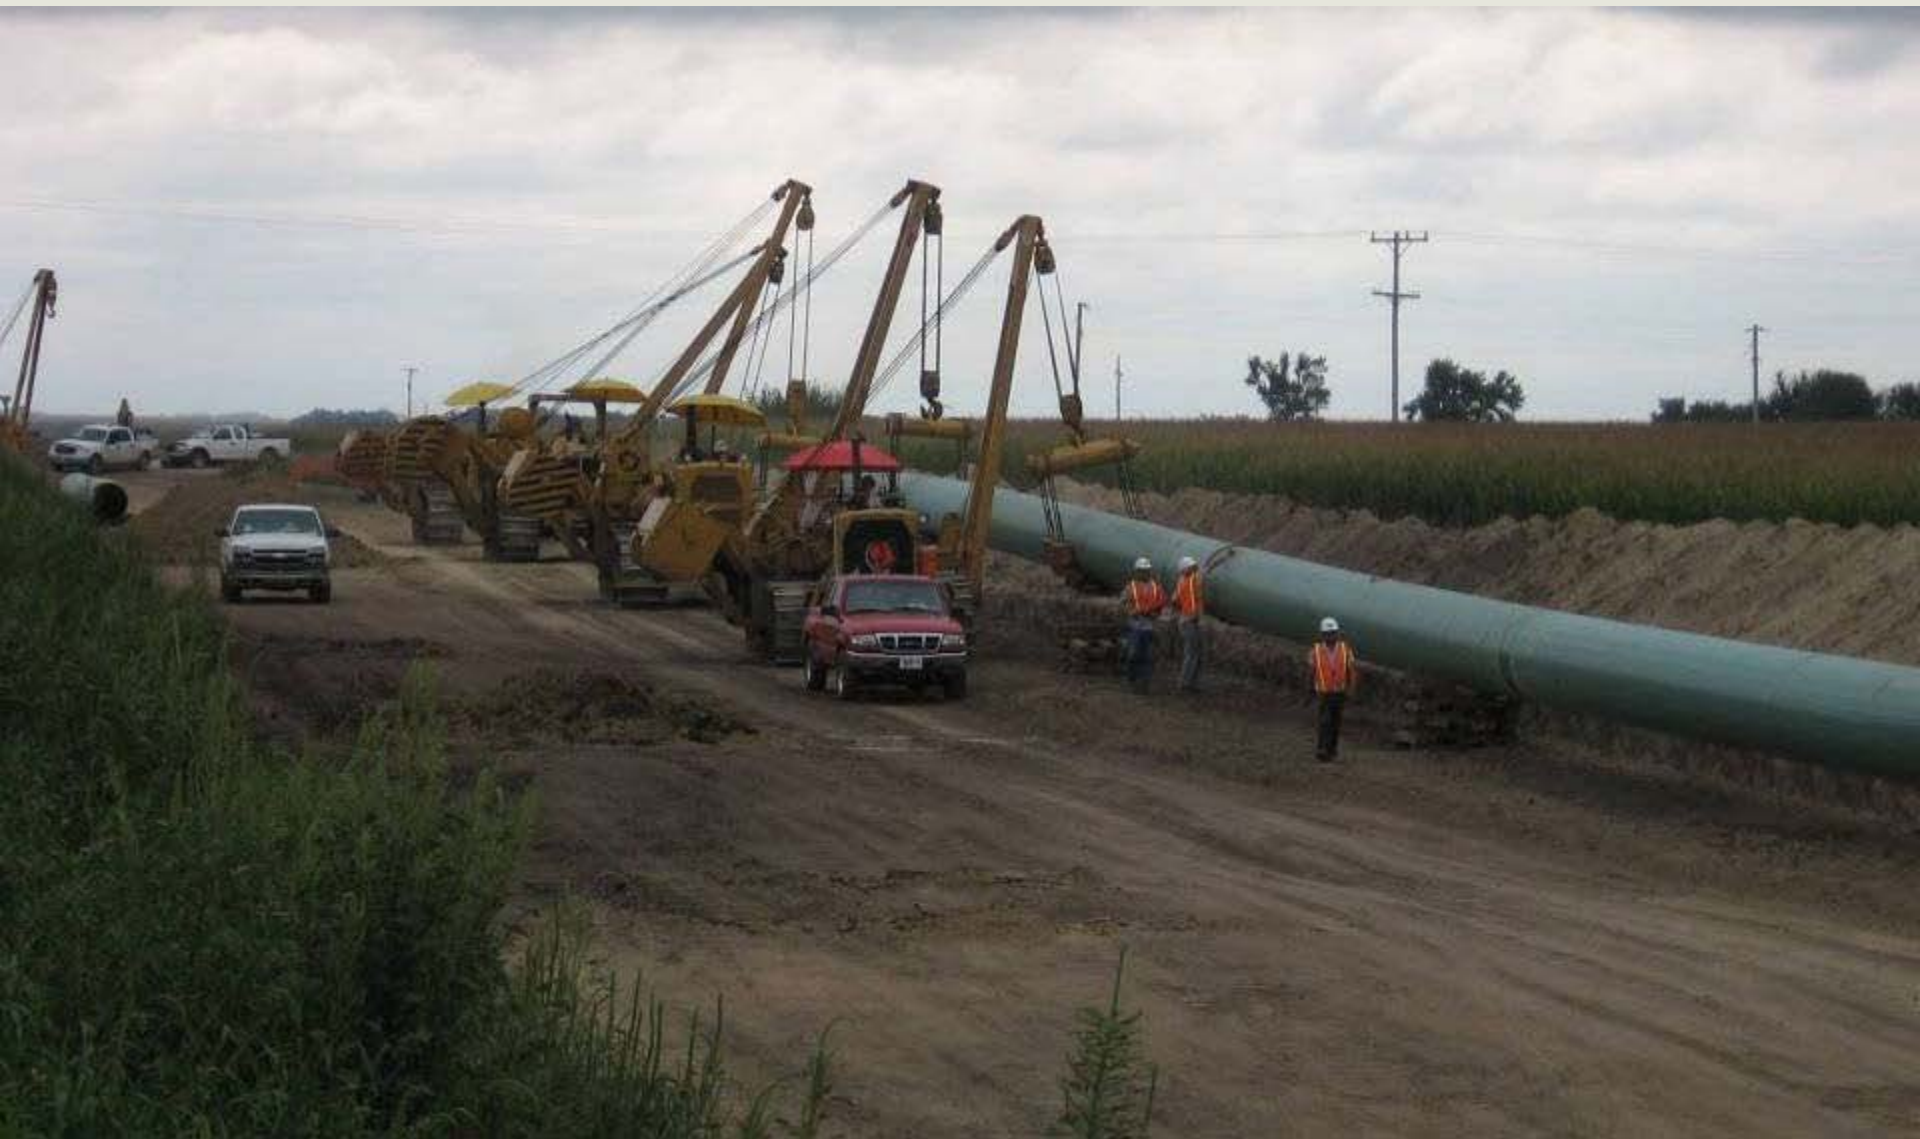
Are the workmen finding coating holidays? Do the workmen operating the jeep have time to find and repair coating holidays?

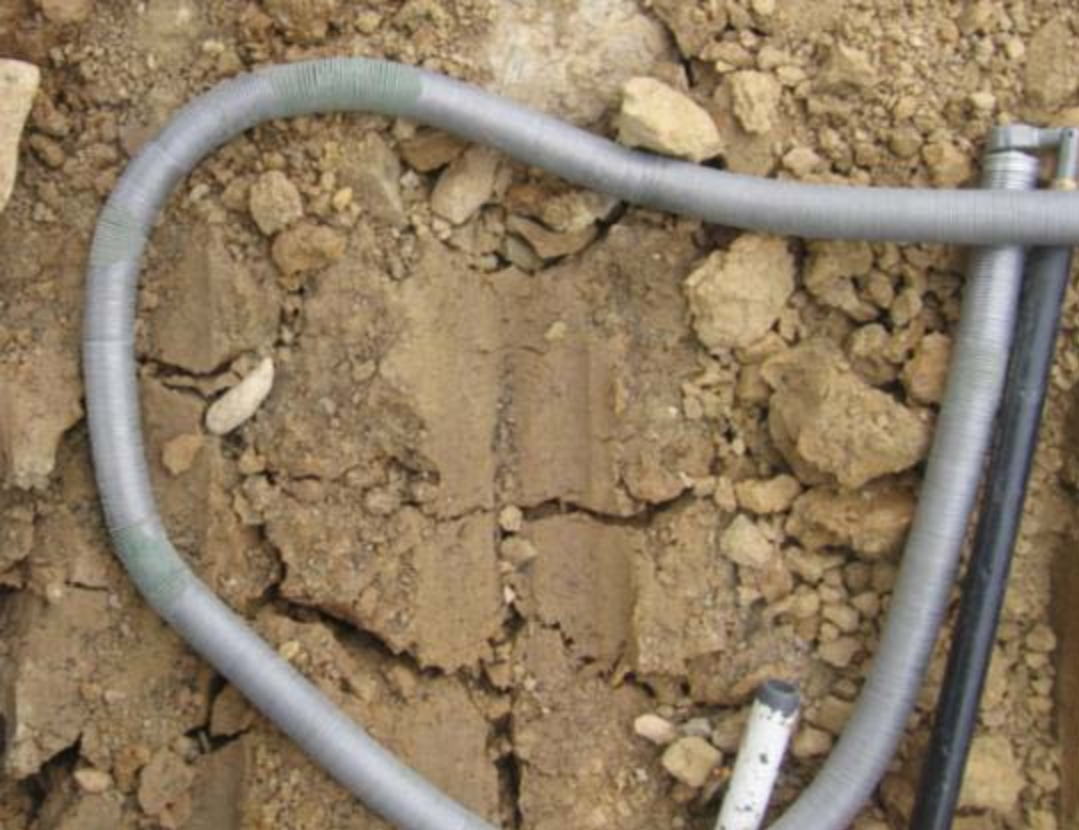
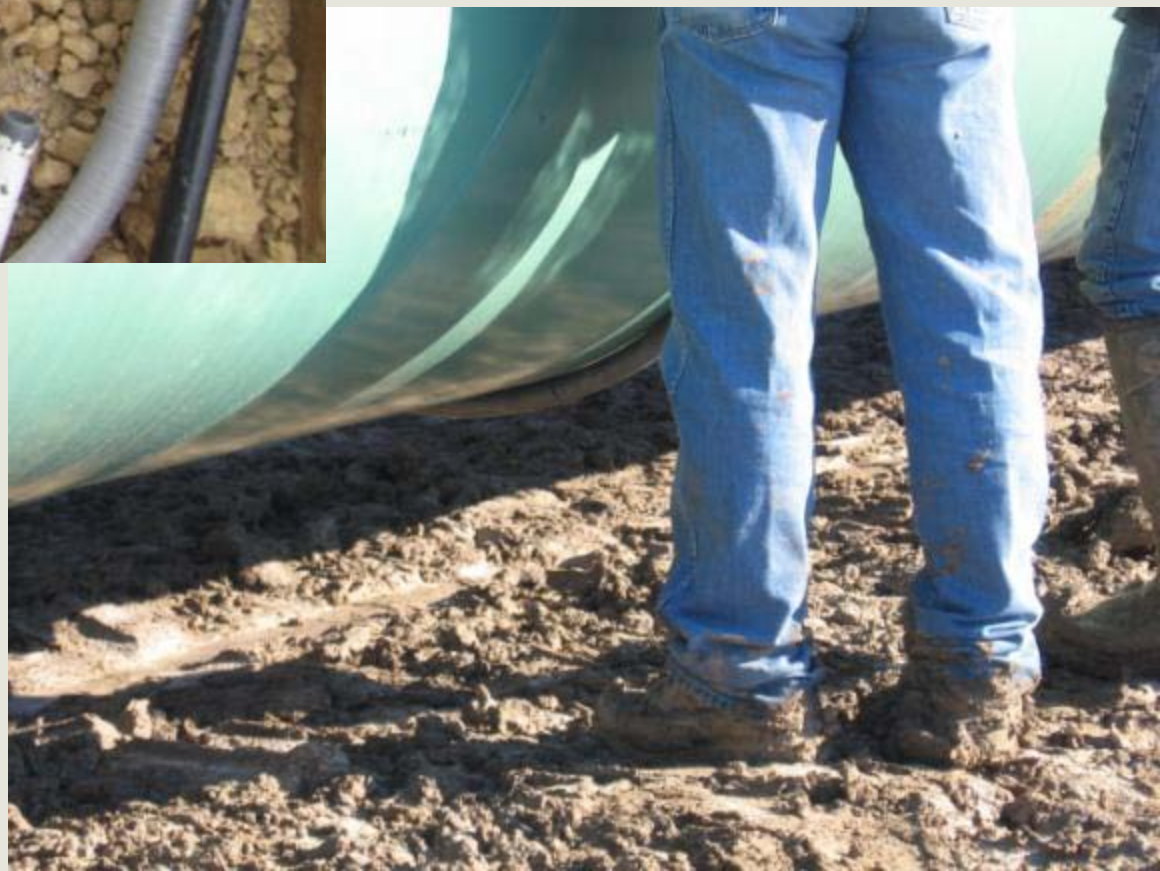
A bent jeep spring can miss coating holidays

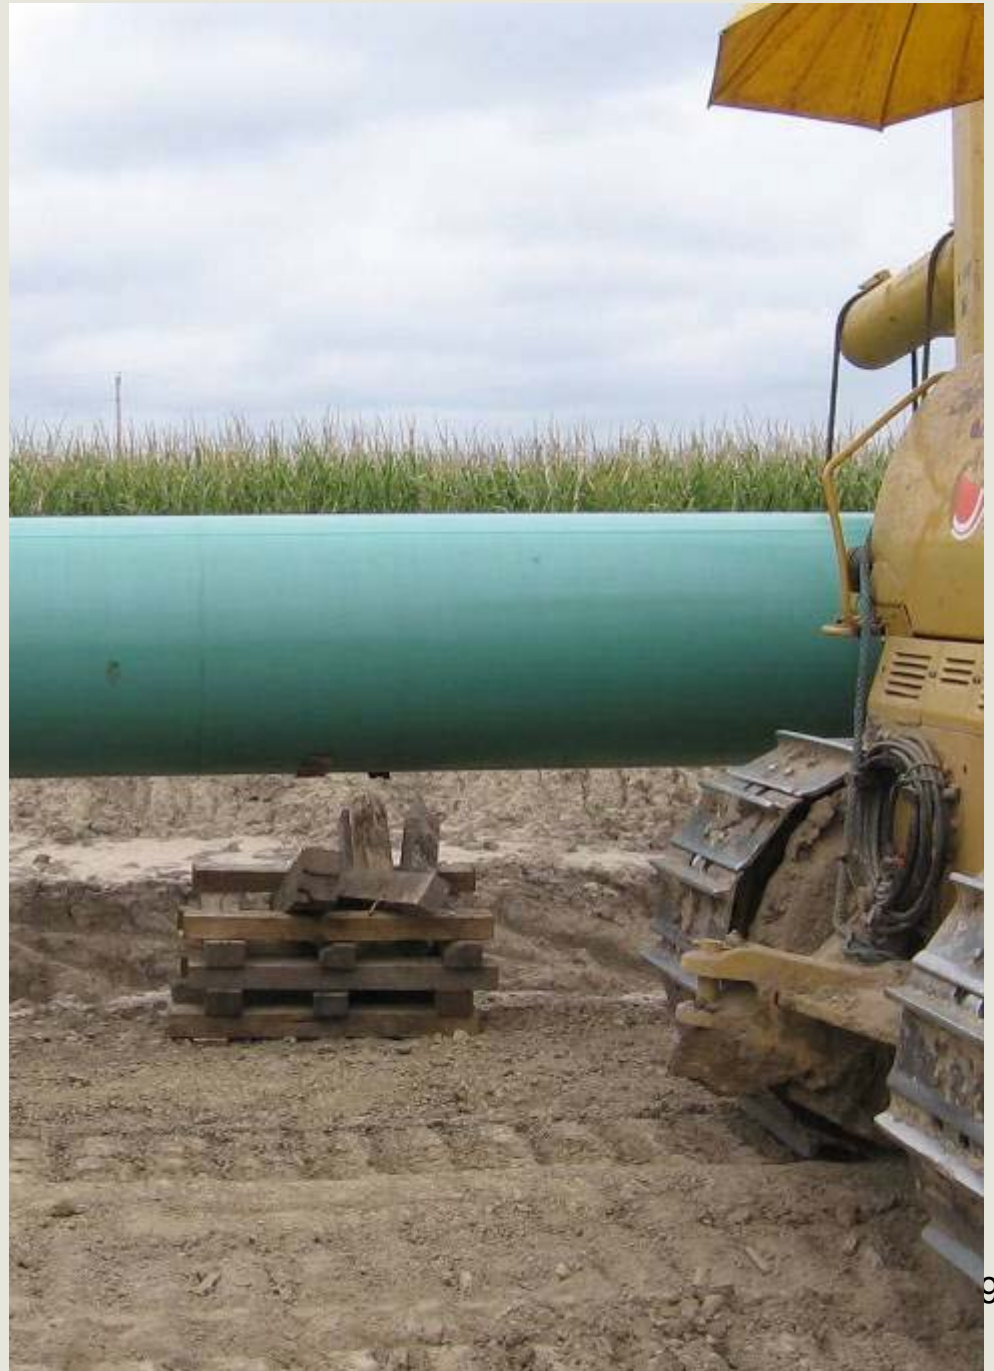
- Manipulating the jeep spring over building fiberboard stuck to the pipe is poor practice

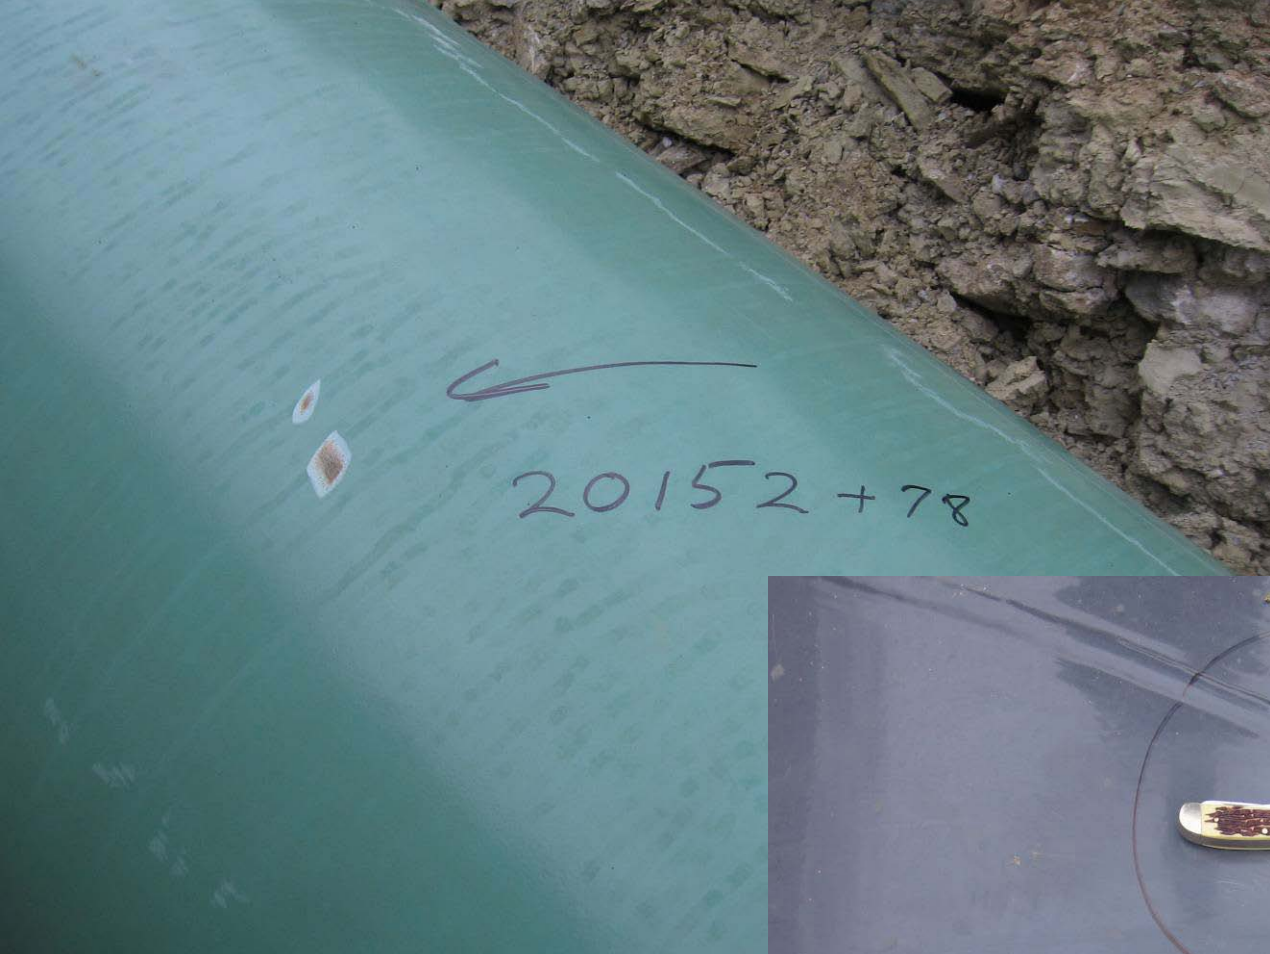
- Look for coating holidays in the ditch.
- Observing these indicates a problem.
