OCC  
Pipeline Safety Seminar  
September 2011

Construction Issues

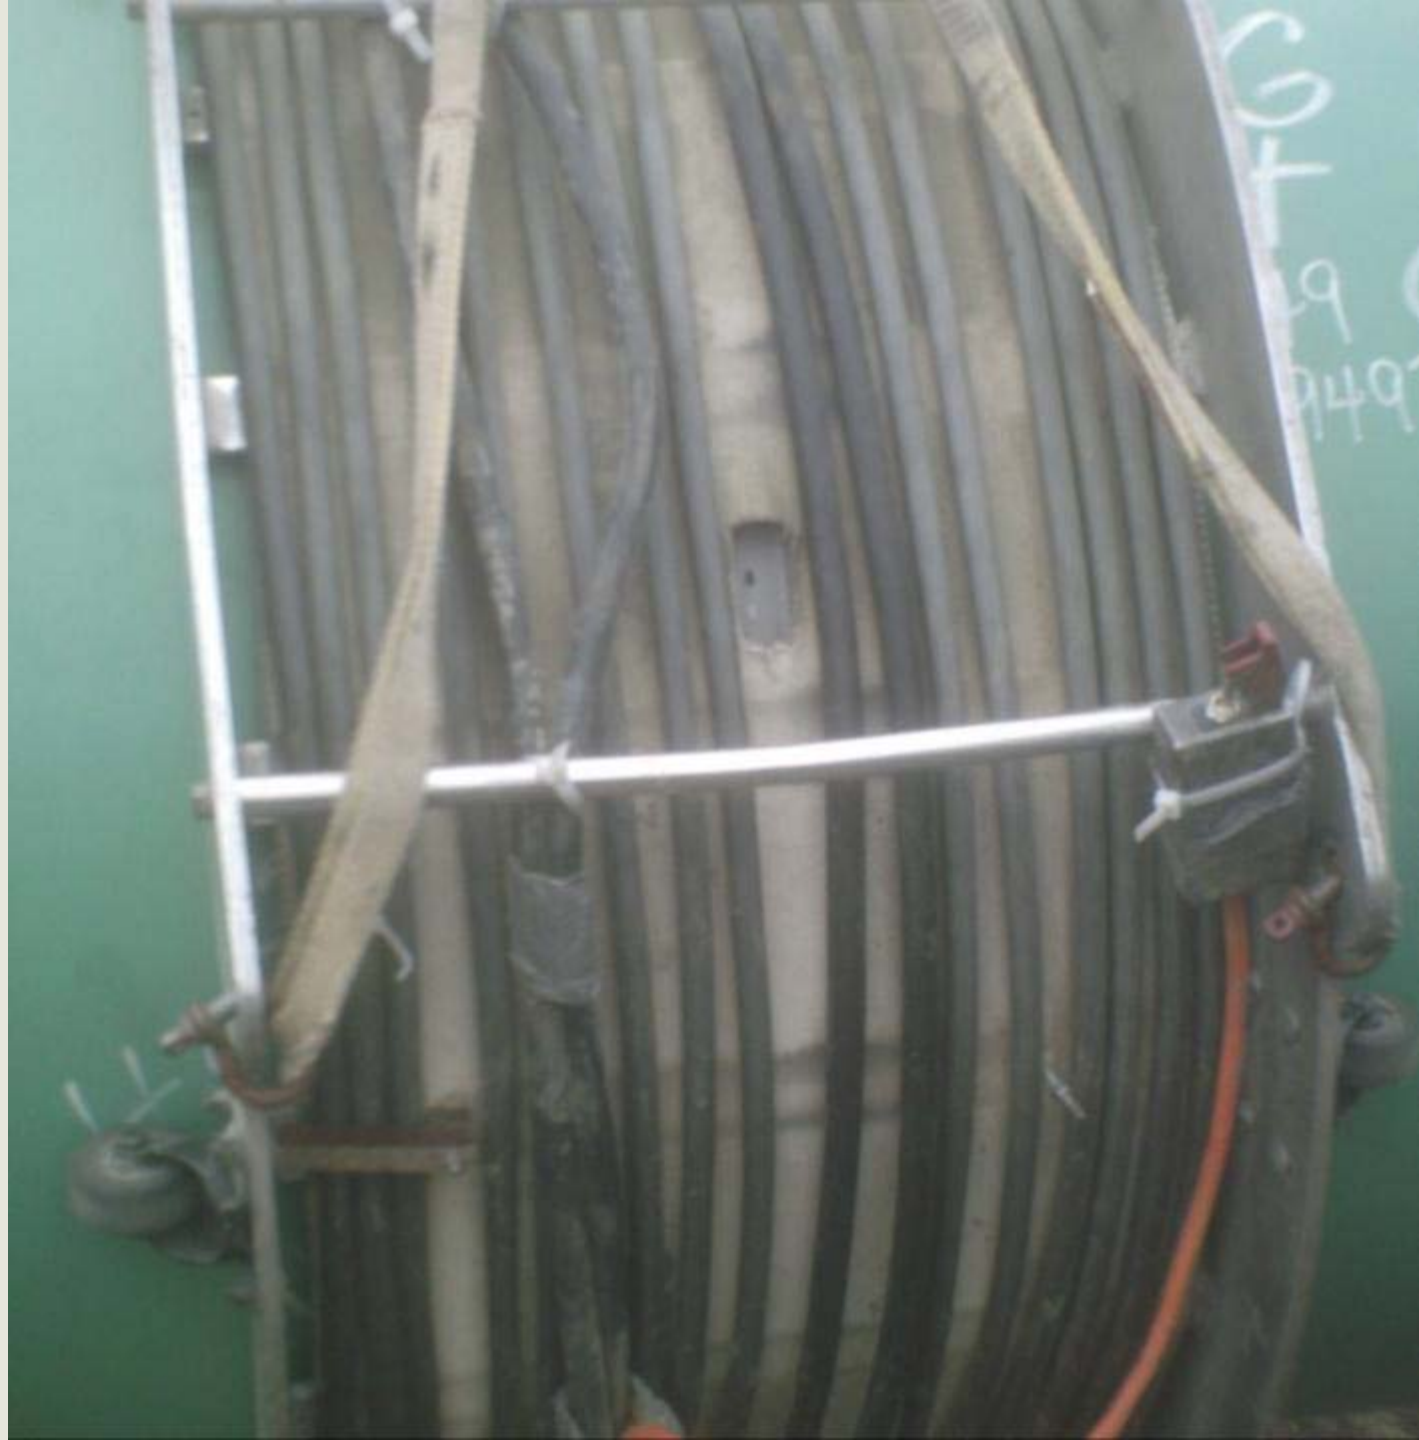
- Insufficient heating (3M procedure specify 425 – 488 degrees F - lower temperatures could mean improper curing)
- Over heating during application can be a problem (the coating looks burnt and is unacceptable)
- Poor sandblasting

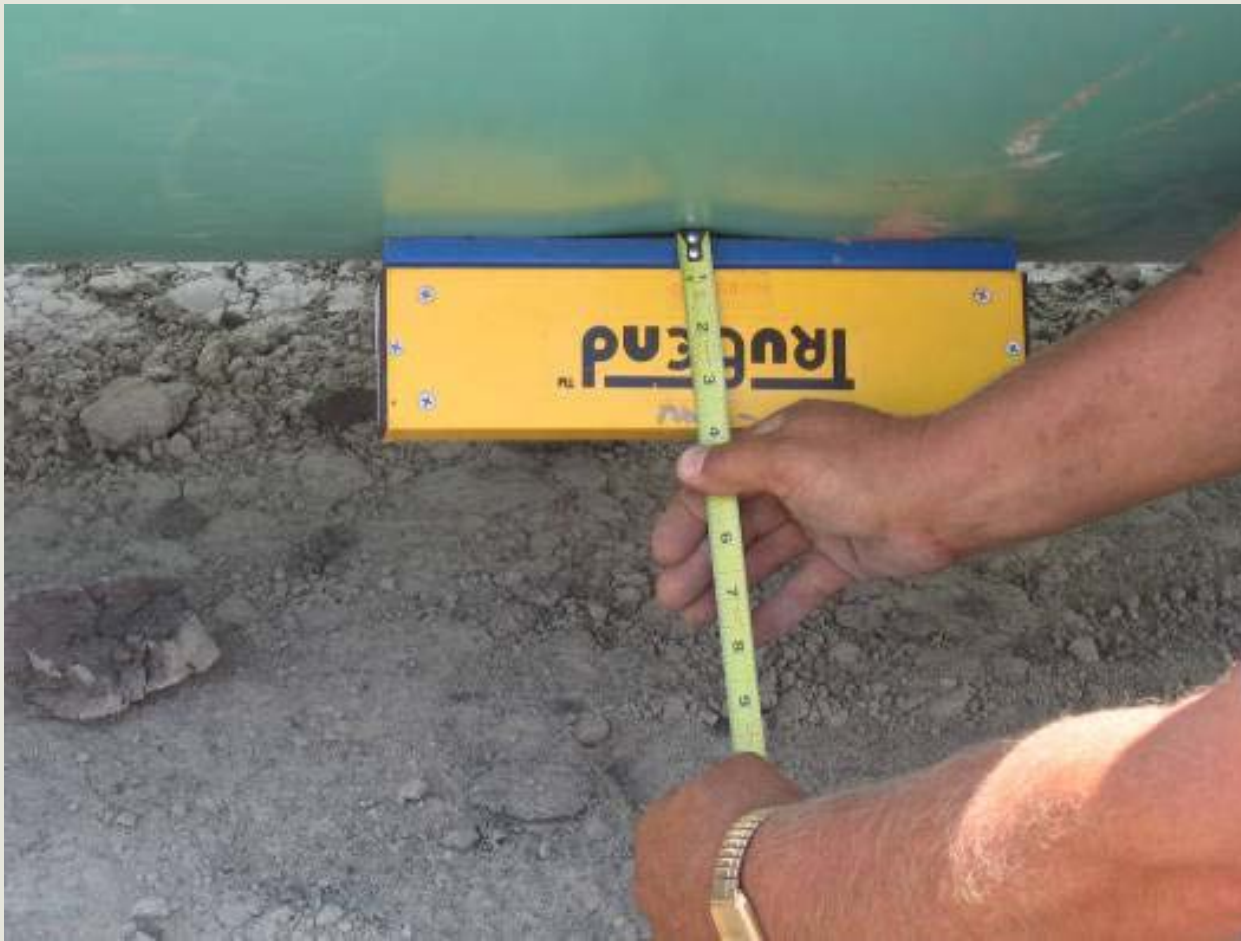
# Gouges and Bending

- Gouges – consult procedures
- Acceptable wall thickness?
- $< 1\%$  diameter?

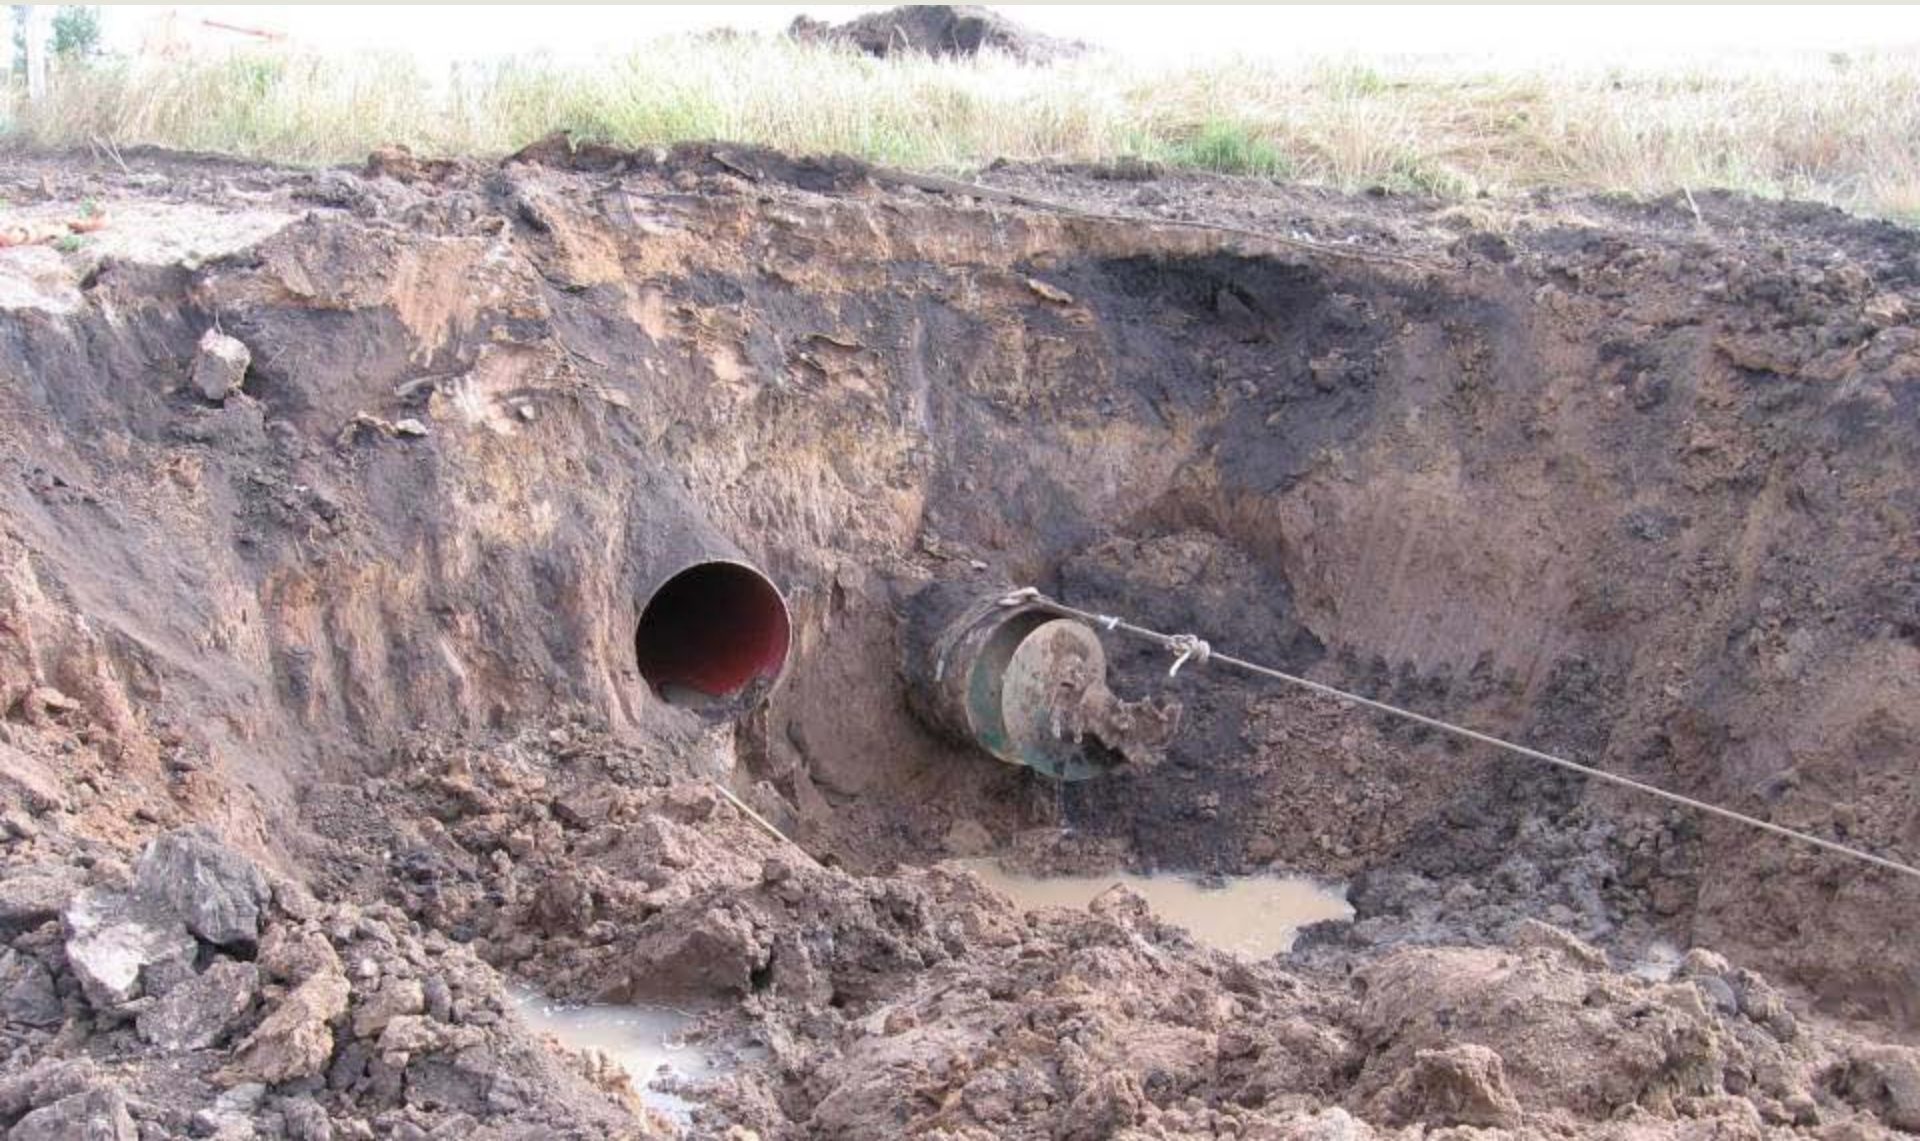
# Proper burial depth on bores?

Is the pipeline buried deep enough  
and protected from erosion?

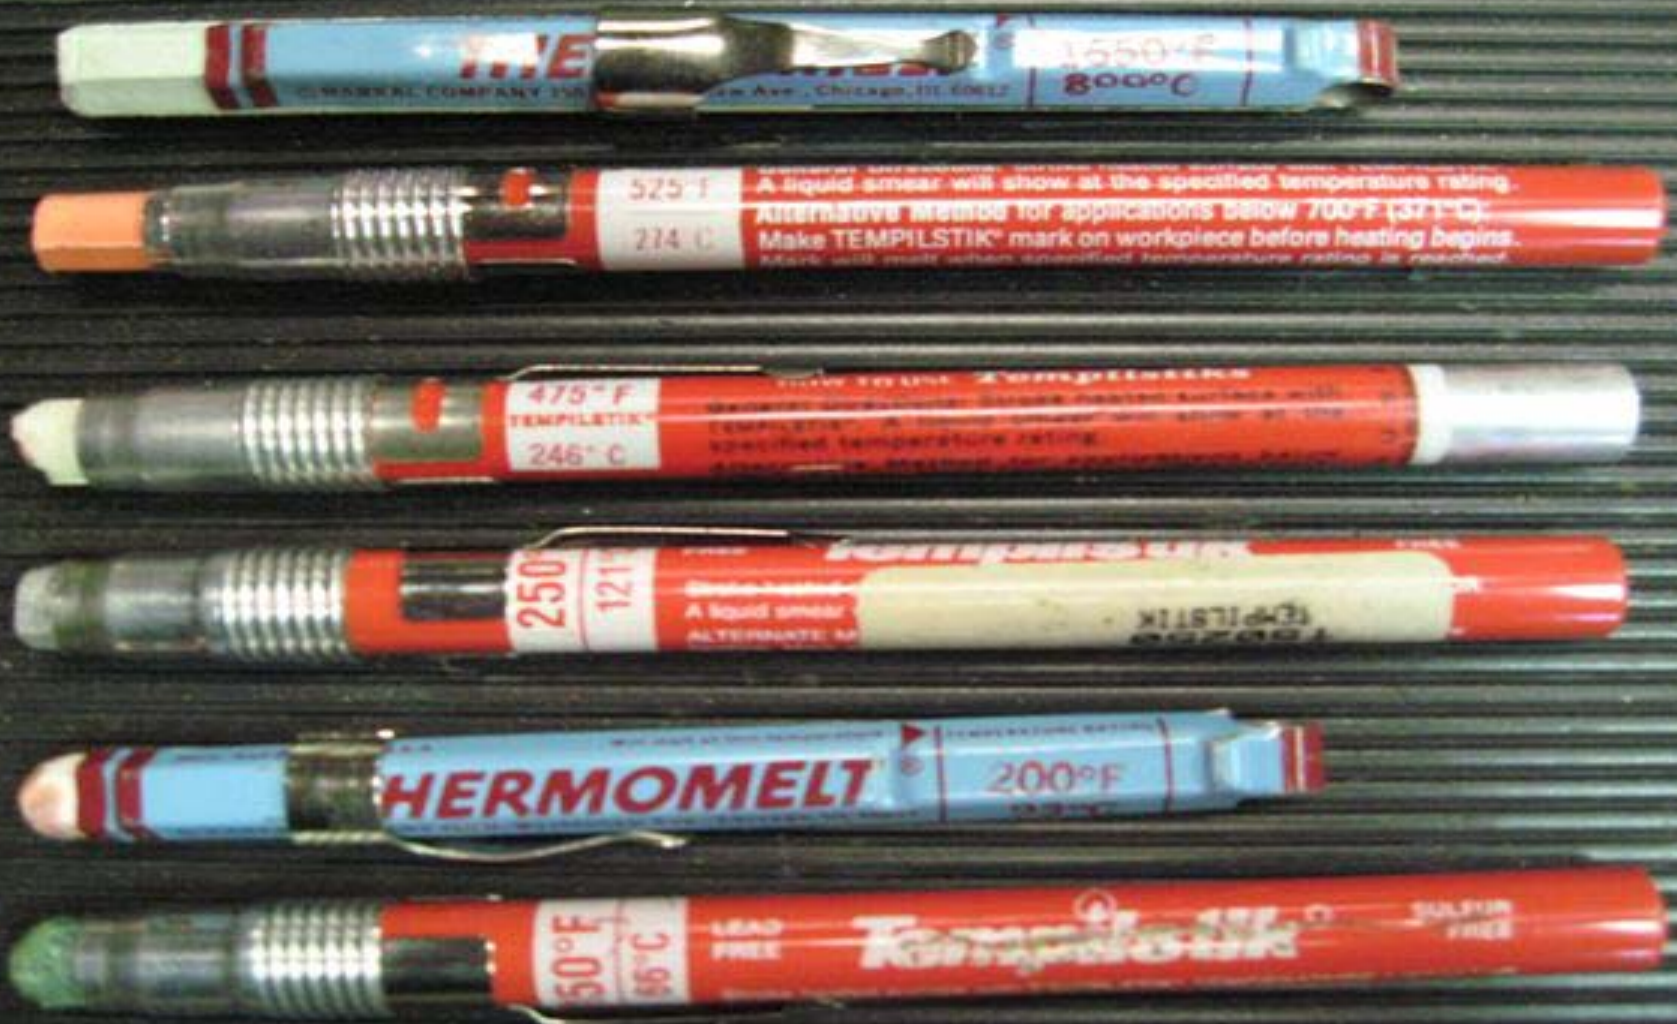
The crayon holder specifies the melt temperature.

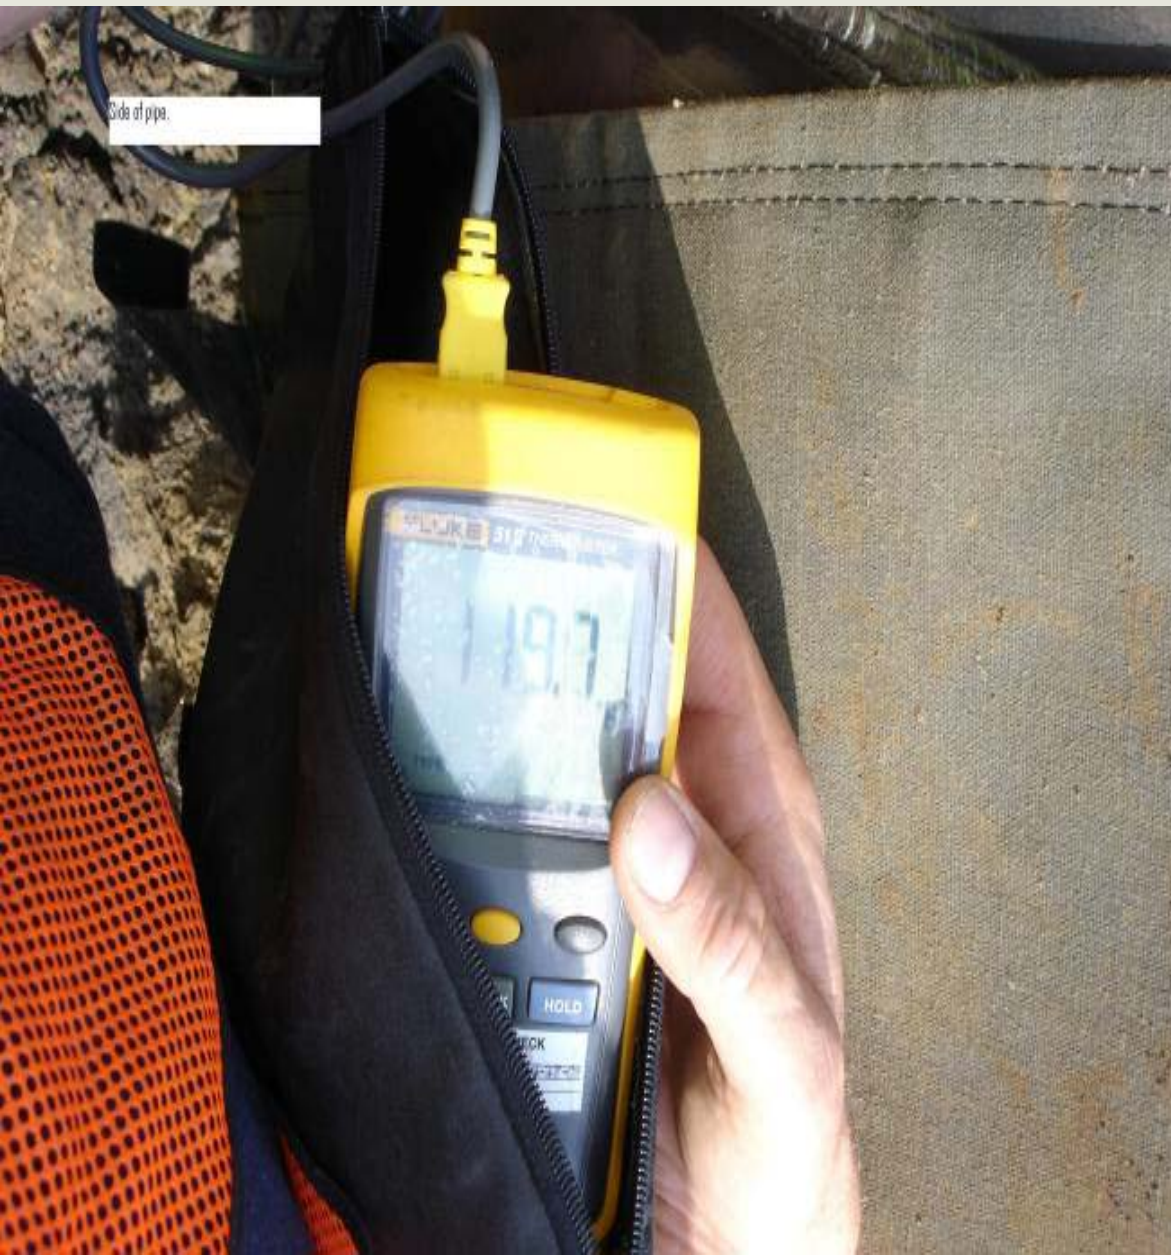
Welding  
procedure  
required  
250°F  
preheat

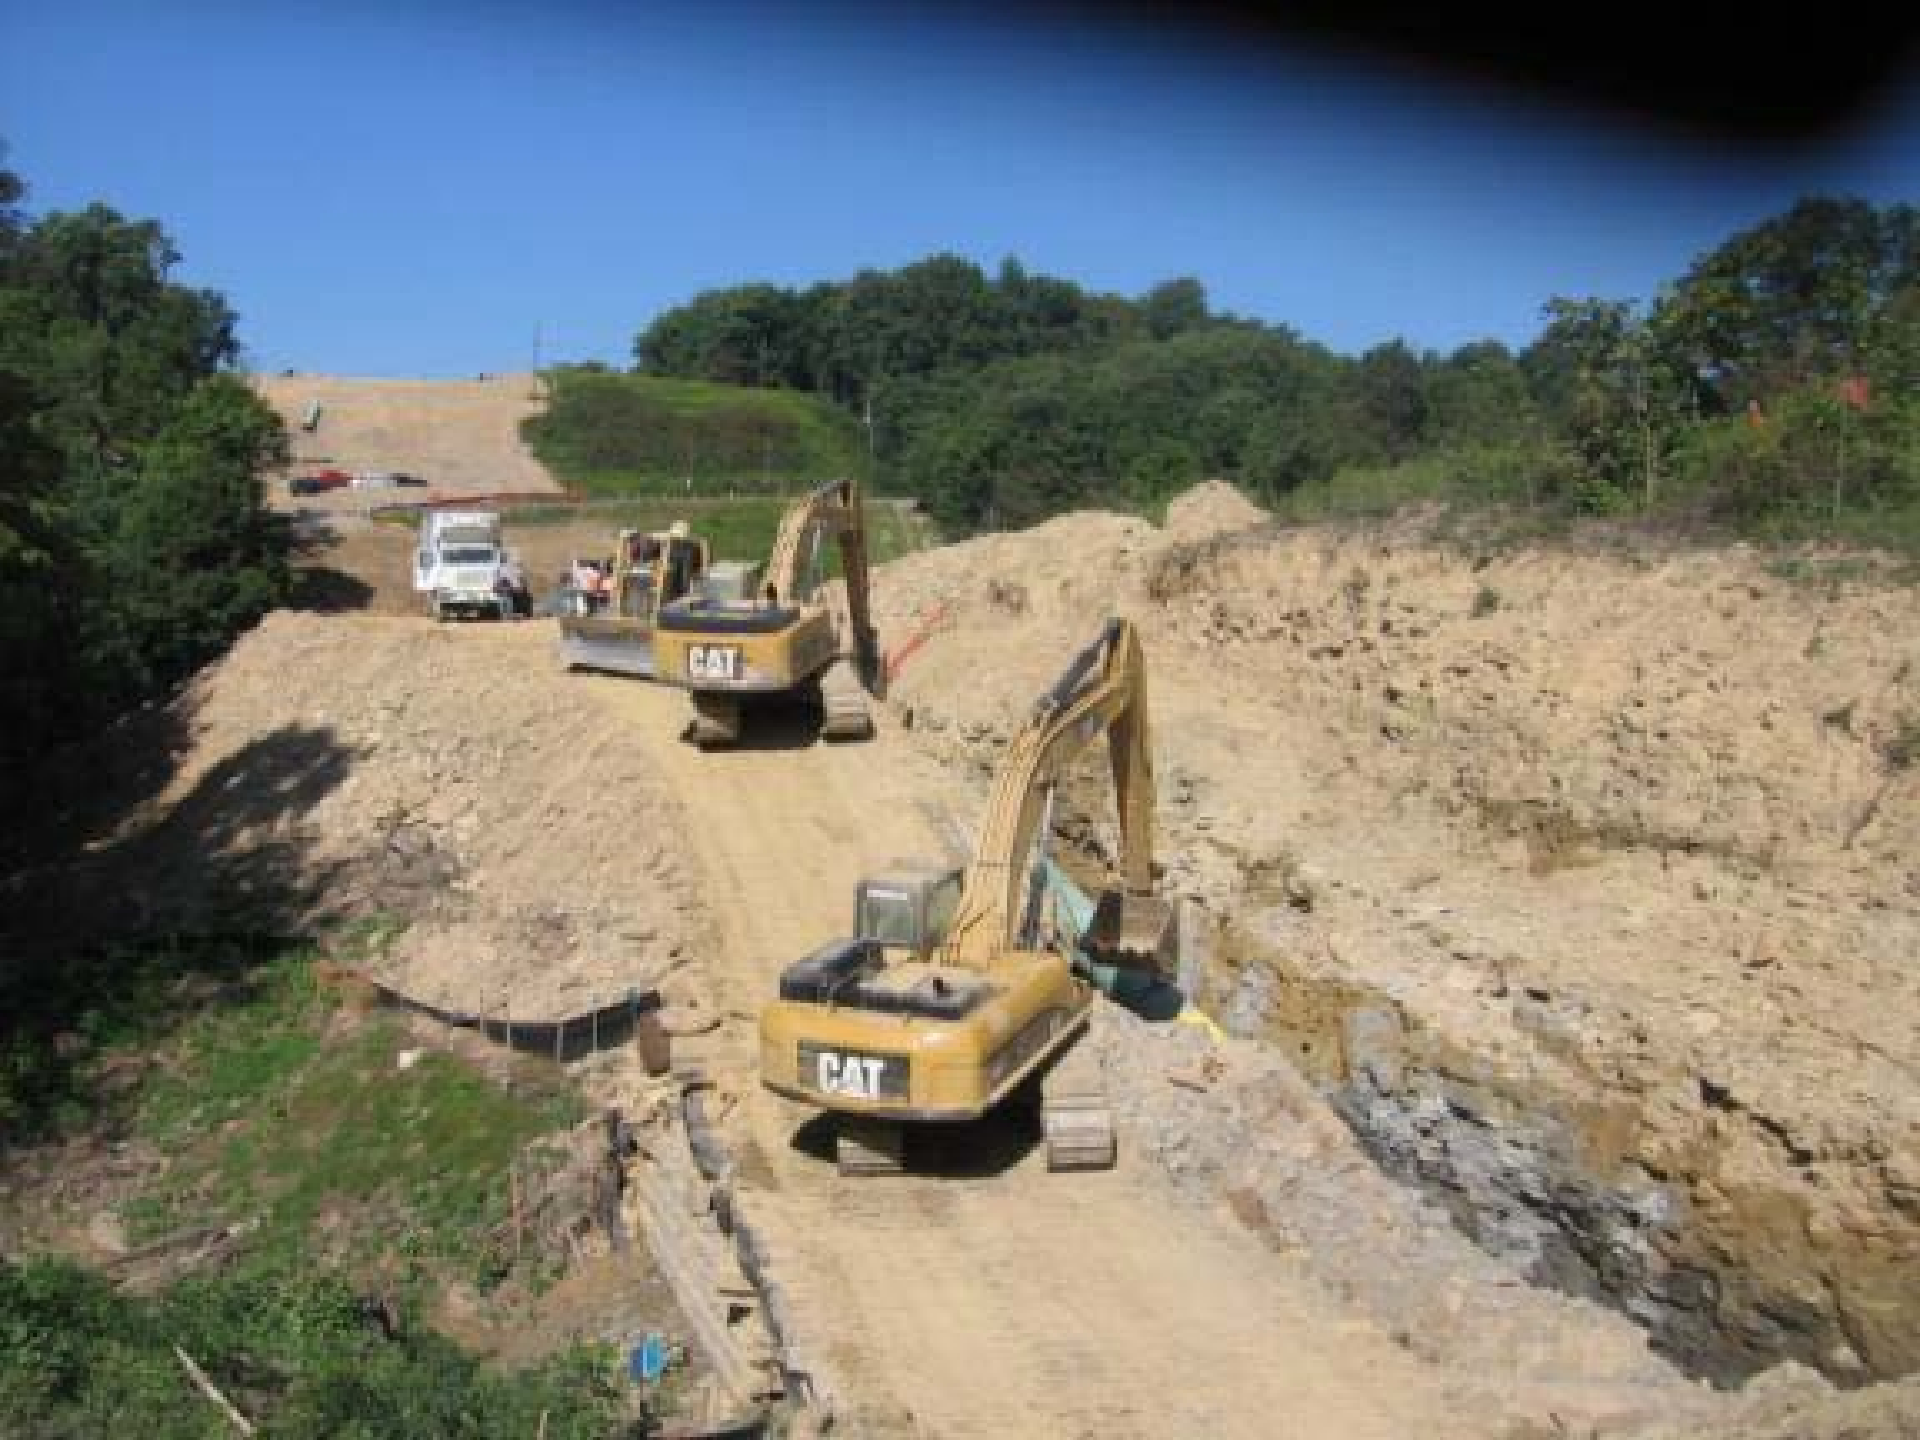
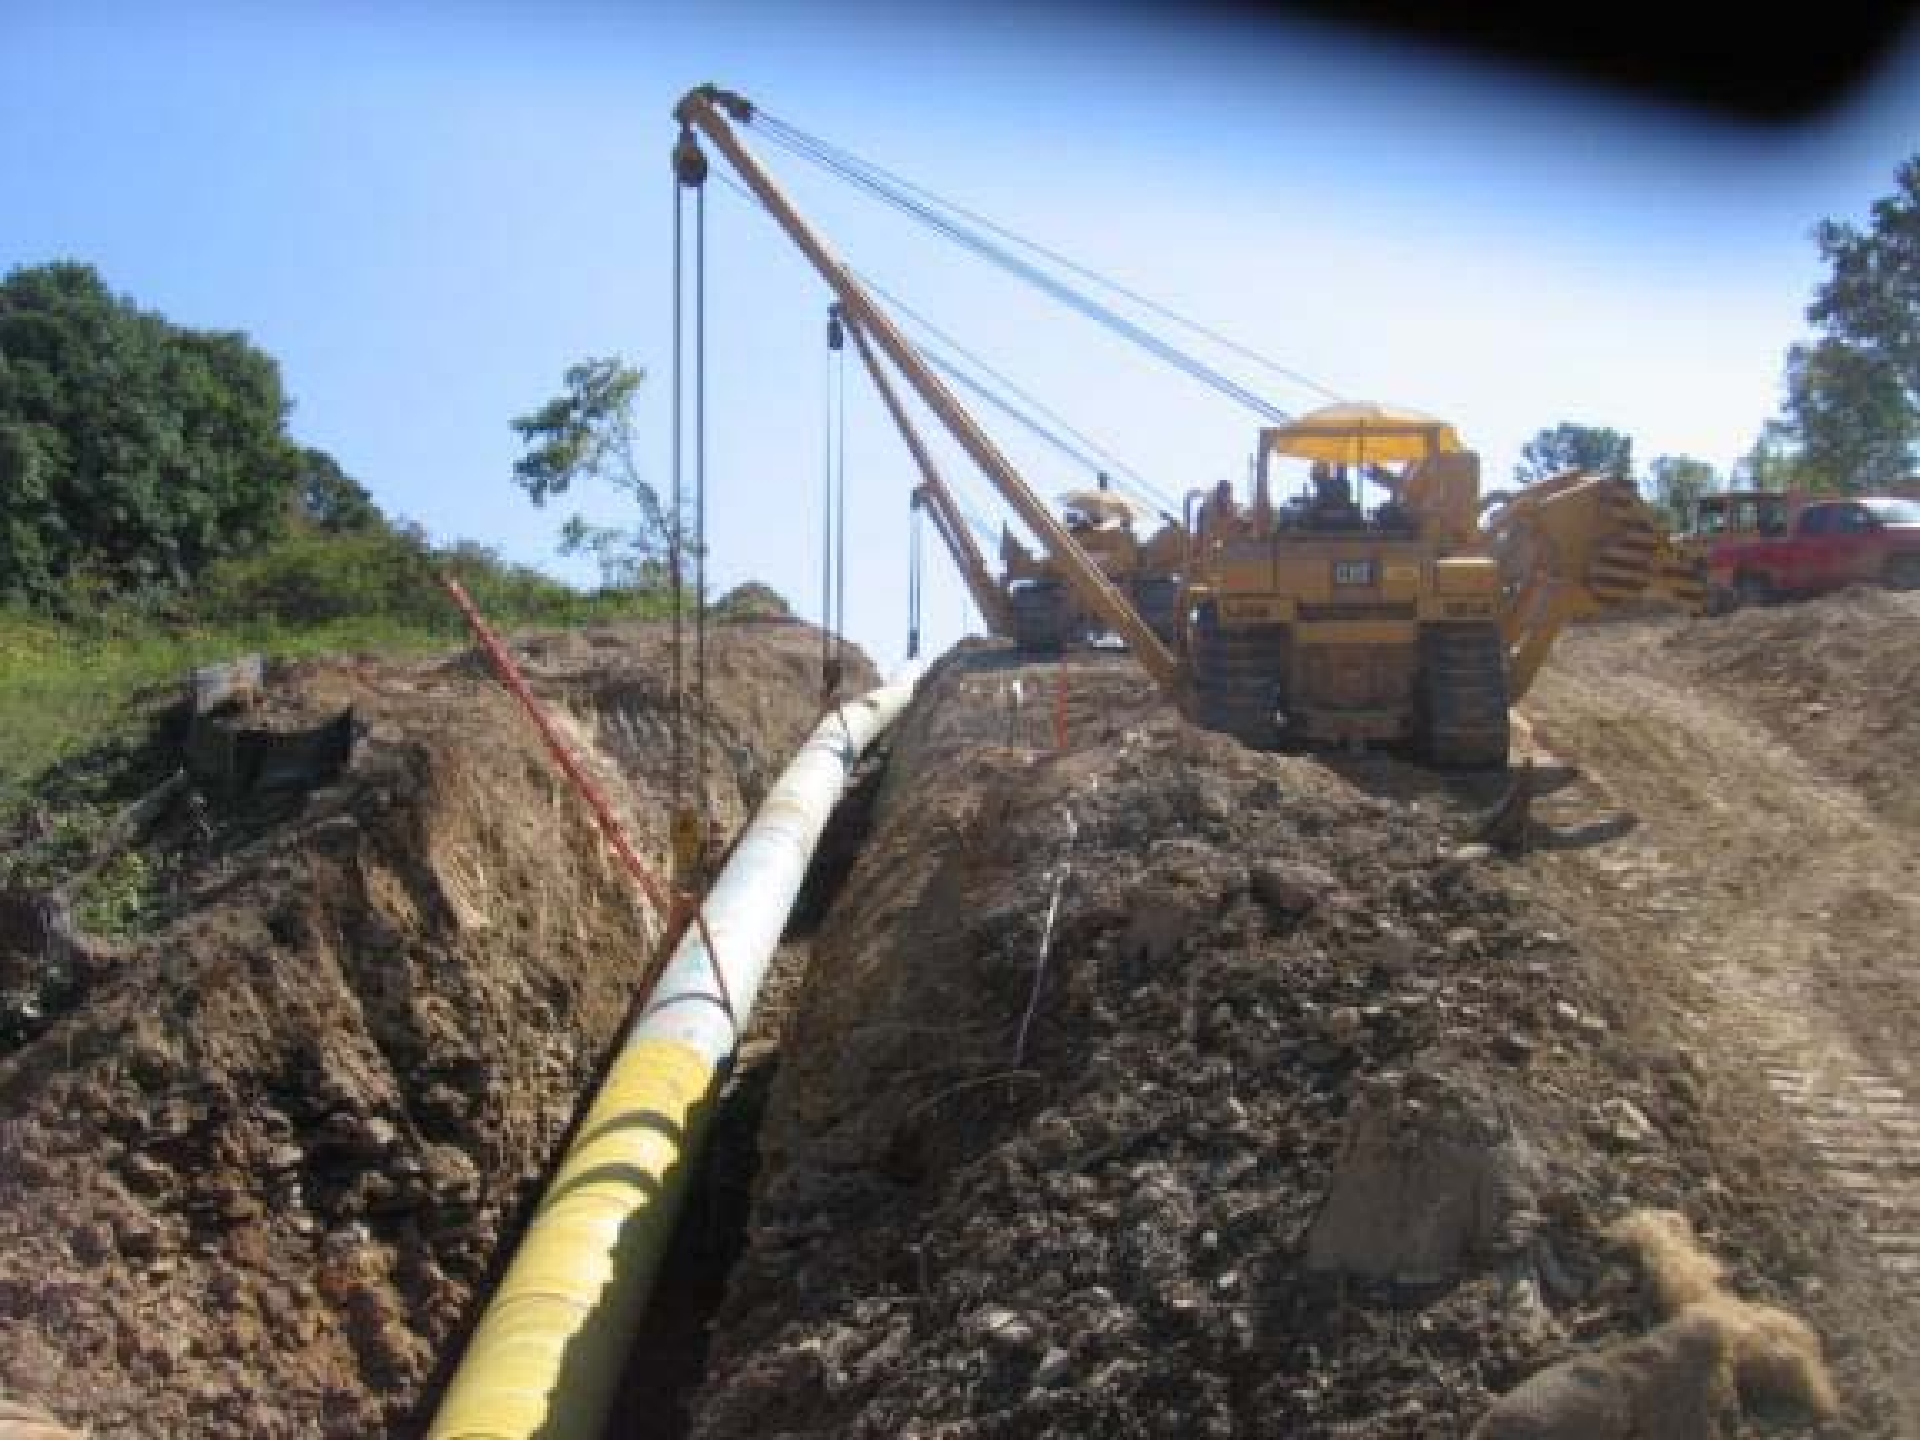
Seriously???

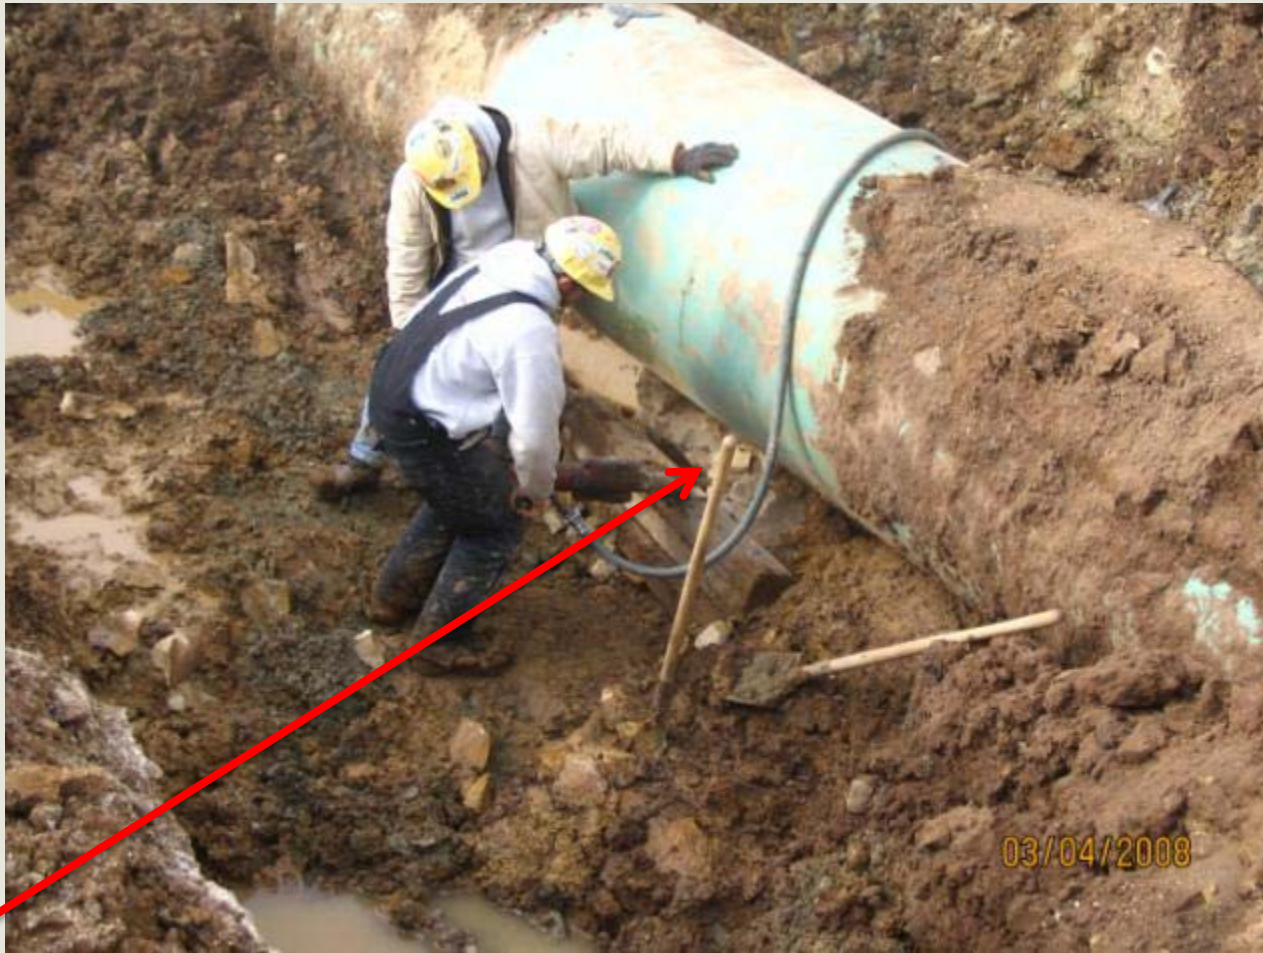
Pipe on Solid Rock

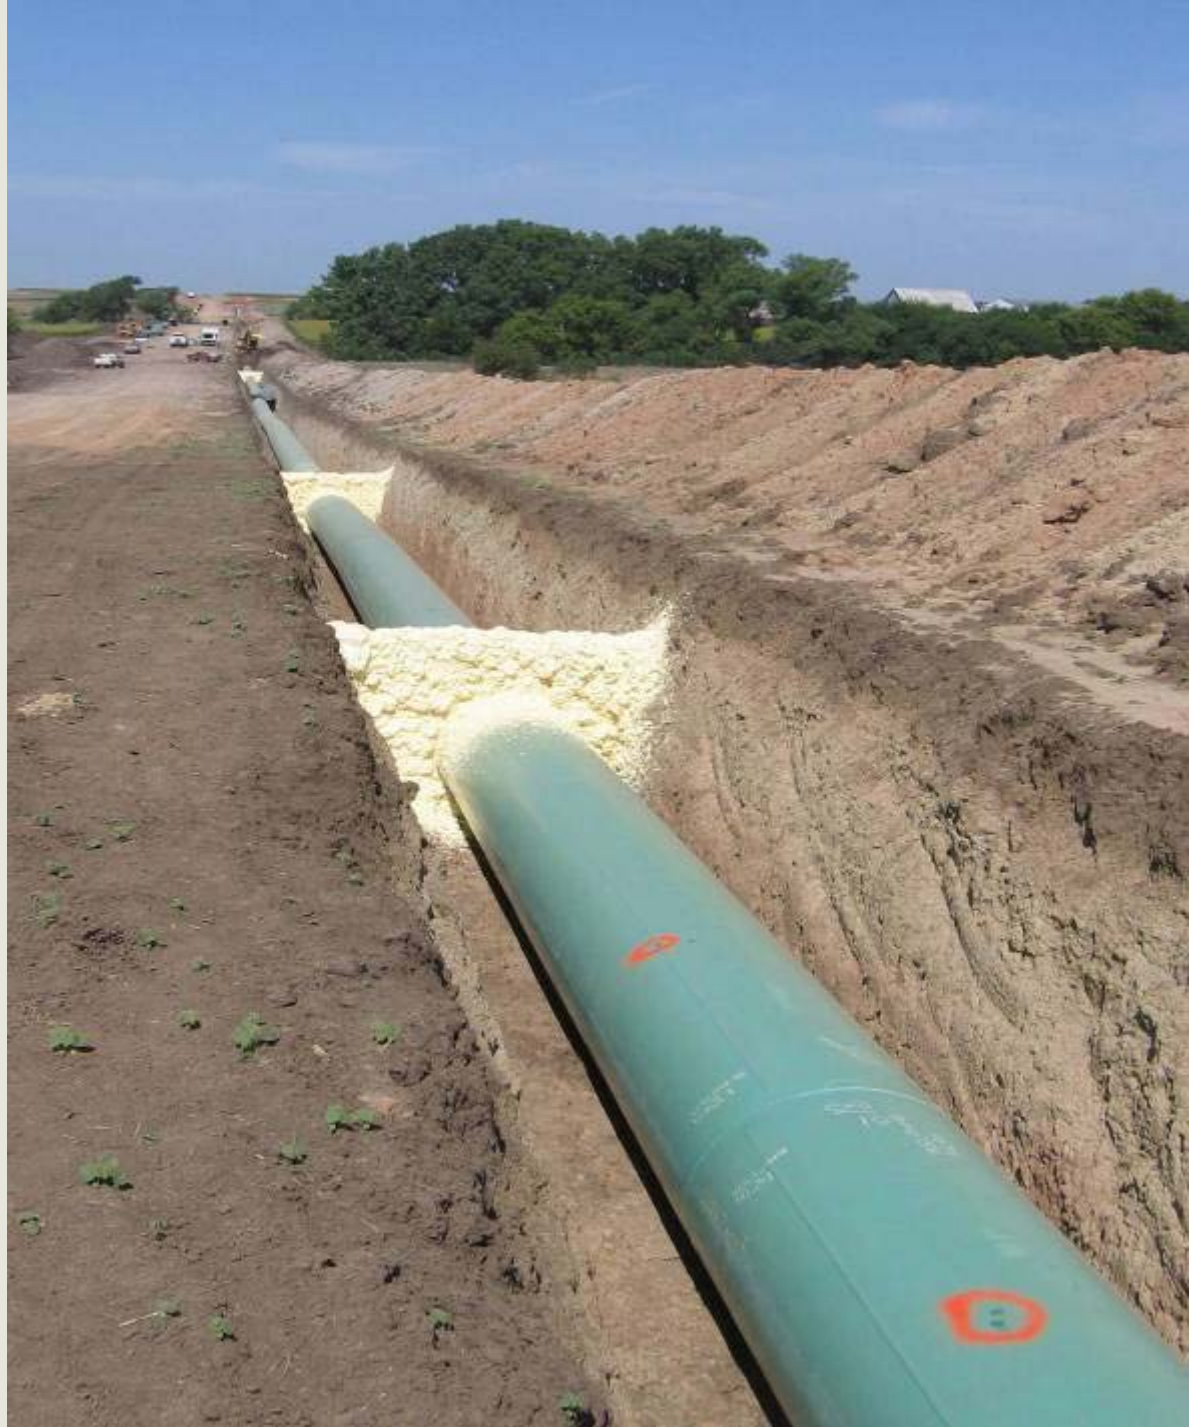
# Are there sufficient weights?

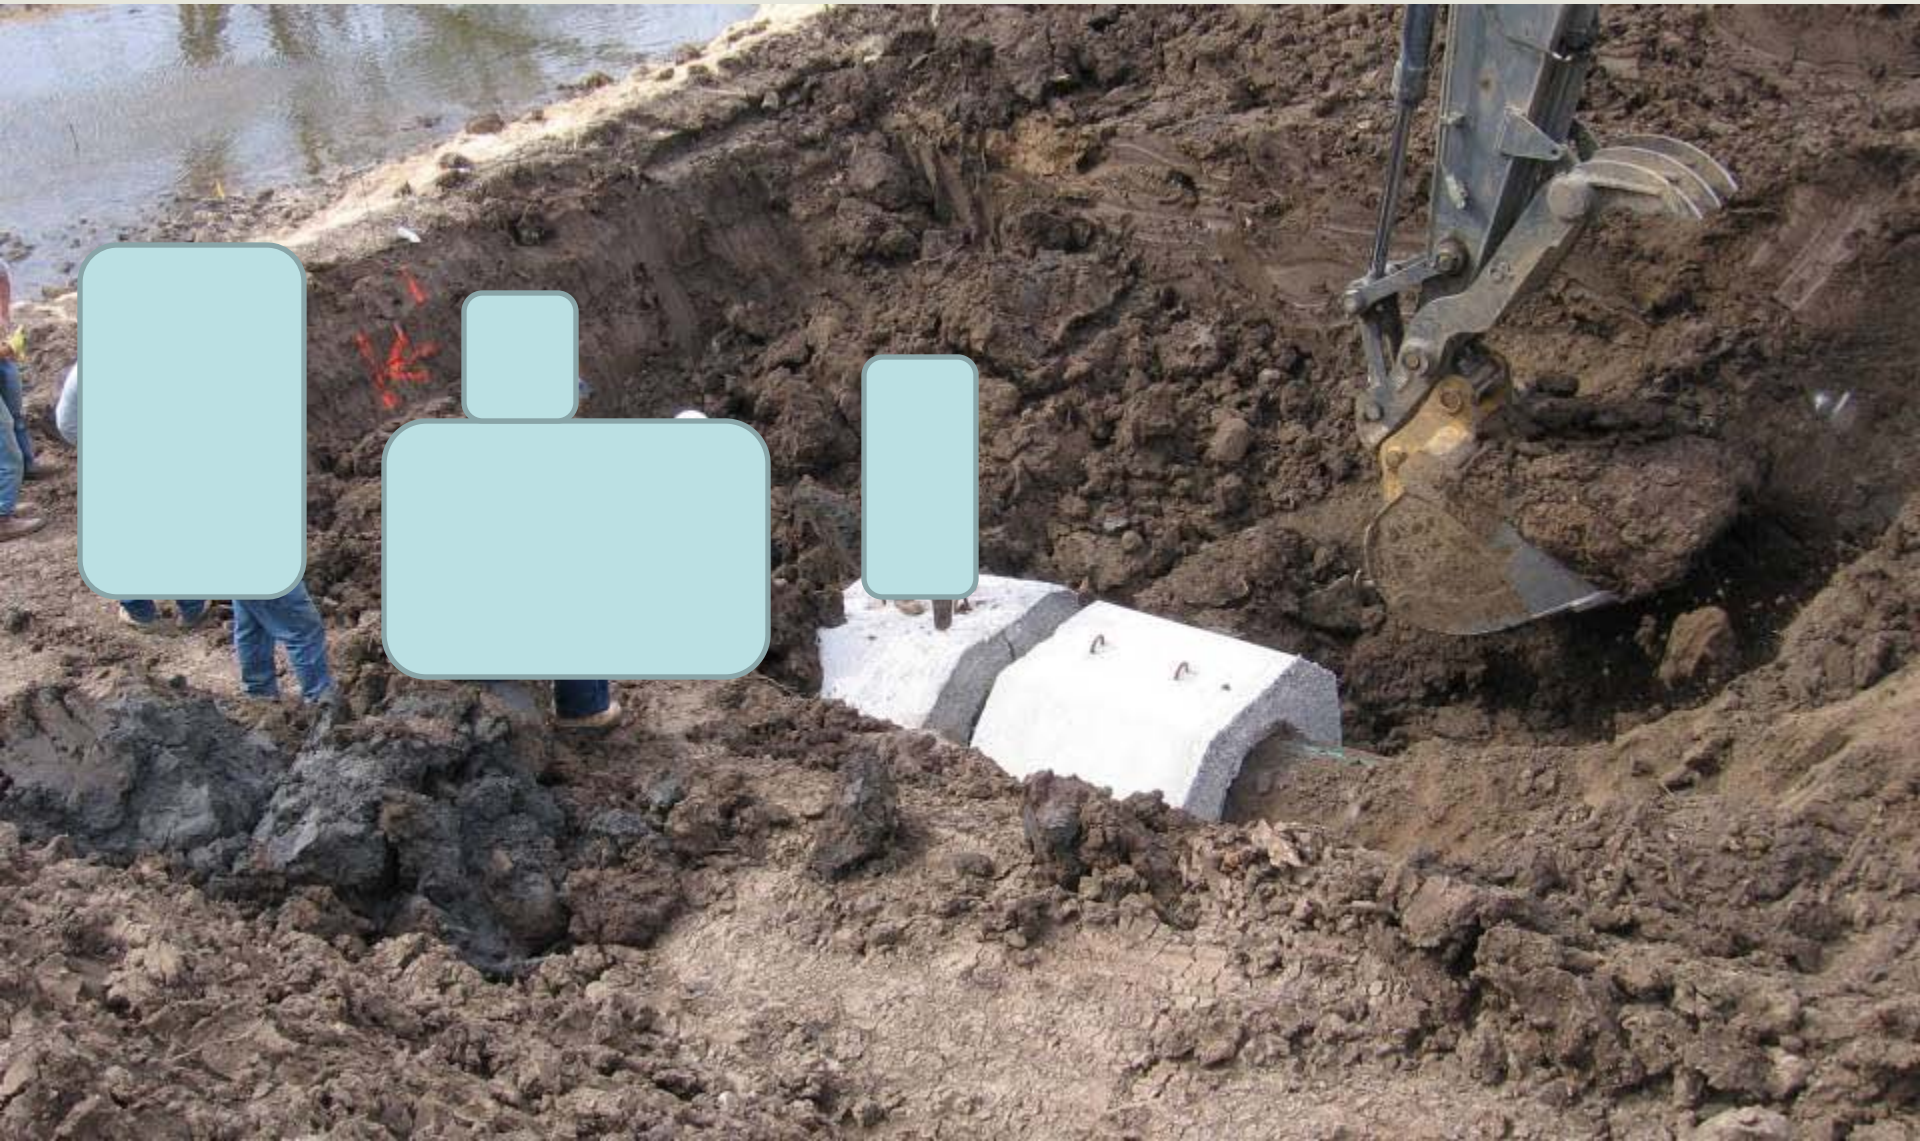
Protected from rocks in the ditch?

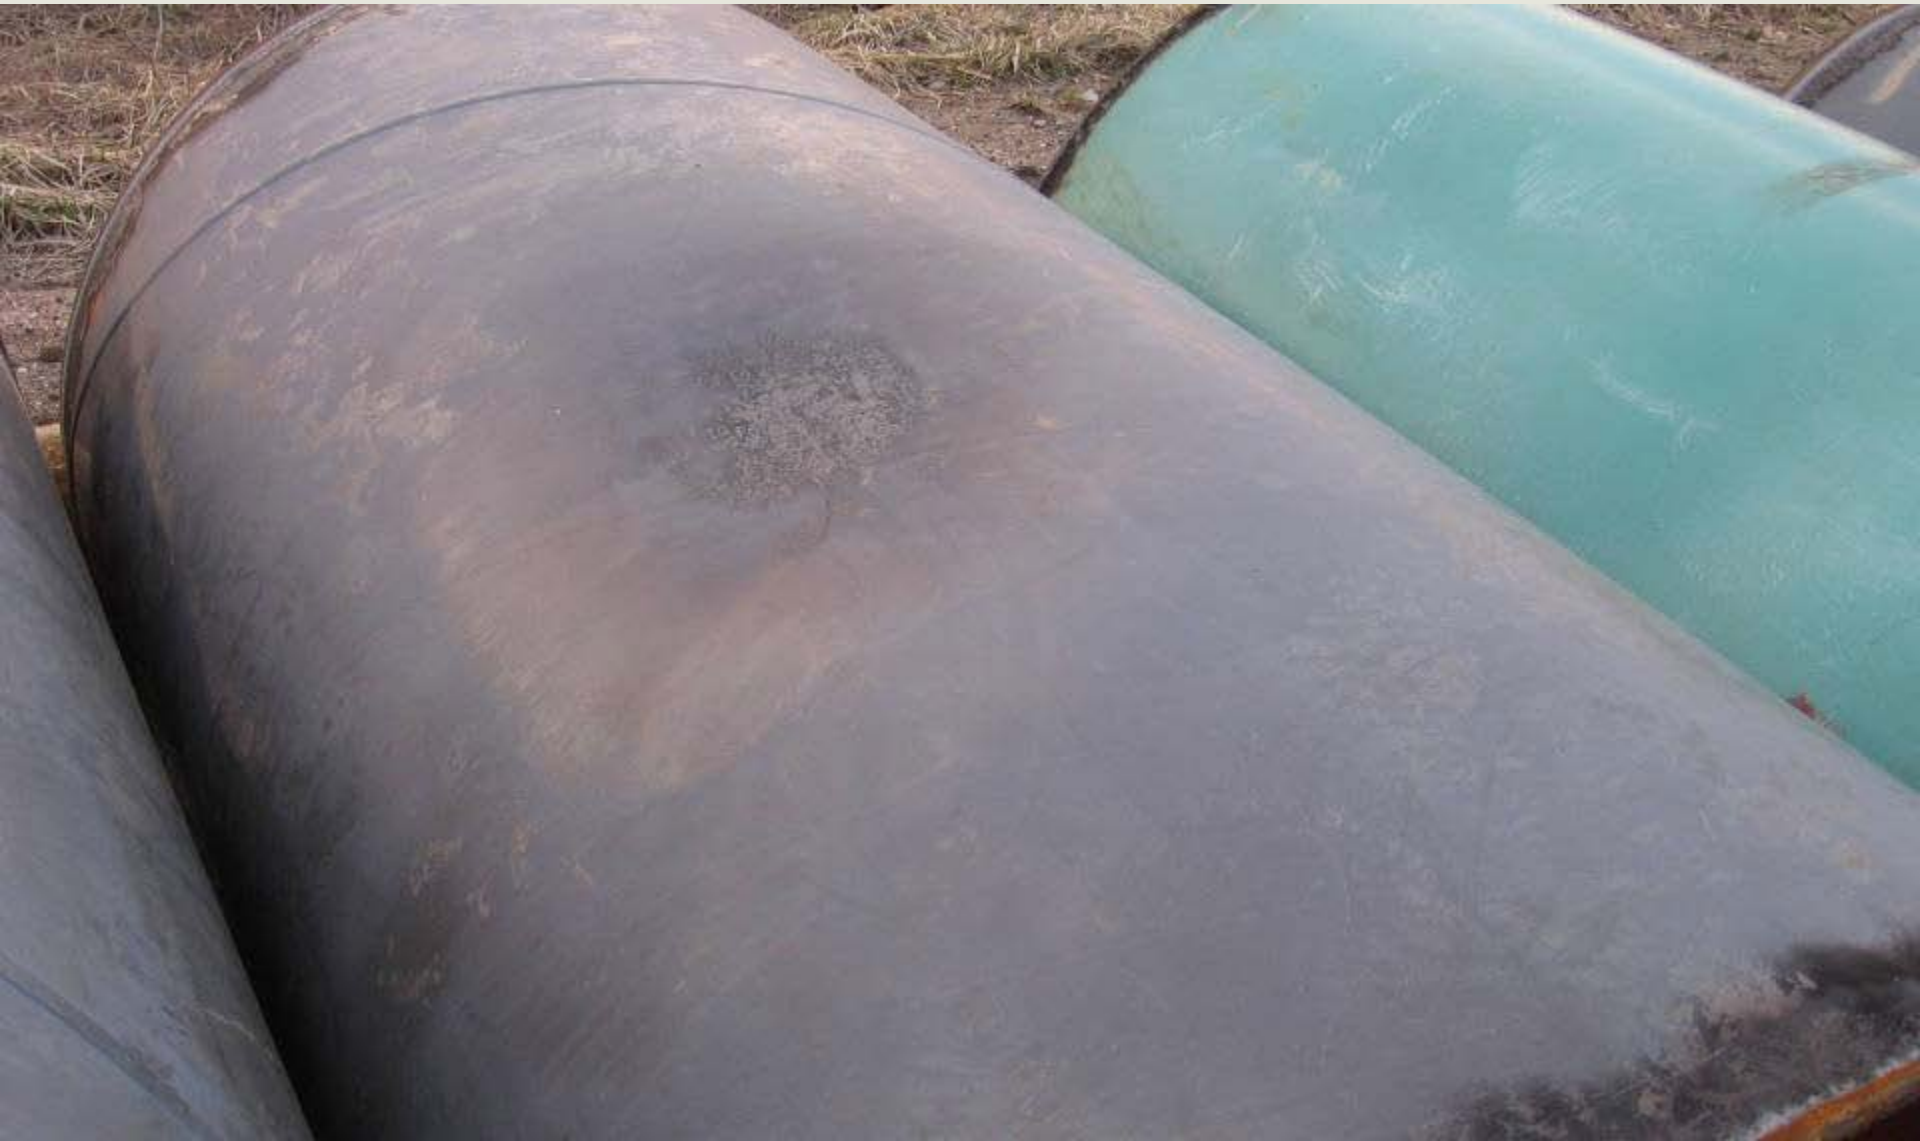
Pipe Defect – Does remaining wall thickness meet requirements of API 5L?
