OCC  
Pipeline Safety Seminar  
September 2011

Construction Issues

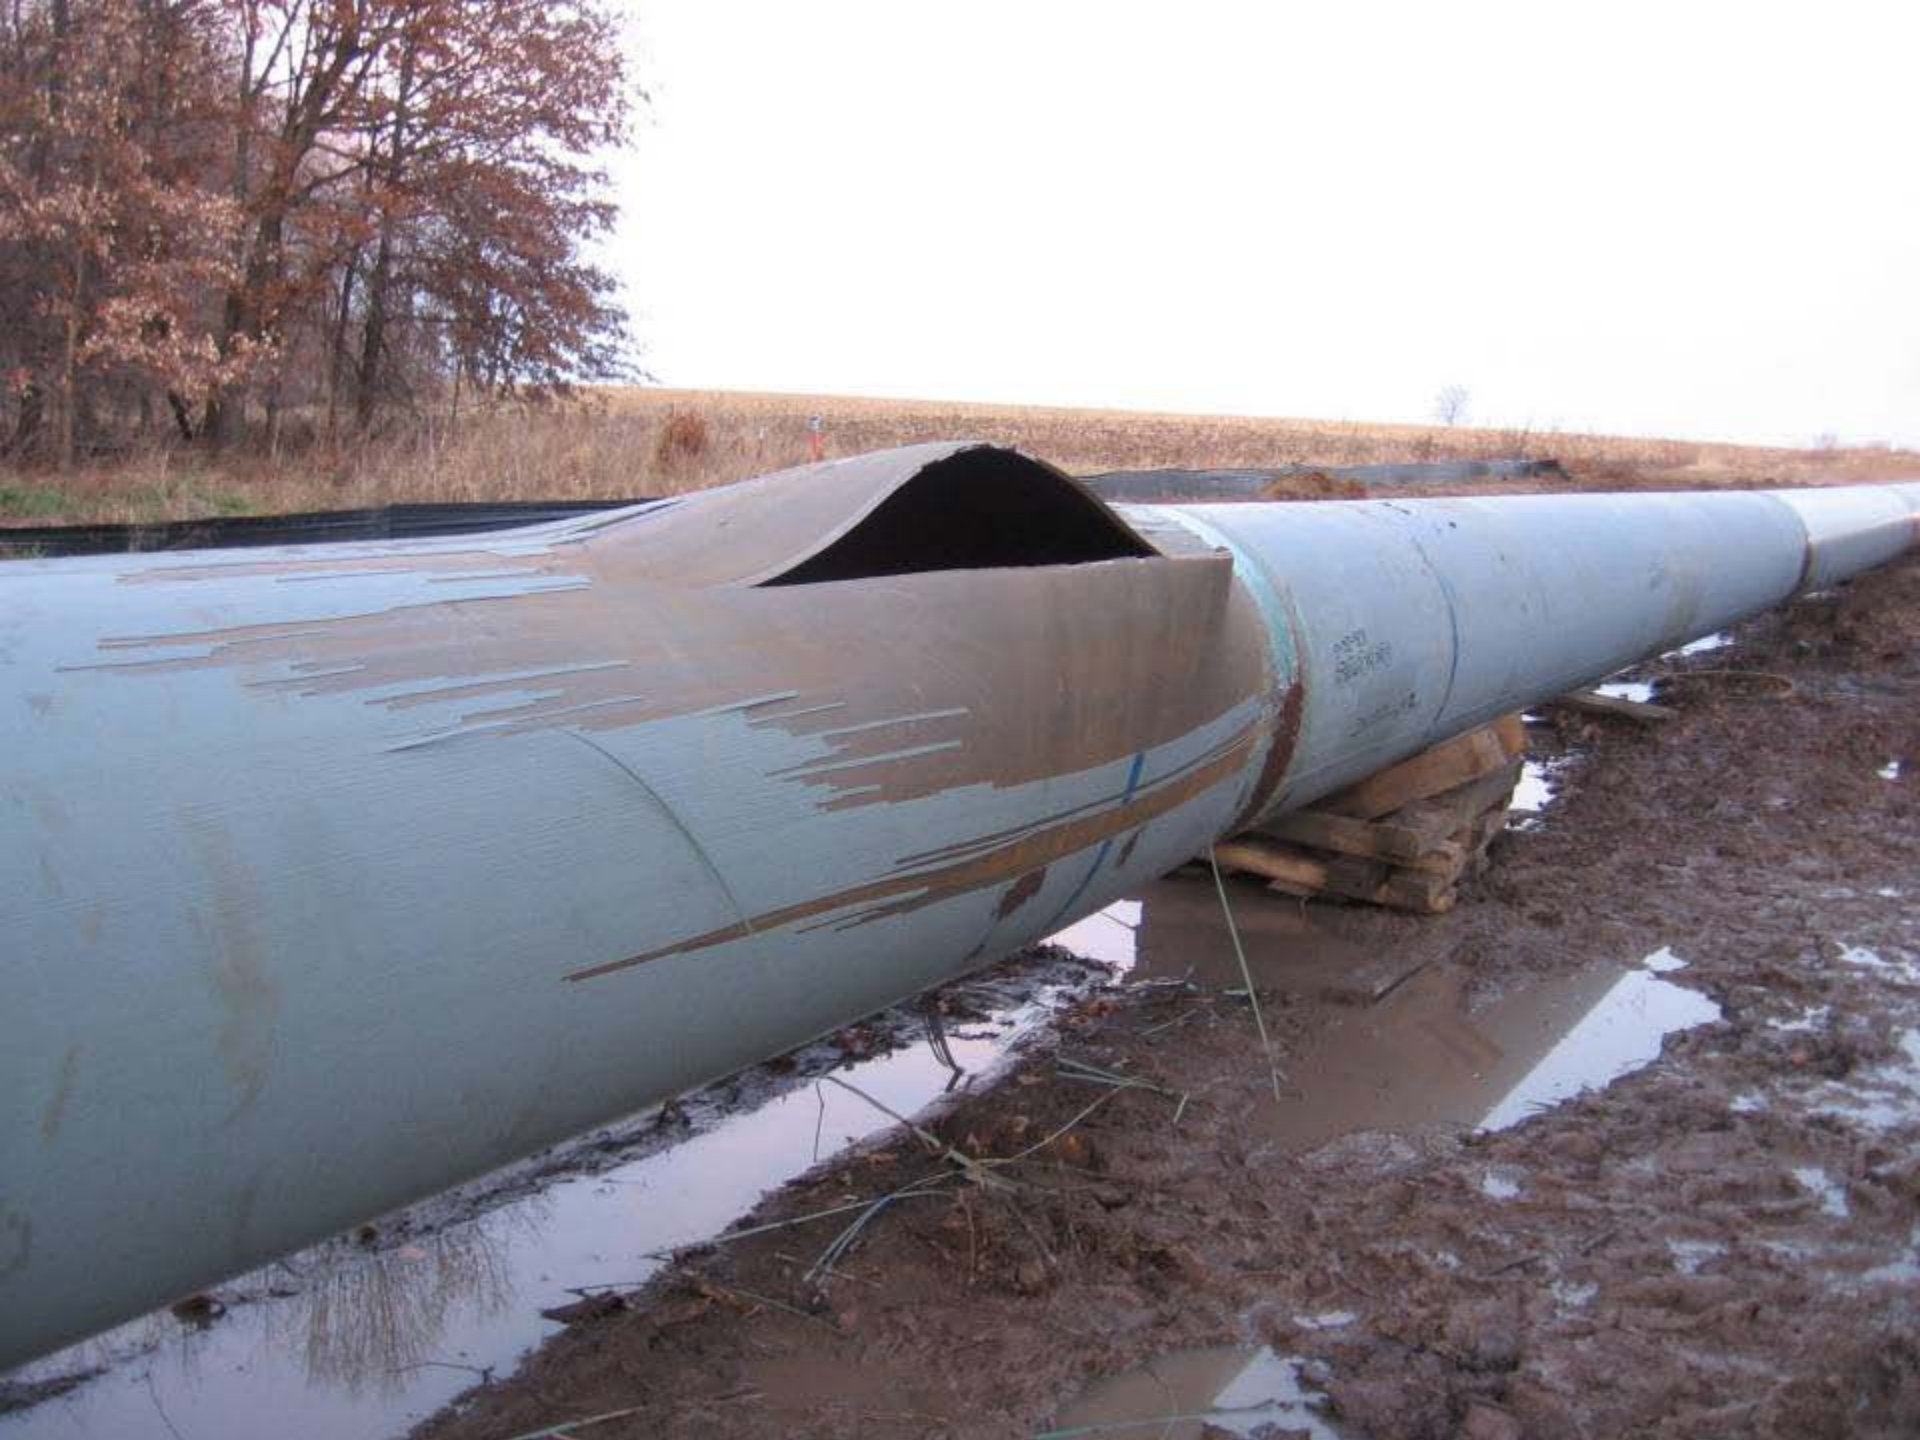
Chart shows pressure loss last 3 ½ hours

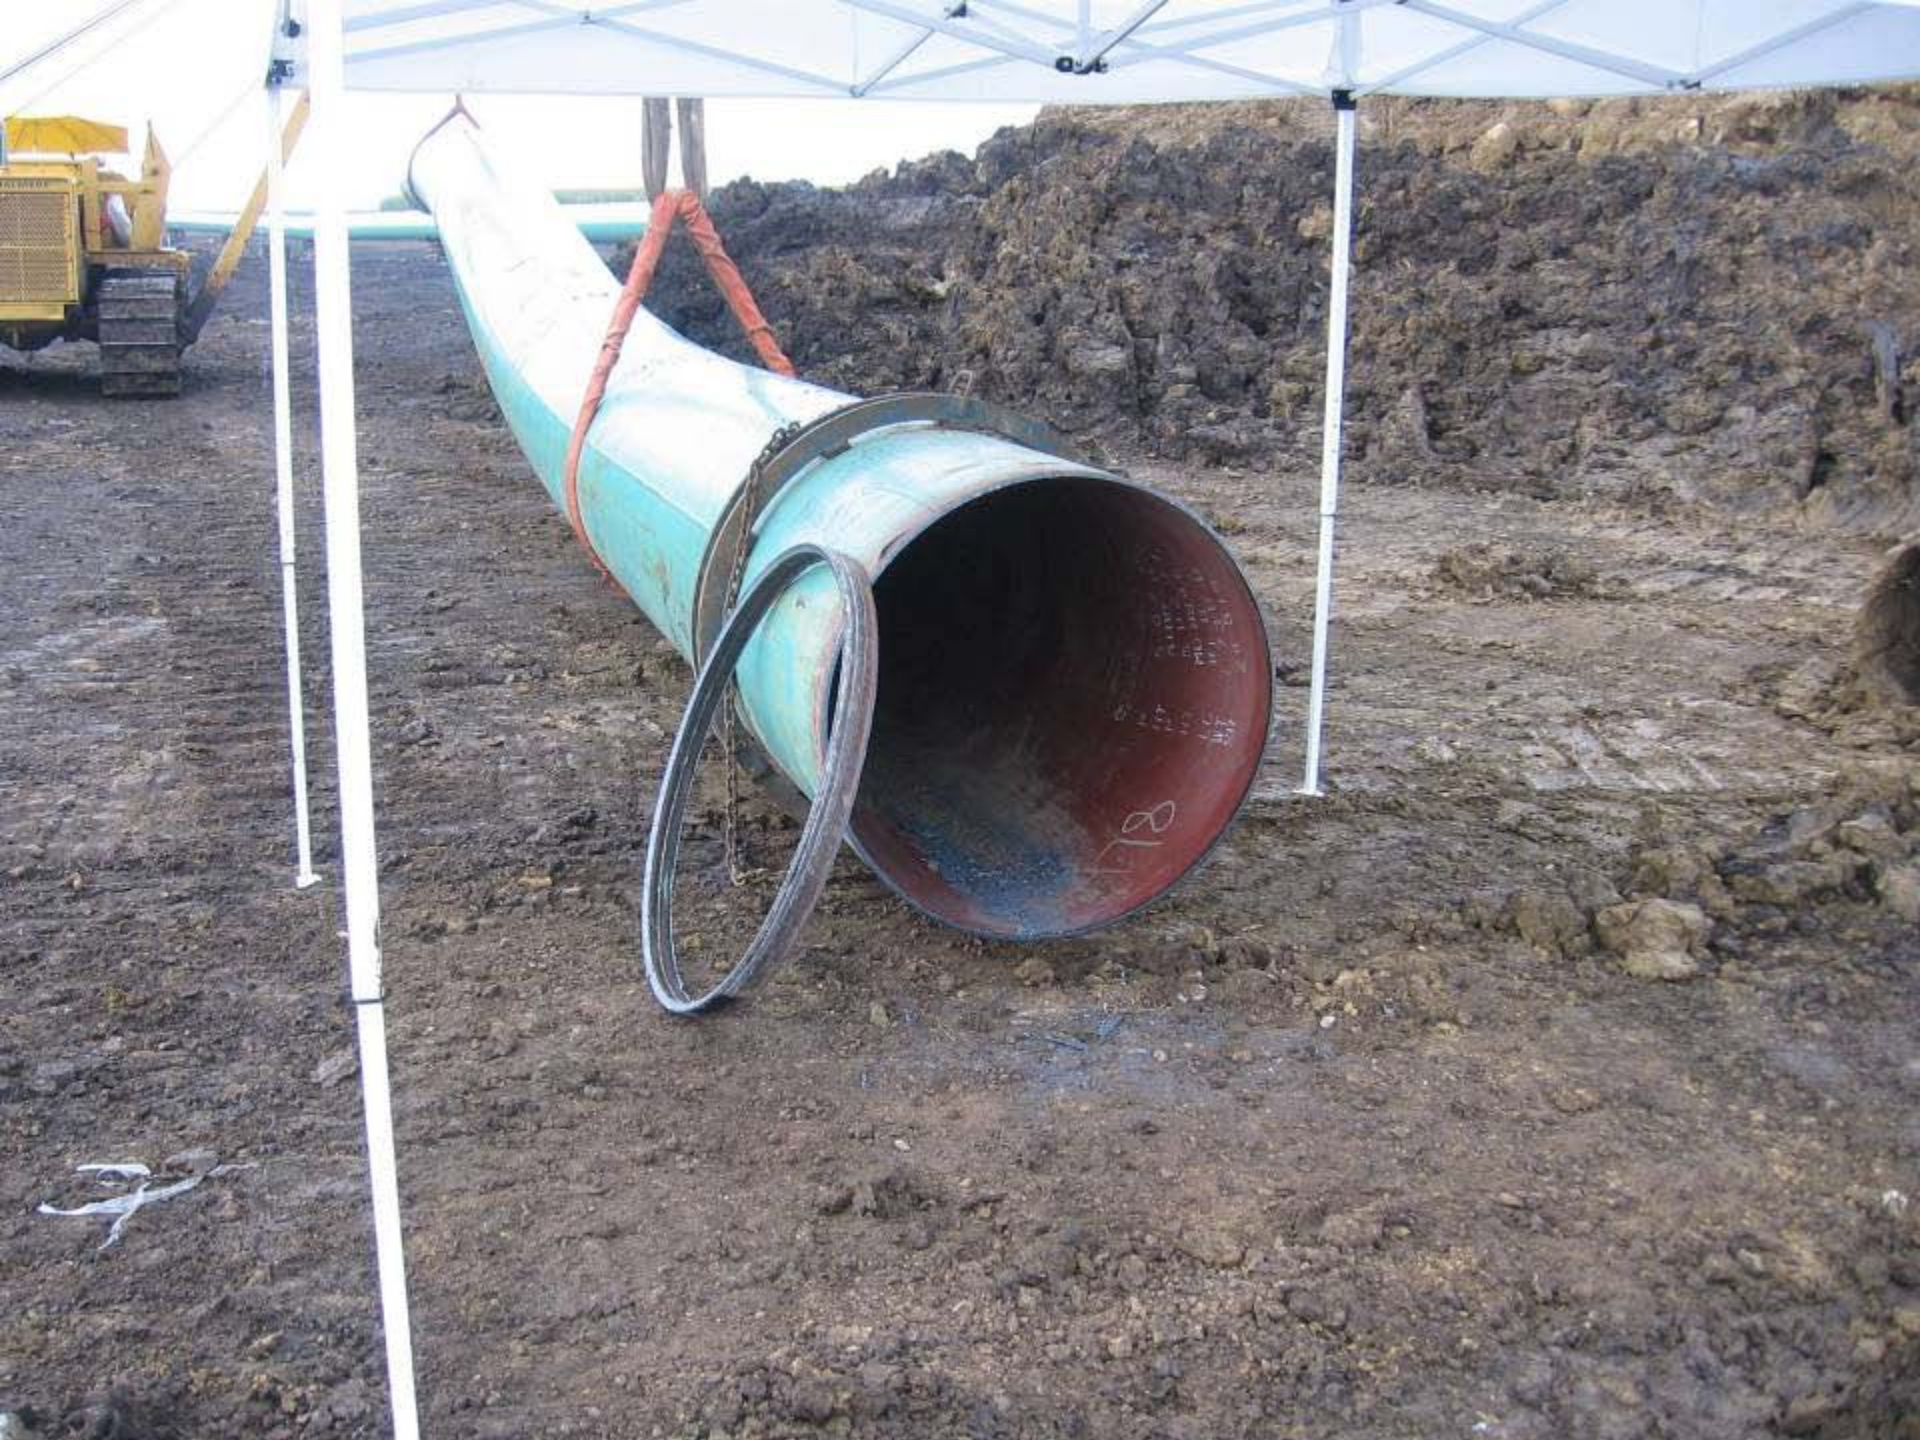
The external weld was completed in the trench box. Then the welder crawled inside and completed the back weld. This was a transition weld between 0.740 and 0.486 wall thickness pipe. The welder struck the arc multiple times inside the pipe and missed the bevel multiple times.

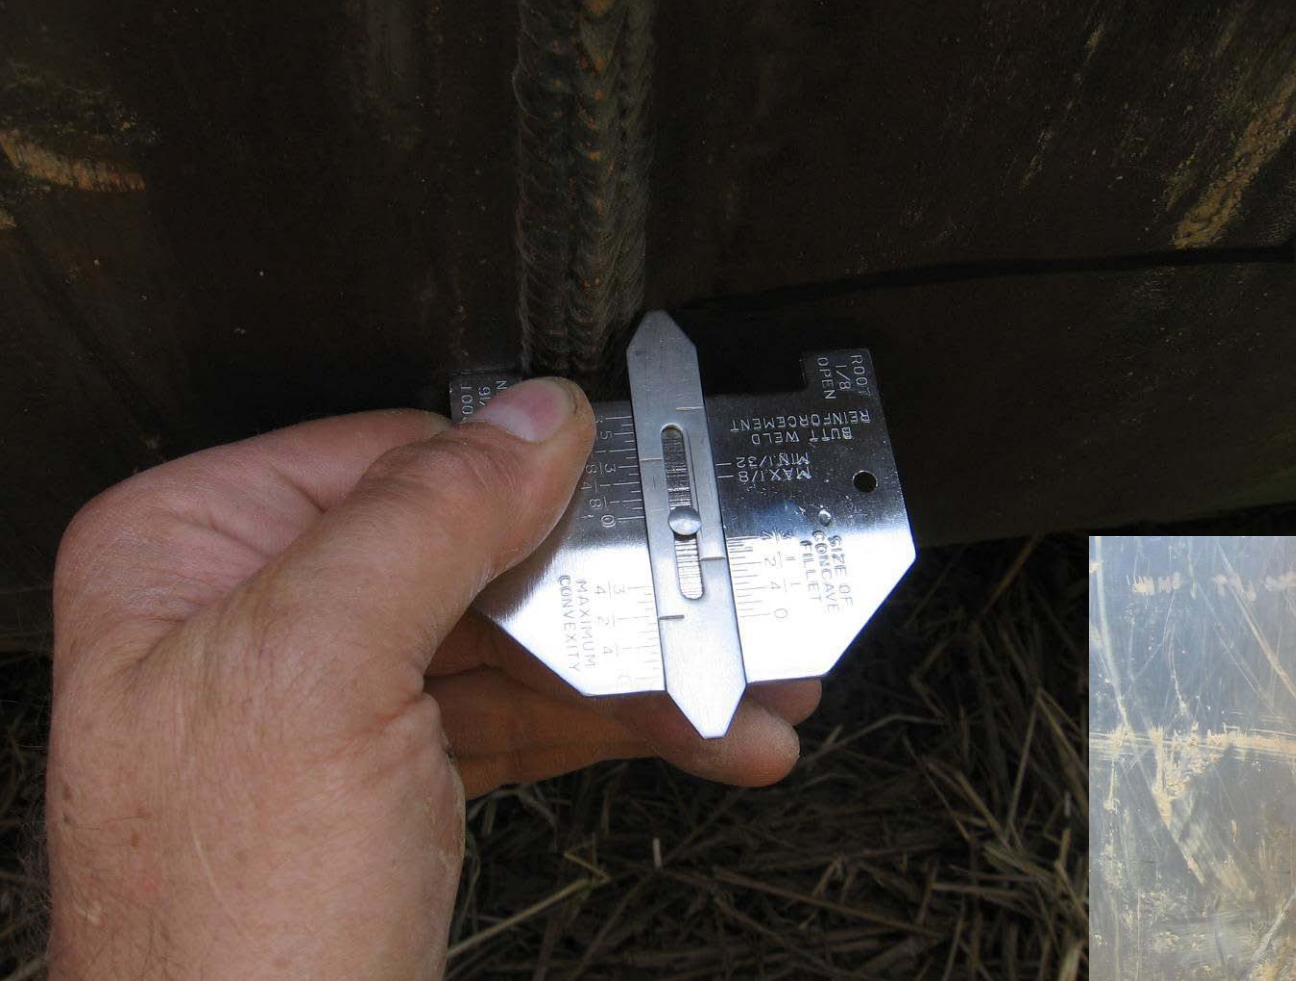
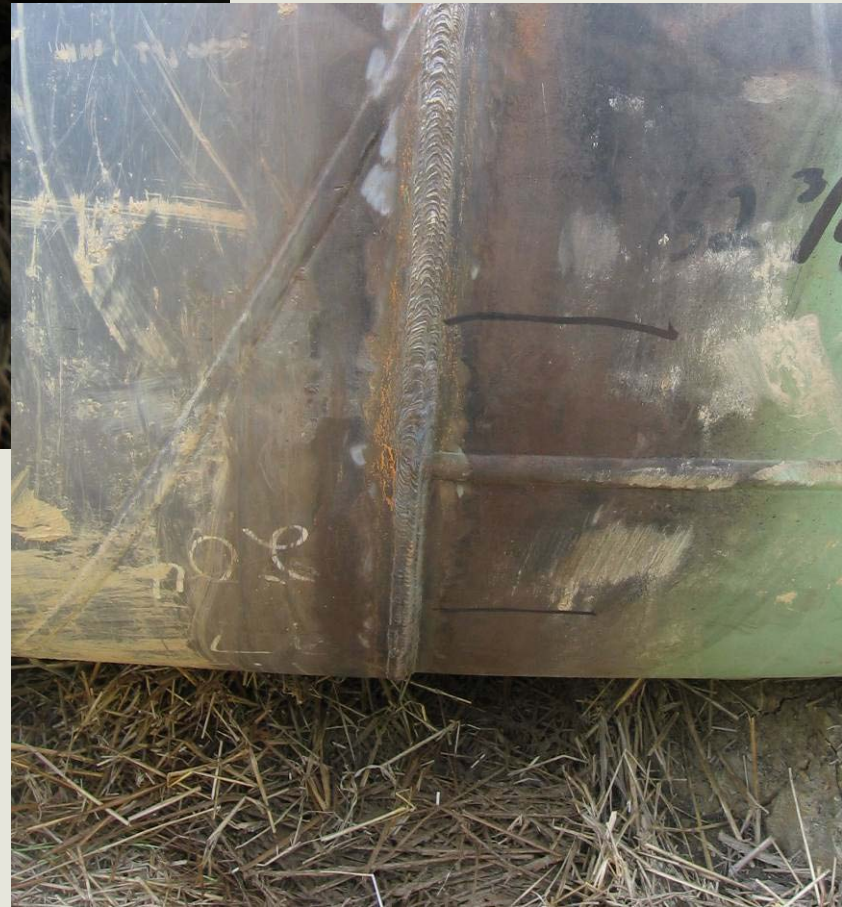
The gauge measures 7/16". Is this okay?
